Mount Penang Parklands

Central Coast Highway, Kariong
(SHR listing number 01667)

Conservation Management Plan

November 2020 • Issue D
Project number 19 0069

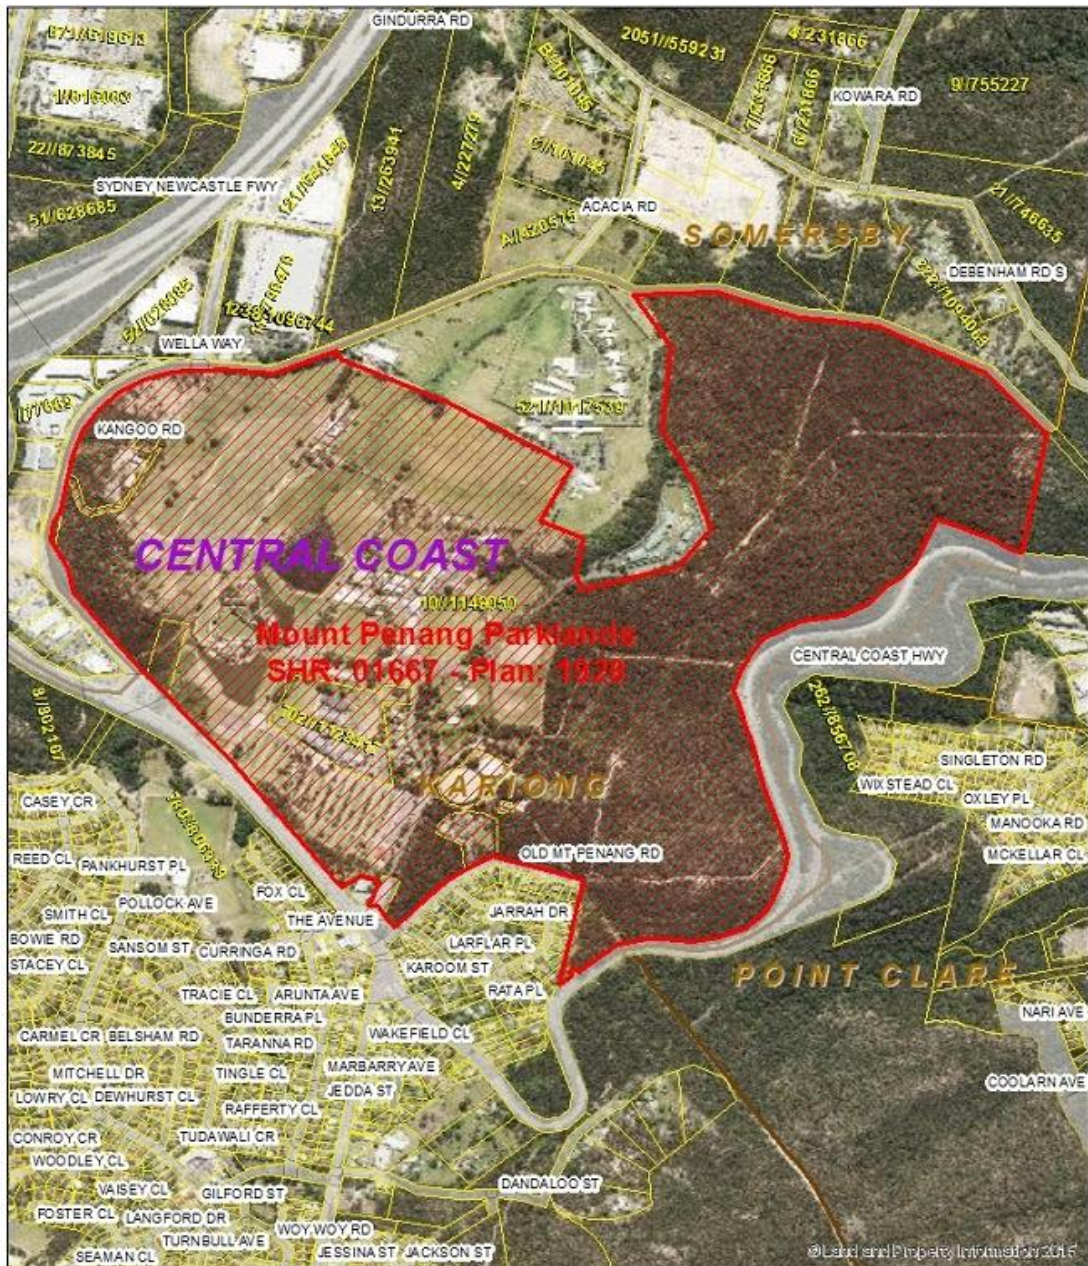
State Heritage Register - SHR: 01667 - Plan: 1928

- SHR boundaries for the listing of Mount Penang Parklands.
Source: State Heritage Register database entry for Mount Penang Parklands.

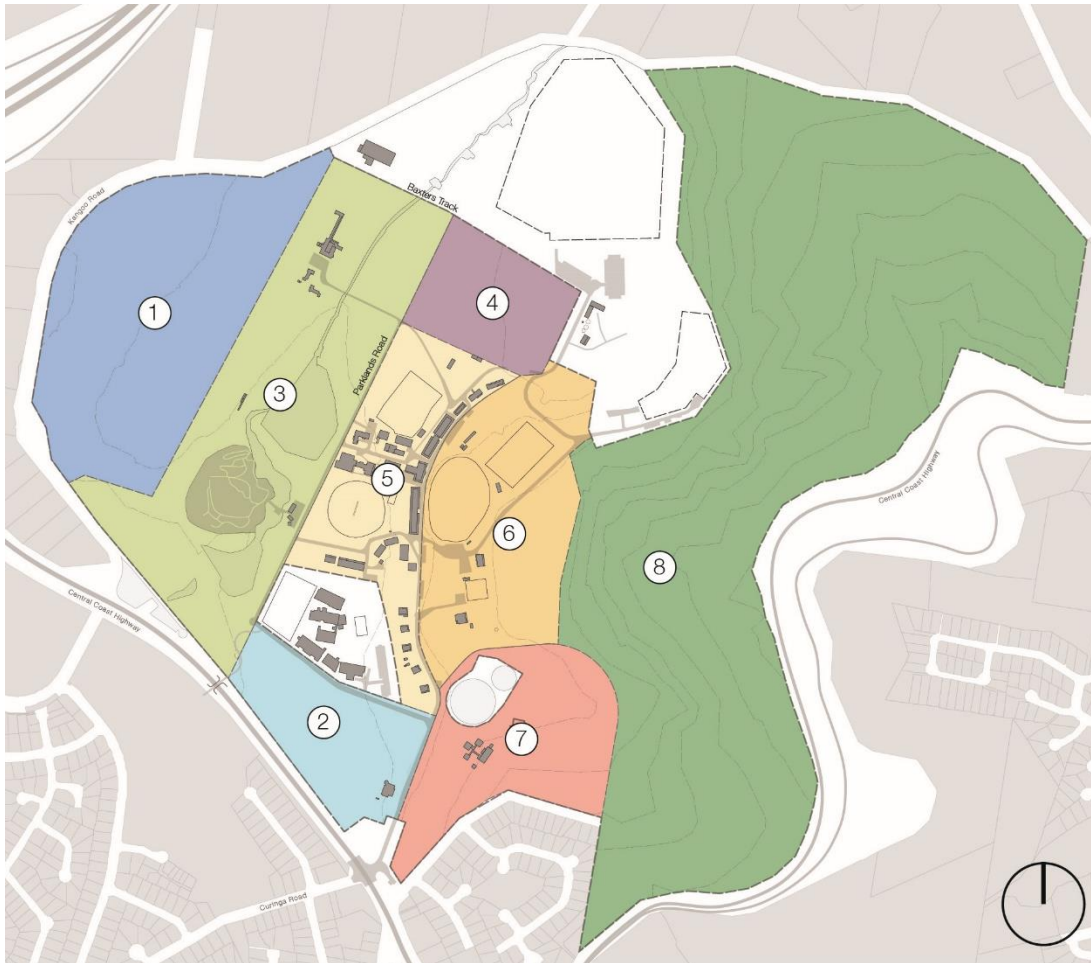
3 Site plan showing the various precincts of the Mount Penang Parklands, not to scale.
Source: HCCDC.

- 1 Kangoo Road Commercial Precinct
- 2 Highway Commercial Precinct
- 3 Festivals/Gardens Precinct
- 4 Baxter's Track Mixed-use Precinct
- 5 Heritage Precinct
- 6 Sports Precinct
- 7 Philip House Mixed-Use Precinct
- 8 Bushland Precinct

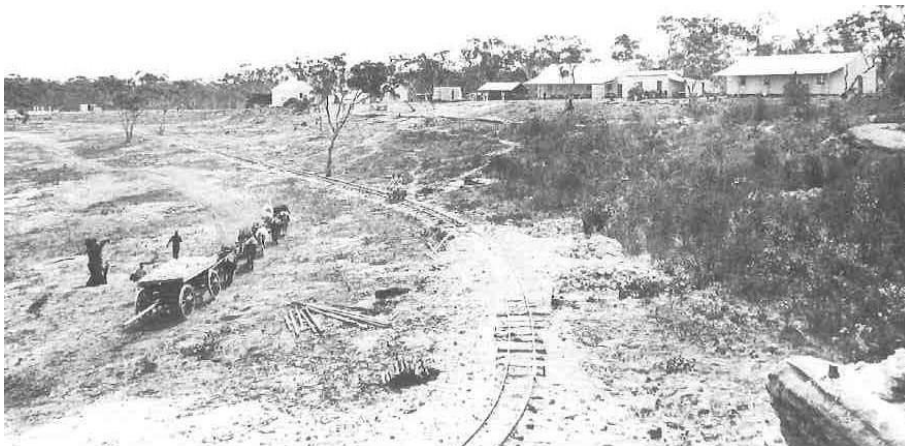
9 One of the tramlines linking the quarries to building sites. Temporary buildings can be seen in the background.

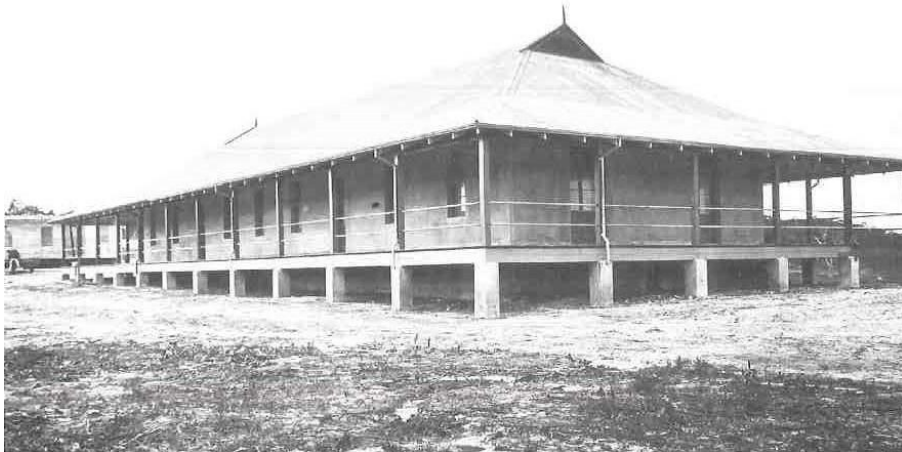
11 Completed dormitory (Building 26, Walpole House), 1913.
Source: Department of Community Services and Department of Juvenile Justice historical collection, reproduced in Rubie.

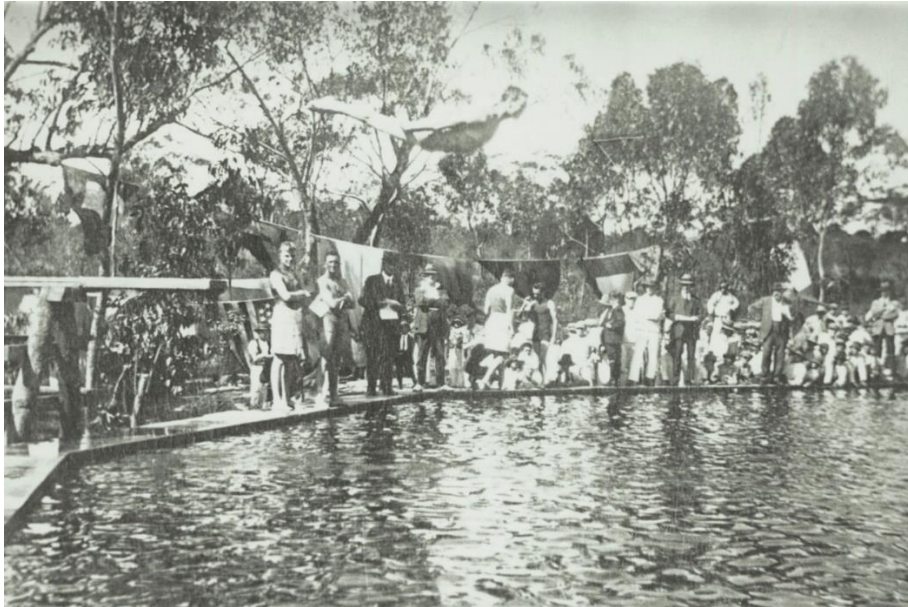
- 14 The dam, completed in 1914, served as a swimming pool for the boys for many years. During the 1920s and 1930s lifesaving and swimming classes were held there. This photograph was taken in 1923.
Source: NSW State Archives Number NRS-15051-1-23-[1283]-2.

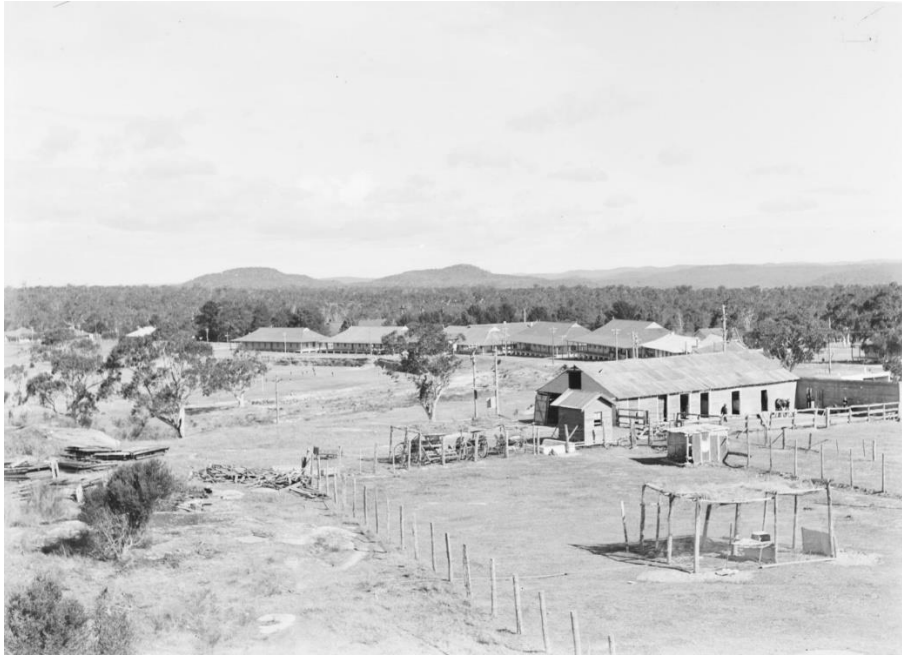
15 Looking south towards the range of dormitories along what is now known as The Avenue. The original dairy is in the foreground. The photograph was taken in July 1938.

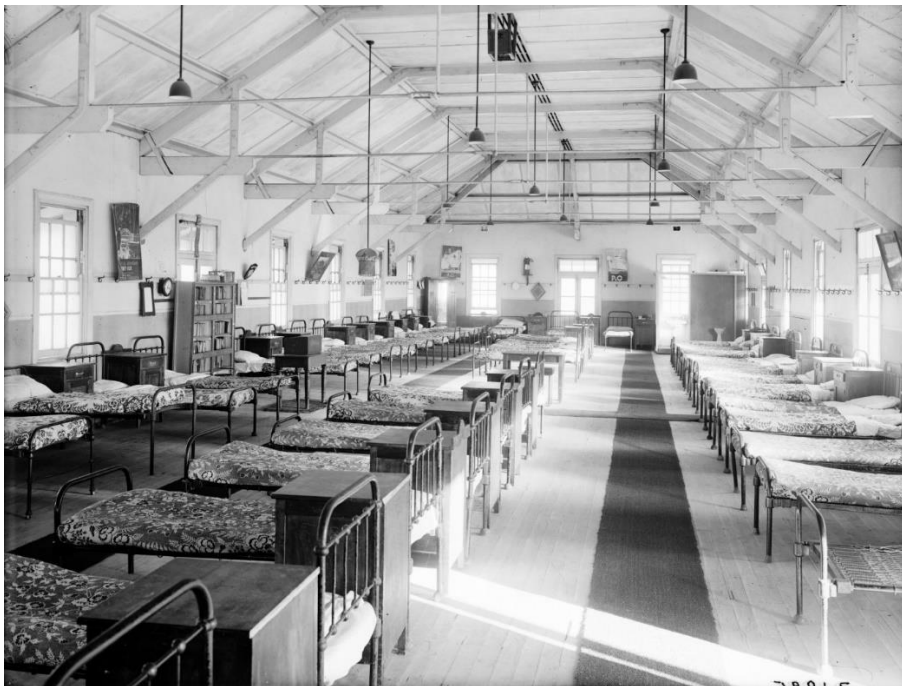
16 Interior of one of the dormitories, July 1938. The easily supervised sleeping arrangements for the boys is clearly illustrated.

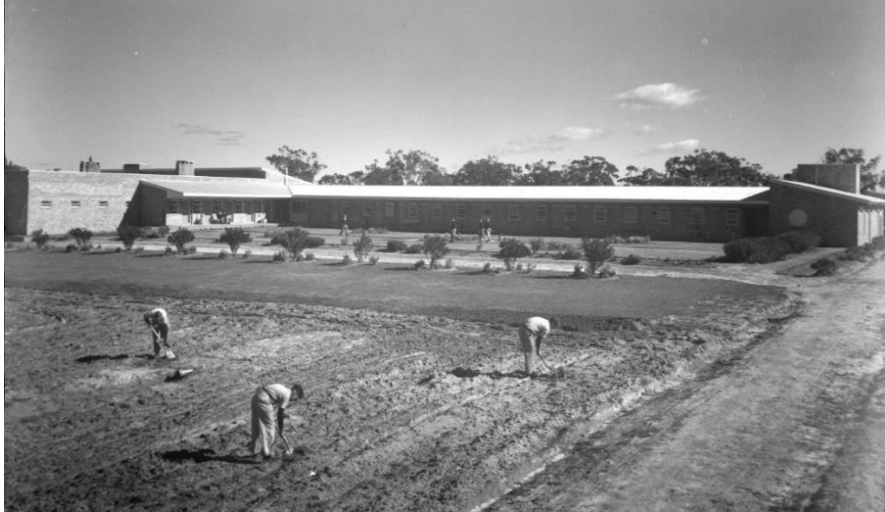
19 The sub-institution (Building 10) after conversion to the Privilege Cottage, 1948.
Source: SLNSW d1_43228h.

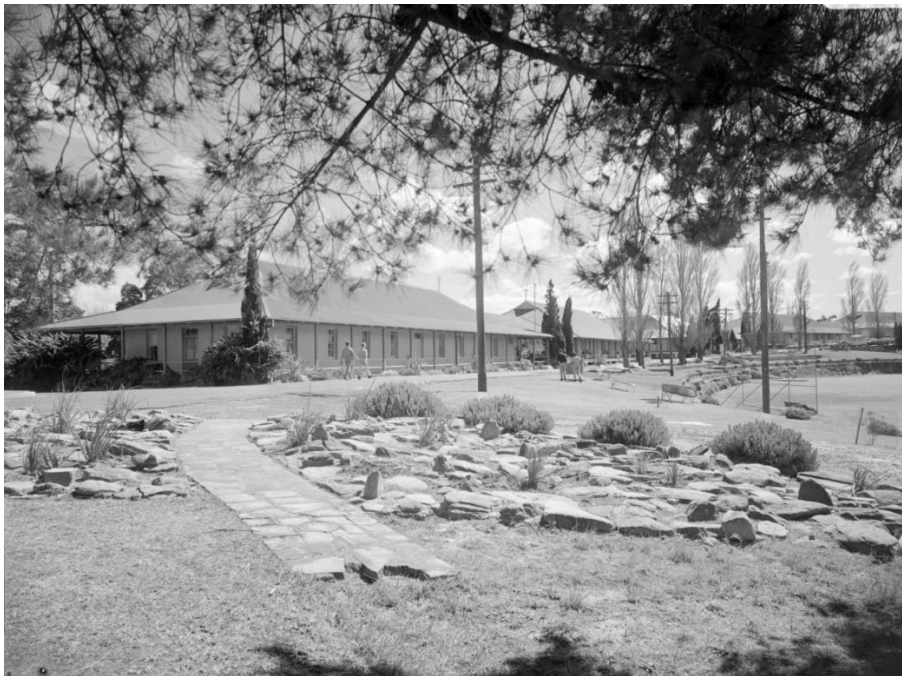
21 Looking towards the dormitories and administrative building (Buildings 25/26, 27, 39 and 40), 4 September 1973.
Source: SLNSW d2_49943h.

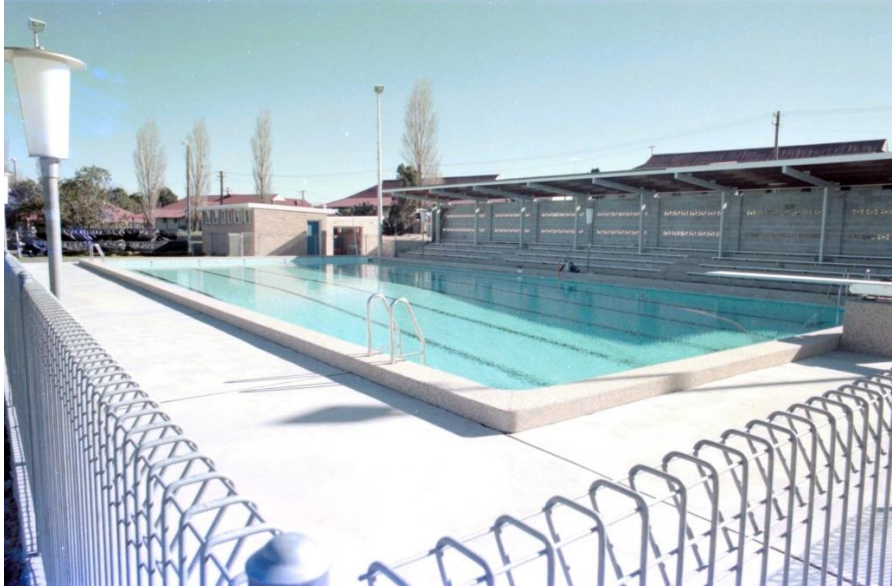
22 The newly completed swimming pool (Building 47), July 1973.
Source: SLNSW d3_48546h.

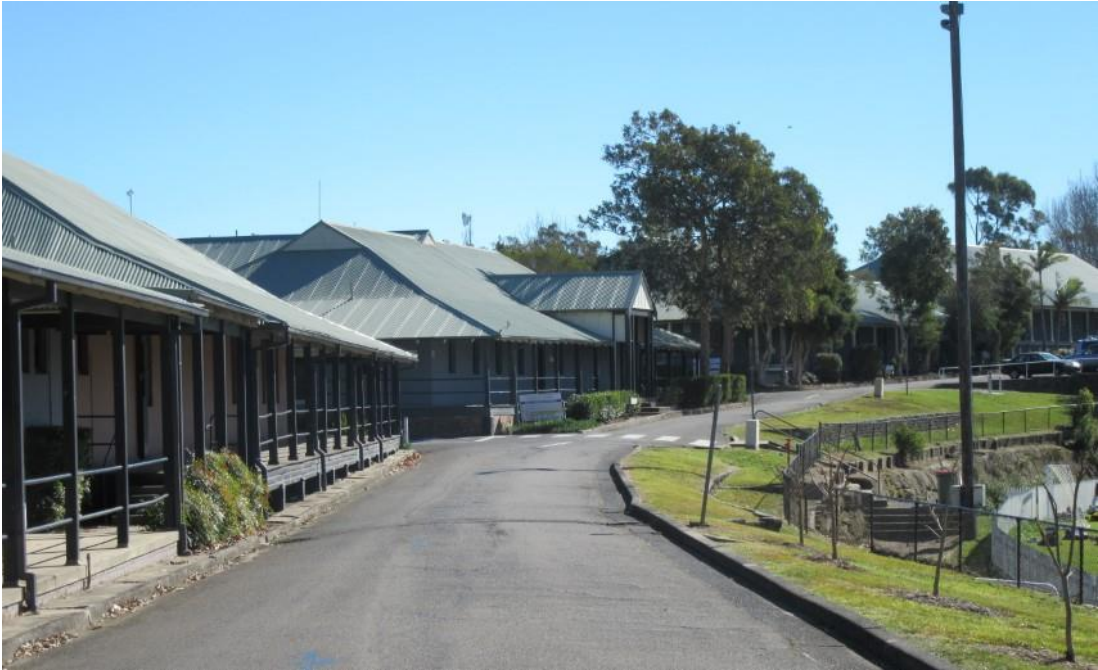
26 Looking north along The Avenue. Early administration and dormitory buildings form a memorable composition as the road curves and rises above the cricket oval to its east.

Buildings at Mount Penang are notable for several reasons. They are all a single storey in height and generally rectilinear in form and share a limited vocabulary of concrete or rendered brick walls and hipped roofs covered by corrugated steel. A number of later buildings have gabled roofs. Many of them are also surrounded by verandahs or have verandahs on two sides. The buildings also read as informal groups, so that their visual relationships and the spaces between them are also important. The buildings are also significant as defining elements in the wider cultural landscape of Mount Penang Parklands (refer also to Section 3.3 following). The location of the various buildings at Mount Penang Parklands is illustrated on the site plan below.

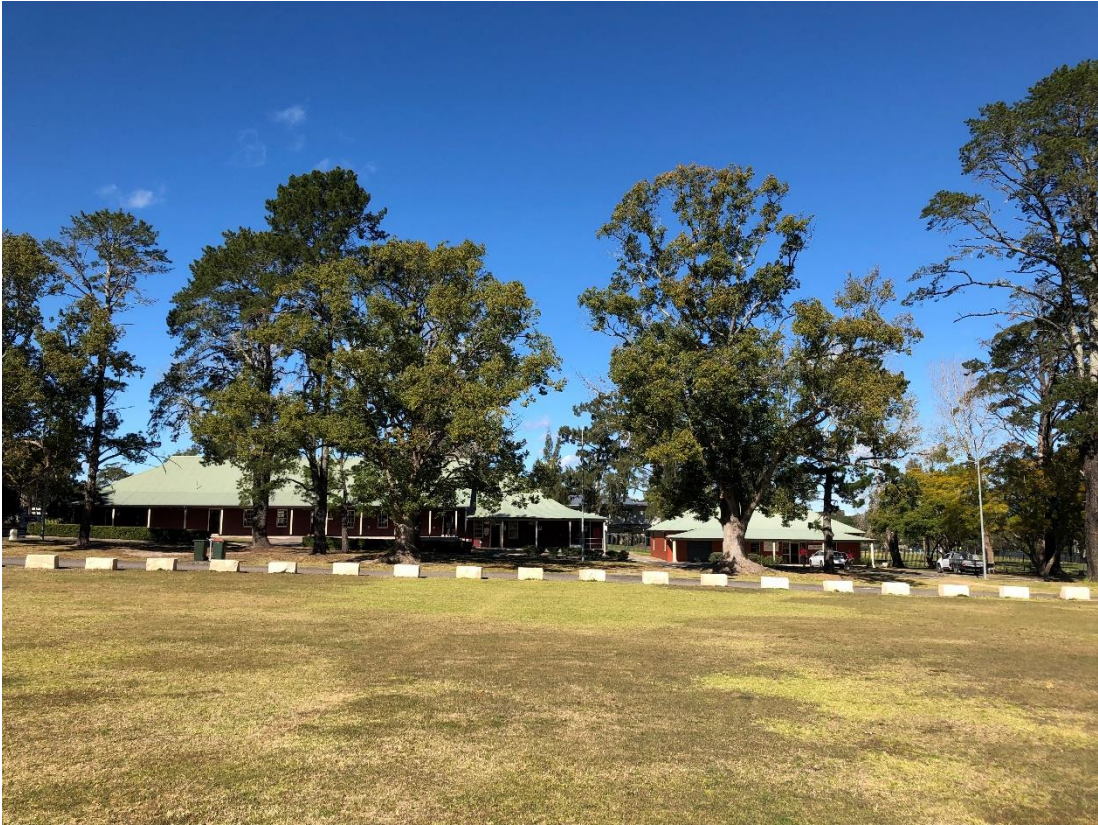
27 Example of the relationship between the open space and building groups at Mount Penang, looking south towards Carinya Street

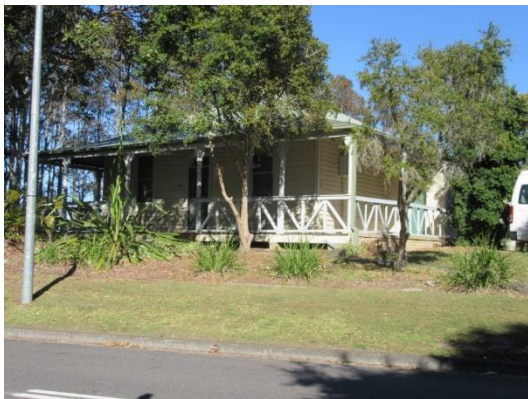
Building 1 - staff accommodation, 1912-1913

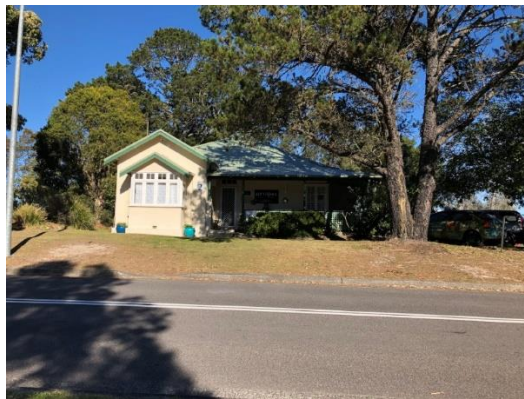
Building 2 – staff accommodation, after 1928

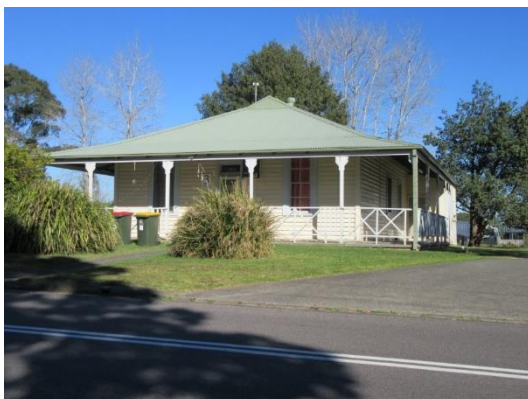
Building 3 – staff accommodation, 1912-1913

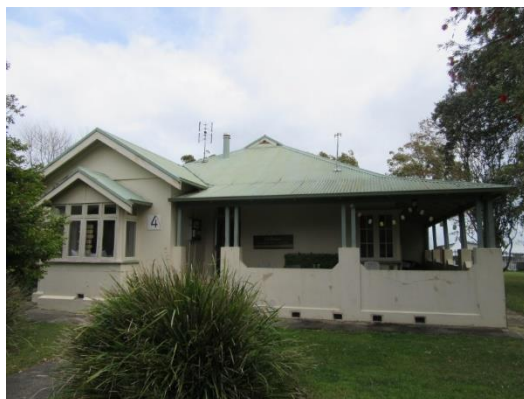
Building 4 – staff accommodation, after 1928

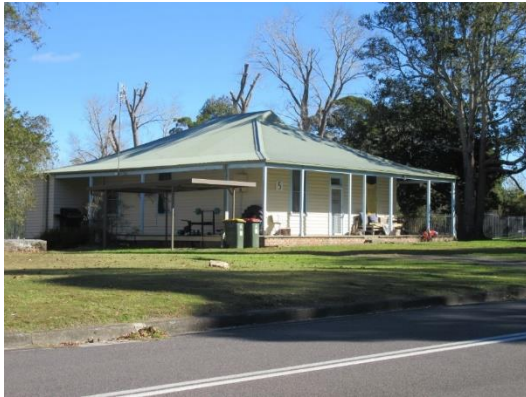
Building 5 – staff accommodation, 1912-1913

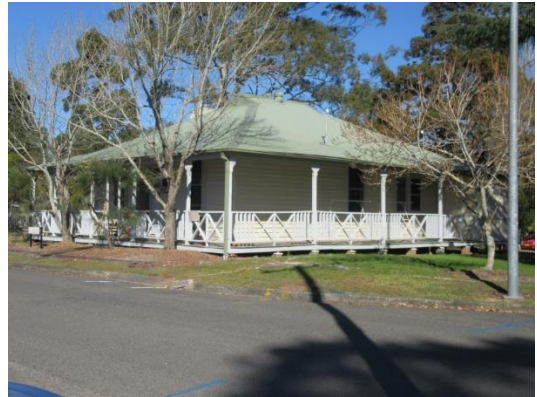
Building 6 – staff accommodation, 1912-1913

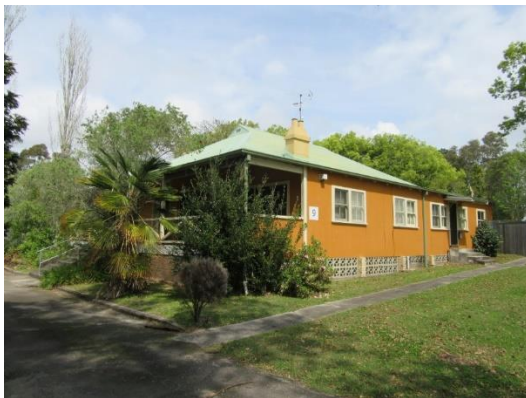
Building 9 - Assistant Superintendent's Residence/ Superintendent's Residence, 1912

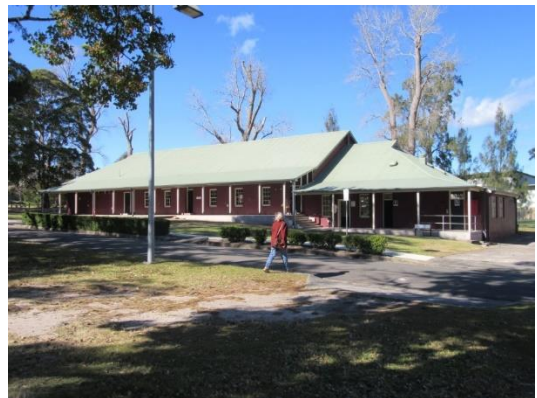
Building 21 – dormitory, circa 1913

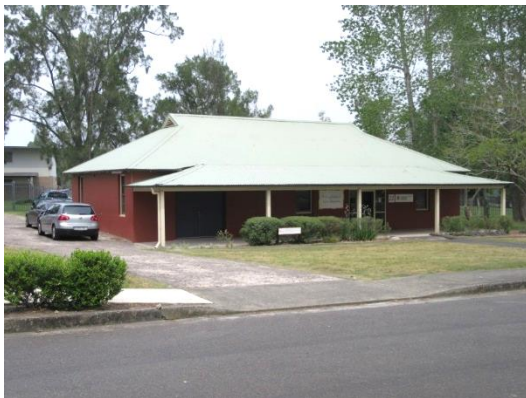
Building 22 – maintenance store, 1912-1915

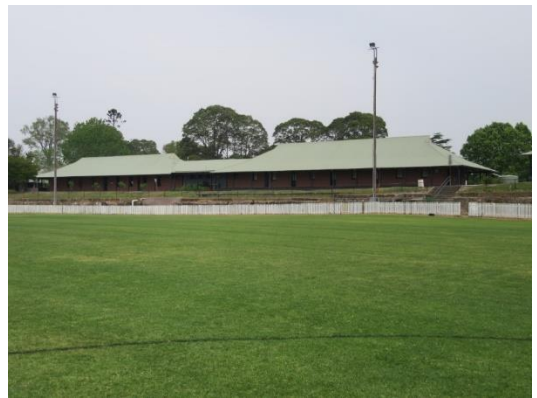
Building 25 and 26 – dormitories, 1912

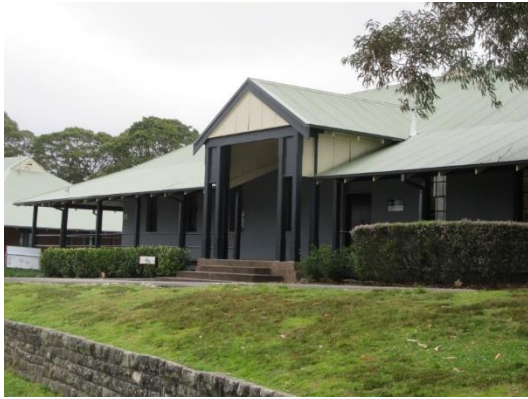
Building 27 – admissions, operations annexe and theatre, circa 1915

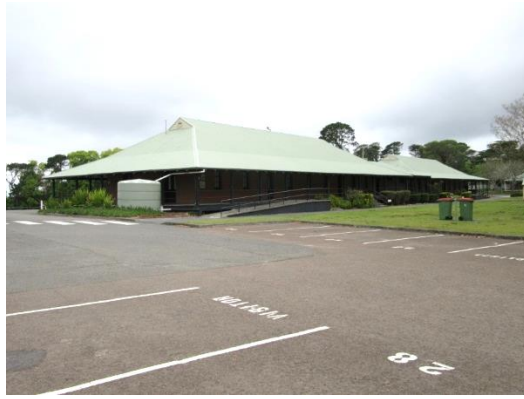
Building 39 and 40 – dormitories, circa 1912-1922

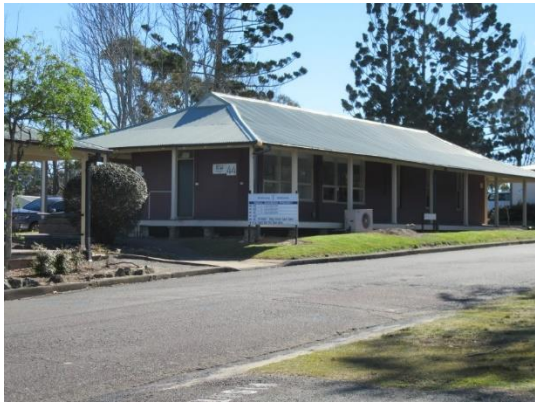
Building 44 – formerly workshop, circa 1912-1922

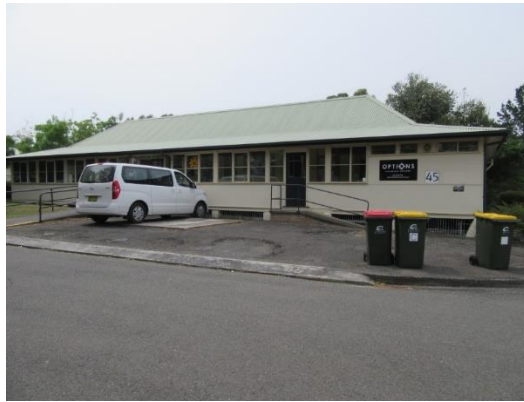
Building 45 – formerly workshop, circa 1912-1922

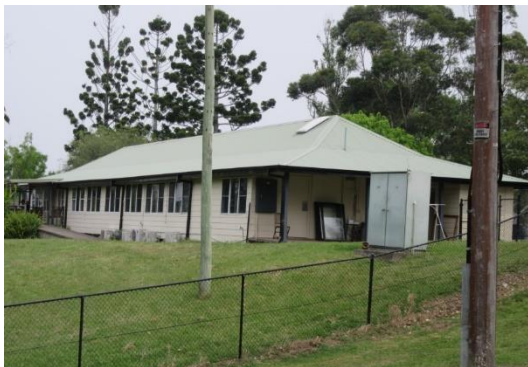
Building 46 – residential accommodation, circa 1912-1922

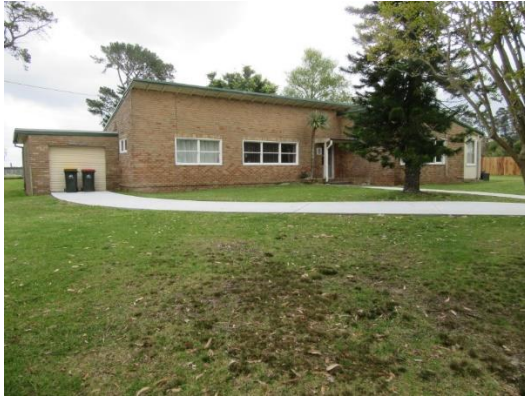
Building 7 – staff cottage attached to sub-institution/Privilege Cottage, 1944

the buildings are brick with hipped or gabled roofs, apart from Buildings 7, 8 and 10, which have shallow pitched skillion roofs. These buildings, along with Building 38 (the detention cell block) have retained a high level of integrity. The other buildings have been modified to a greater extent although their original form and scale is still evident.

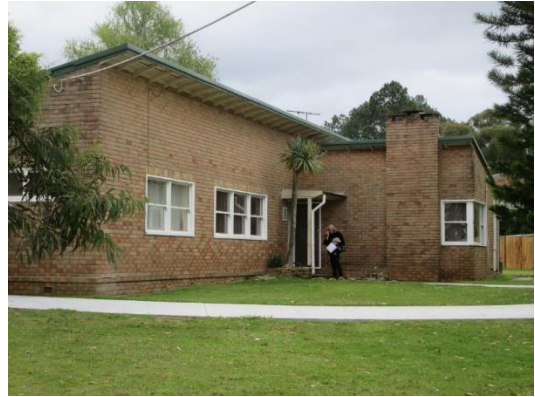
Building 8 - staff cottage attached to sub-institution/Privilege Cottage, 1944

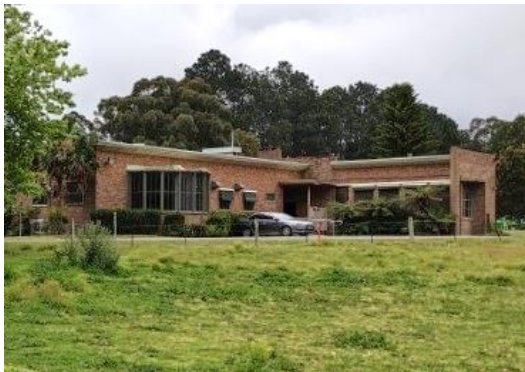
Building 10 - Sub-institution/Privilege Cottage, 1944

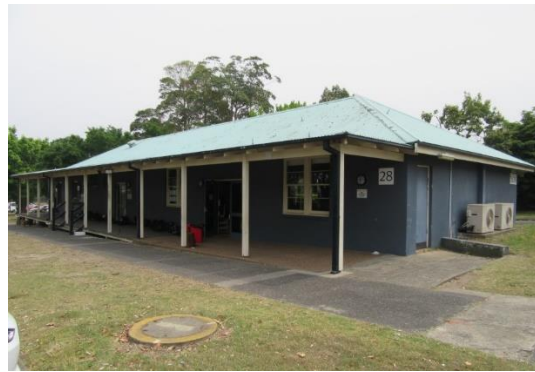
Building 28 – day toilets and stores, circa 1945

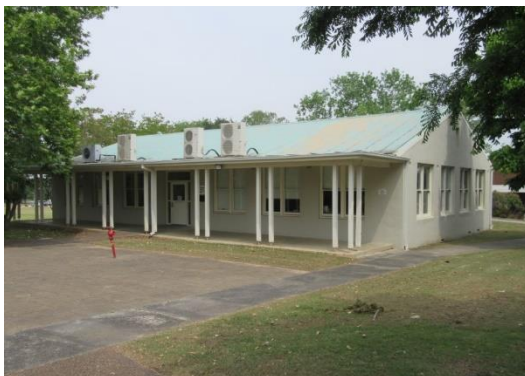
Building 31 – dining room and main kitchen, circa 1950

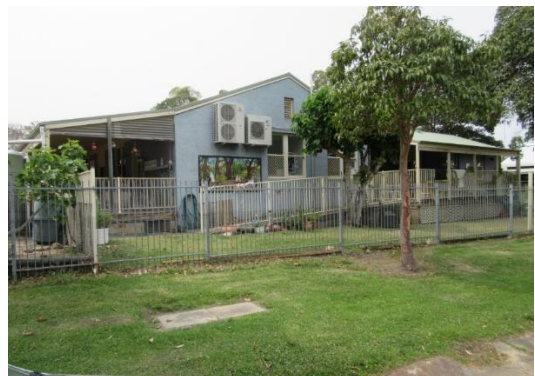
Building 34 – laundry, circa 1950

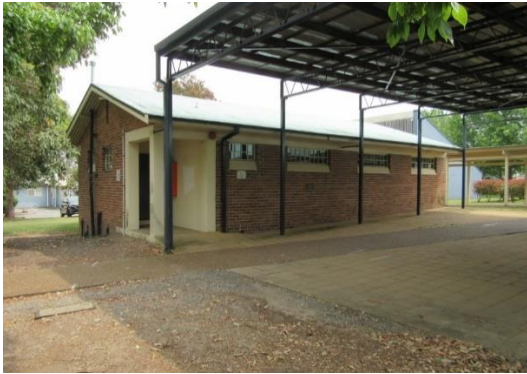
Building 36 – detention cell block, circa 1950

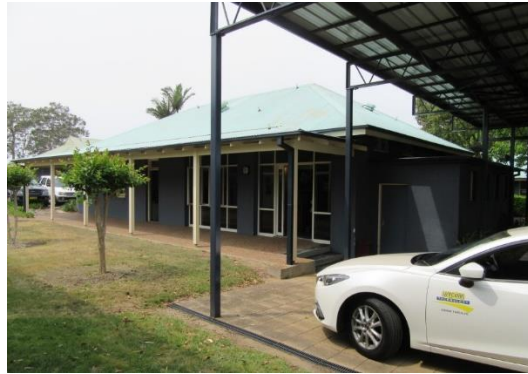
Building 37 – tool and small motors workshop, circa 1950 (assumed)

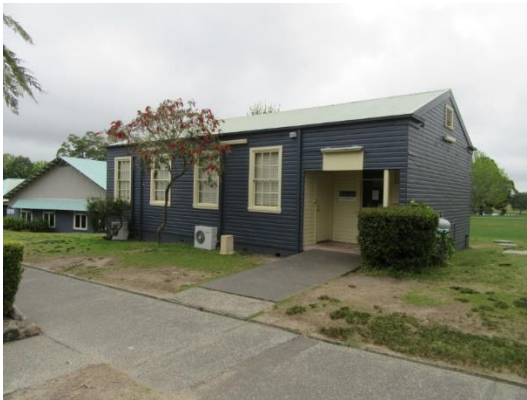
Building 41 - manual and vocational instruction, 1947-48

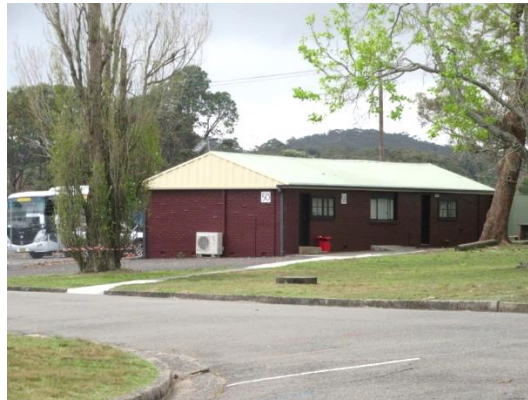
Building 50 – boot manufacture, 1948

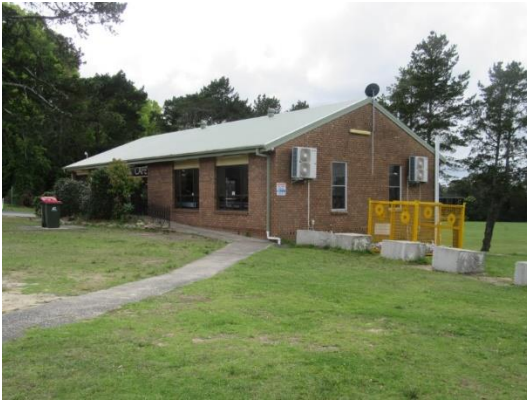
Building 11 – Community clubhouse, 1976

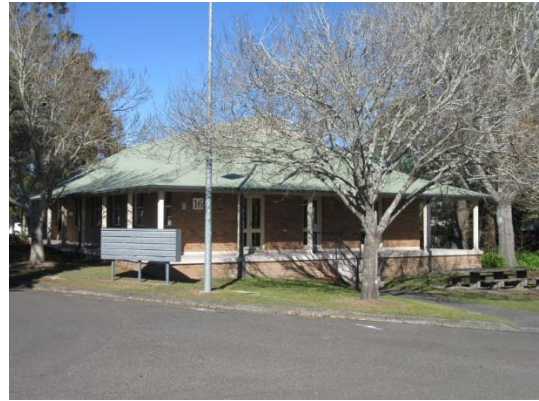
Building 16 - Administration building, 1978-79

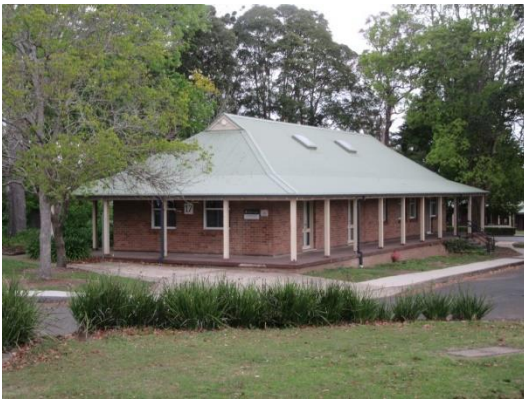
Building 17 – Hospital, 1977-78

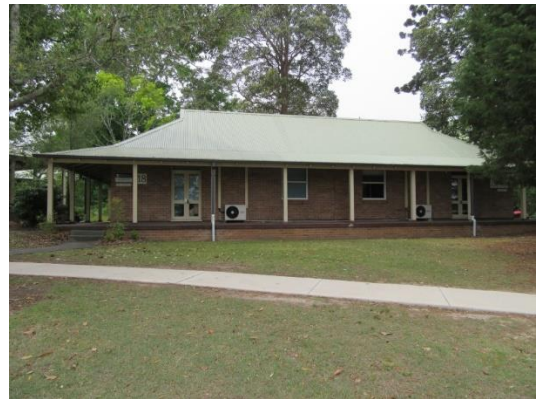
Building 18/19 – Nurses' accommodation, 1977-78

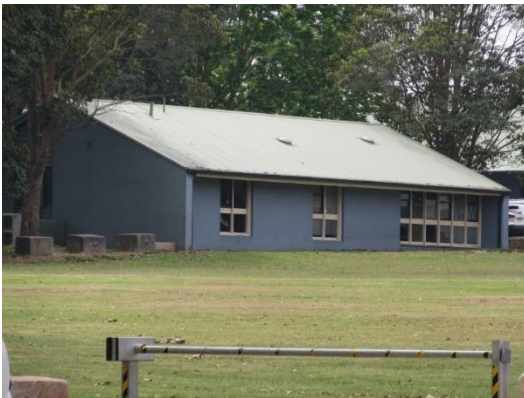
Building 30 – stores and amenities, 1977-78

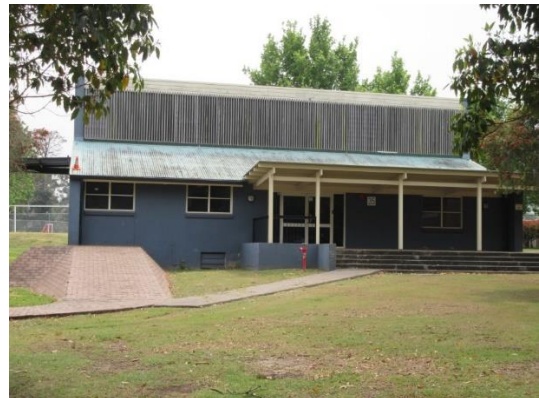
Building 35 – stores, 1976-77

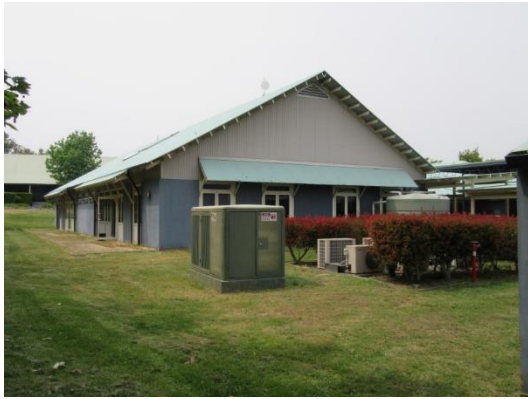
Building 38 – stores and amenities, 1976-77

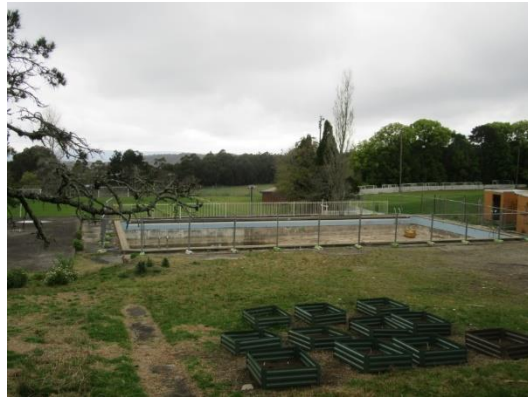
Building 47 – swimming pool, 1978

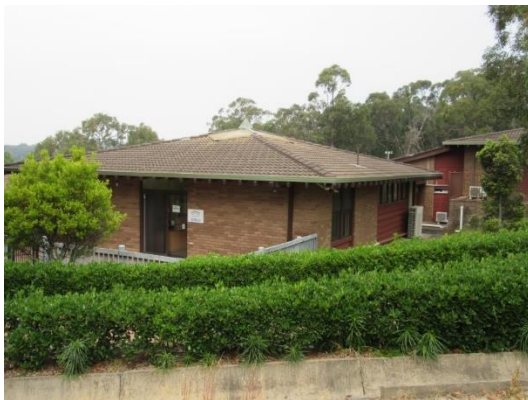
Building 51 - Phillip House residential facility,
1976-77

The group of buildings making up Building 51 are in Precinct 7 (Philip House Mixed-use Precinct). The group is known as Philip House, which was built for state wards. It comprises four single storey pavilions and a large two storey pavilion organised around a central court. The buildings are constructed of brick, with hipped roofs covered by tiles.

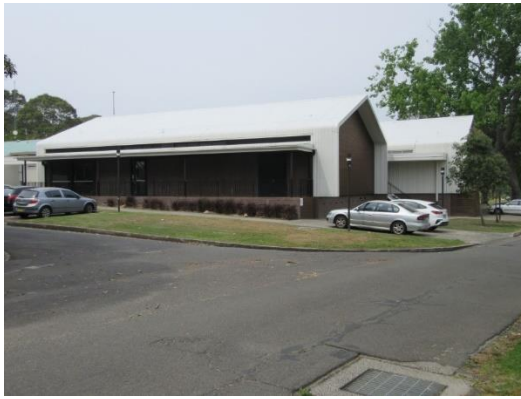
Building 32 – dance studios, 2010-11

Building 32 is a purpose designed studio complex built for NAISDA. Buildings 48 and 49 consist of a café, amenities and storage spaces associated with Mt Penang Gardens. Building 52, at the southern edge of the site, was constructed as a tourist information centre. Buildings 54 to 61 were constructed on Mount Penang's property by the Roads and Traffic Authority around 1986 and were purchased by the department in 1989. Vocational classes and workshops were relocated into them. In 1991 facilities for vocational training and opportunities for apprenticeships were improved with the construction of new buildings adjacent to the renovated RTA buildings, forming the first vocational training unit in juvenile justice in New South Wales.

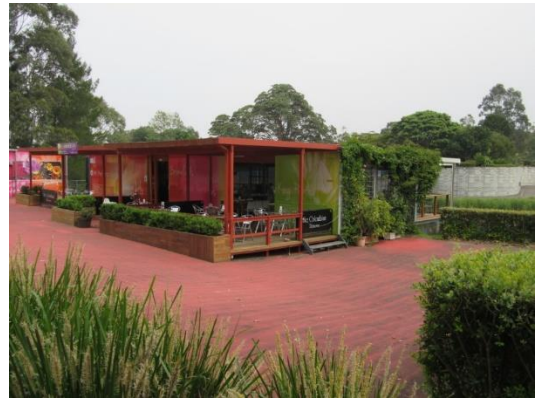
Building 48 – café for Mt Penang Gardens, circa 2003

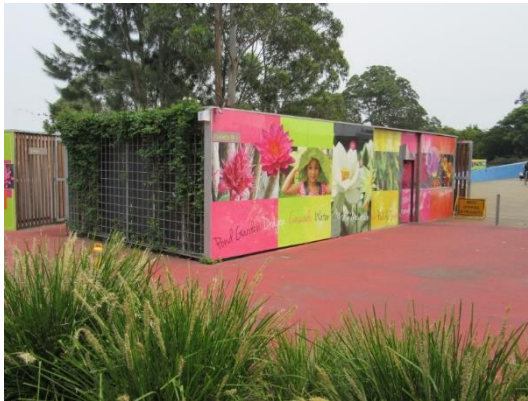
Building 49 – toilets and stores, Mt Penang Gardens, circa 2003

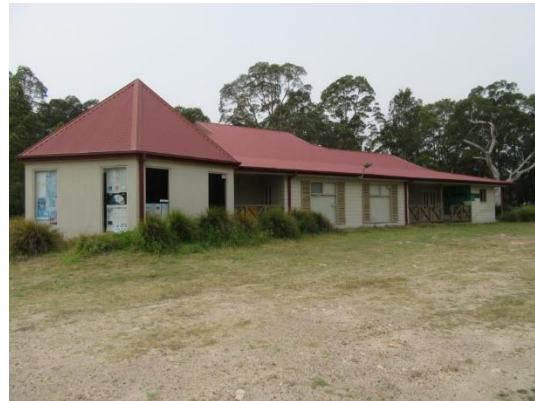
Building 52 – tourist information centre, circa 2005

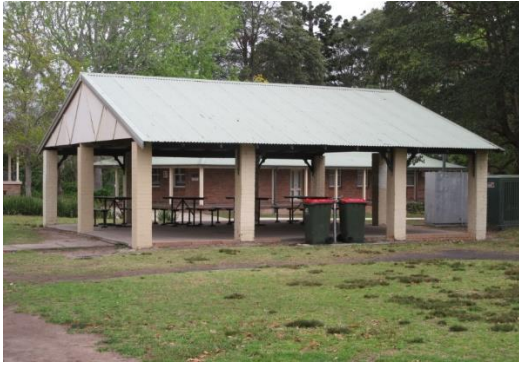
Shelter to the west of Building 25.

- The shelter to the west of Building 25, which was constructed by inmates at Mount Penang;
- The greenhouse to the north of Building 50;
- Garages to the north of Building 2 and south of Building 9;
- The carport to the south-east of Building 19;
- The tennis courts;
- Barbecues in various parts of the site;
- The old bowling green;
- The lower dam, to the south of Mt Penang Gardens.

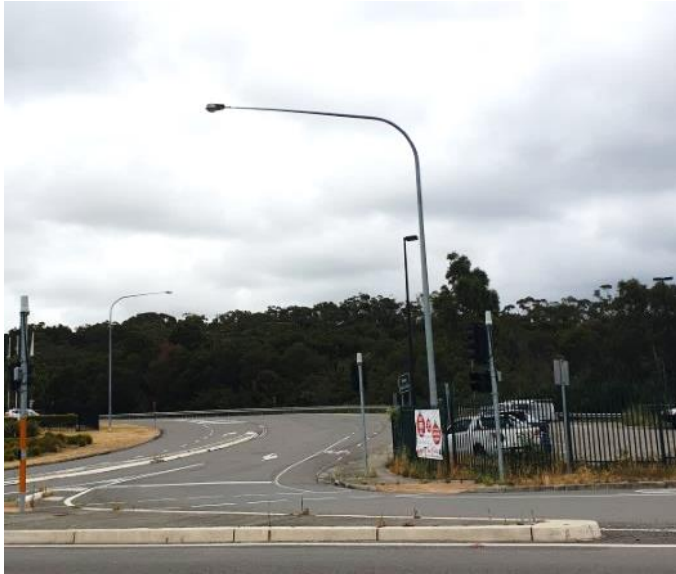
31 View of Precinct 1 looking north from Central Coast Highway showing existing bushland as buffer to adjacent property uses.
Source: Taylor Brammer.

This precinct is characterised by an extensive, relatively flat, open grassed landscape and is a central zone for the festival activities with substantial areas marked out for car parking. The precinct is located on a minor ridge to the west of the central Heritage Precinct with regional views gained to the east, west and south to vegetated hills. To the western boundary is established bushland that provides an enclosing vegetated element.

This precinct maintains the open historical landscape character that is a distinguishing feature of Mount Penang Parklands. The car parking areas have replaced in part what was pasture. This change of use has not marginalised the interpretation of the place as an institutional landscape that provided both education and rural activities for Mount Penang. Scattered native trees are located to the east of the bushland in the former pasture areas.

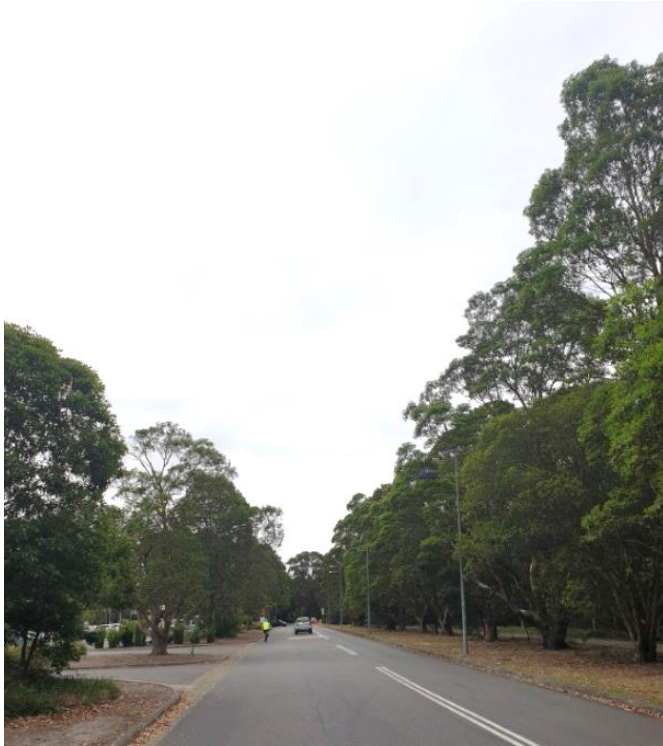
33 View of entry driveway looking north showing vegetated character of Brush box with Eucalyptus interspersed in between.
Source: Taylor Brammer.

Occupying an area to the entry portion of the southern portion of the overall site, this precinct is characterised by an extensive gravel car park with native plantings between car parking bays. Within the car park, the native plantings are informal in character and located in rows. Some tree staking and protection are evident along with native grasses between the car parking bays. The eastern boundary of the precinct is defined by the main drive to Mount Penang Parklands and consists of a bitumen driveway that features an established avenue of Brushbox trees with more recently planted Eucalypt trees interspersed in between the Brushbox trees. To the northern portion of the precinct, Festival Drive forms the intermediate boundary between the Kariong Mountains High School and the car park. These works formed part of the Mt Penang Gardens in early 2000. To the southern boundary is established bushland that screens the site from the Pacific Highway and provides a substantial enclosing element to the site.

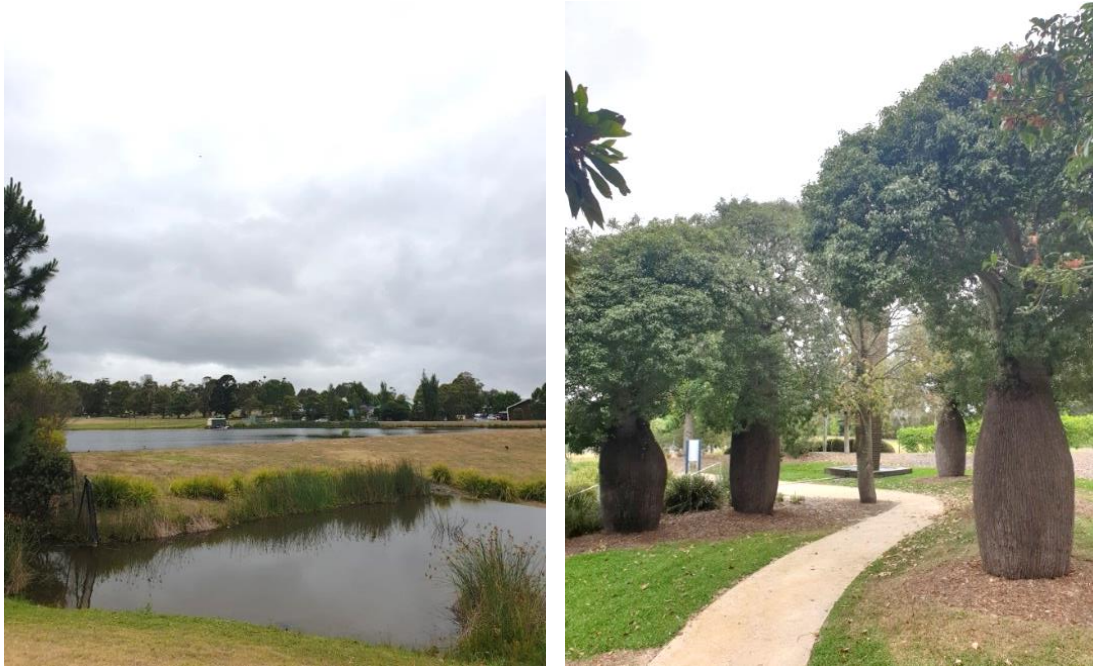
35 View looking north-east over dam (left); view looking south of arrangement of Bottle Trees located in Mt Penang Gardens (right).
Source: Taylor Brammer.

Mt Penang Gardens (established in 2000) is a contemporary landscape design that consists of a central raised “plateau” defined by substantial concrete walls, stepped water feature and a series of enclosed themed gardens within the “plateau”. It is noted that the landscape designer, Anton James in describing the gardens is that they conceptually have:

As a result of this conceptual framework, the Gardens bear little relationship to the overall established landscape character of the site. The McCabe Centre consists of a modest arrangement of buildings with an established and informal treed arrangement. The trees consist of a mix of cultural plantings of native eucalypts and typical eucalypt species of the late 20th century, a Cook Pine, Bottlebrushes and mixed shrubberies. A sculpture garden consisting of substantial sandstone blocks set in grassland from the International Sculpture Symposium are located to the north west of Mt Penang Gardens.

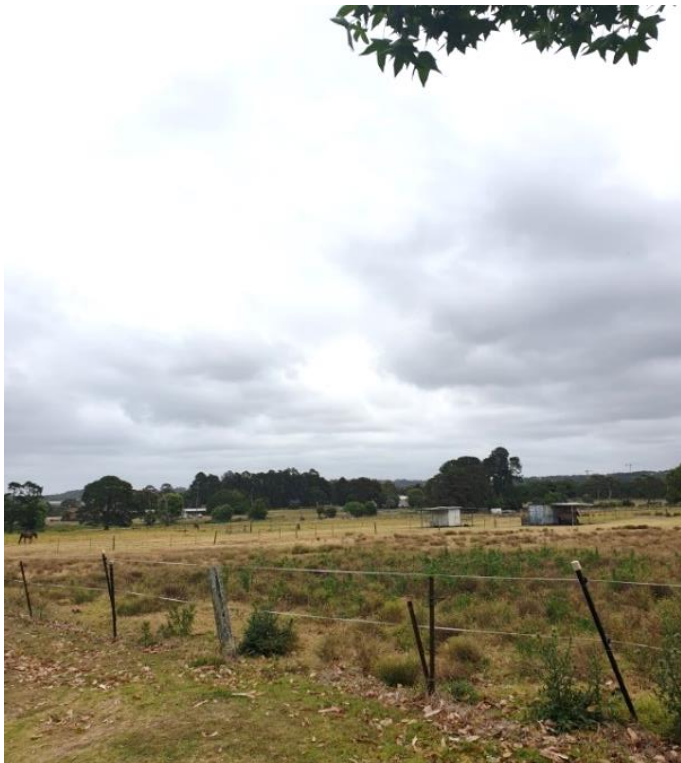
41 View looking south-west over open pasture area.
Source: Taylor Brammer.

This precinct continues the landscape theme of a broad open grassed area of Precinct 1. It is defined by a perimeter road with the Baxter Juvenile Correctional Centre to the north. The landscape character of the former pasture area has not been modified by car parking and other festival functional requirements. Fencing to this precinct is rural in nature with three strand gal wire between strainer posts and interim star pickets. Much of the fencing has lost its tension and needs to be replaced and/or repaired.

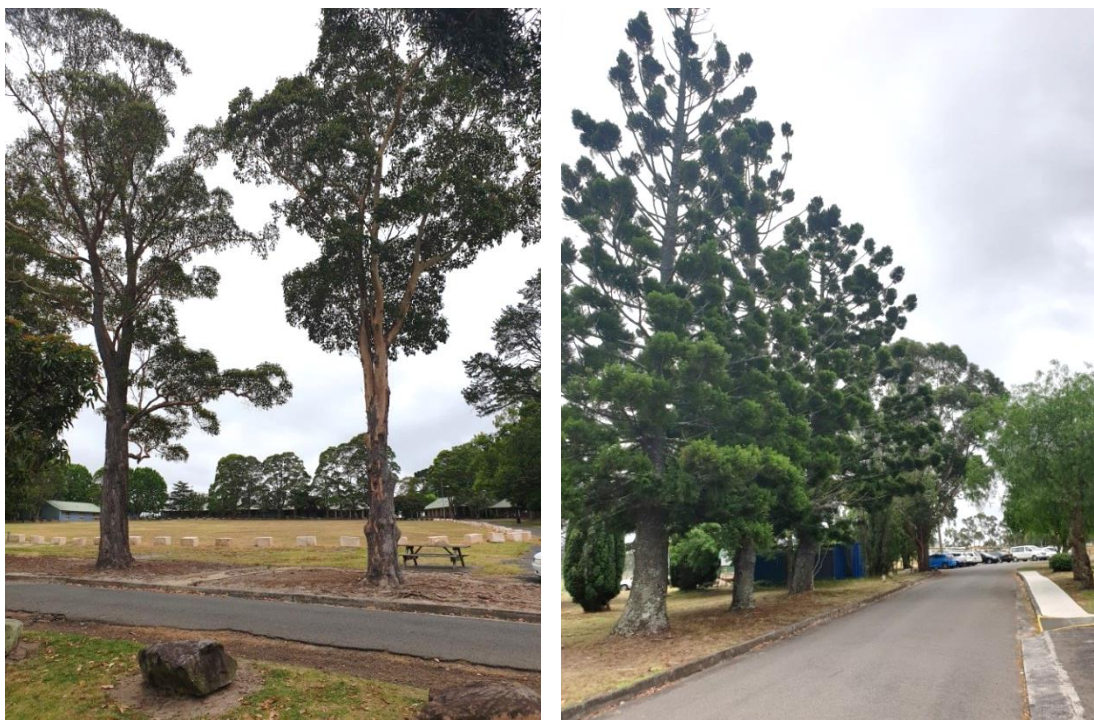
43 View looking north-east showing mature Landscape curtilage consisting of Brushbox, Camphor Laurel and Pine trees. Note: Sandstone blocks to the periphery of the field (left); view north of existing Hoop Pines, forming part of the established character to Precinct 5 (right).
Source: Taylor Brammer.

This precinct outlines the core values of the place within the broader landscape setting of the site. These core values are characterised by the avenues and rows of cultural plantings. The species used include Brushbox, White Poplars and, Hoop Pines that are demonstrated in the photographs below (Figure 42). The species used are typical of institutional plantings in the relevant eras of the development of the place. The avenues and rows of the trees provide a scale and horticultural diversity that distinguishes the heritage precinct of Mount Penang by dividing this precinct into a series of landscape zones and open spaces.
