Mount Penang Parklands

Central Coast Highway, Kariong
(SHR listing number 01667)

Conservation Management Plan

November 2020 • Issue D
Project number 19 0069

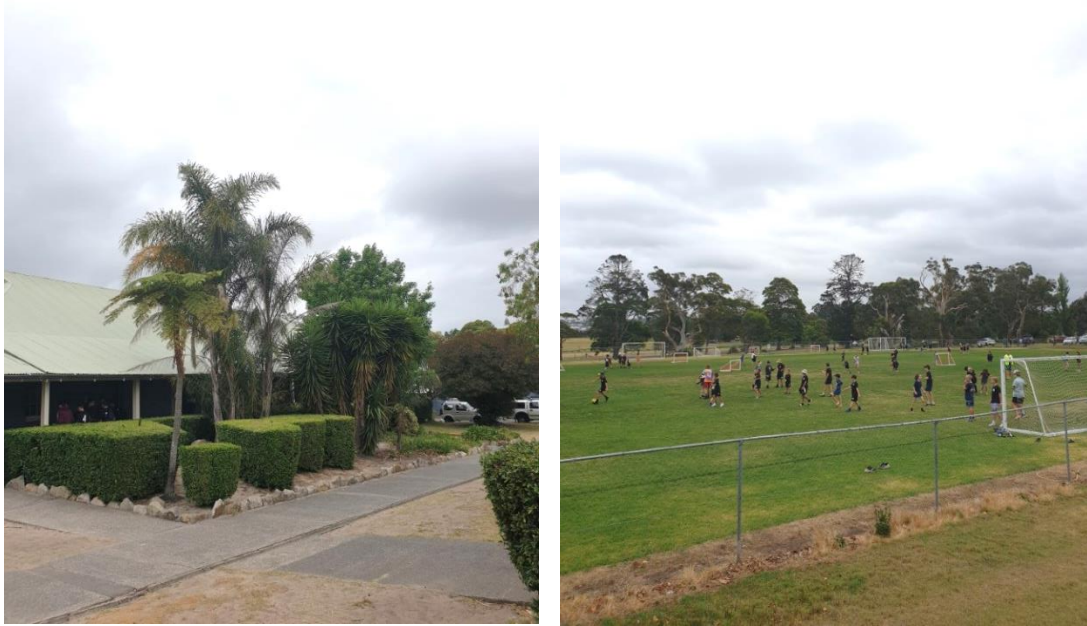
44 View south-east of typical late twentieth century planting style adjacent to buildings in Precinct 5 (left); looking across Sports Field 2 in a north-west direction. Note: Scribbly gum group and mature plantings to periphery of field (right).
Source: Taylor Brammer.

More recent plantings of the late 20th century are typical of the species used in residential and suburban gardens of the time. Palms, mixed shrubberies combined with stone edging and mulched beds are not consistent with the architectural expression of dominant architectural period character of Precinct 5. The palms in particular are a discordant element and consideration should be made to remove these vegetative elements.

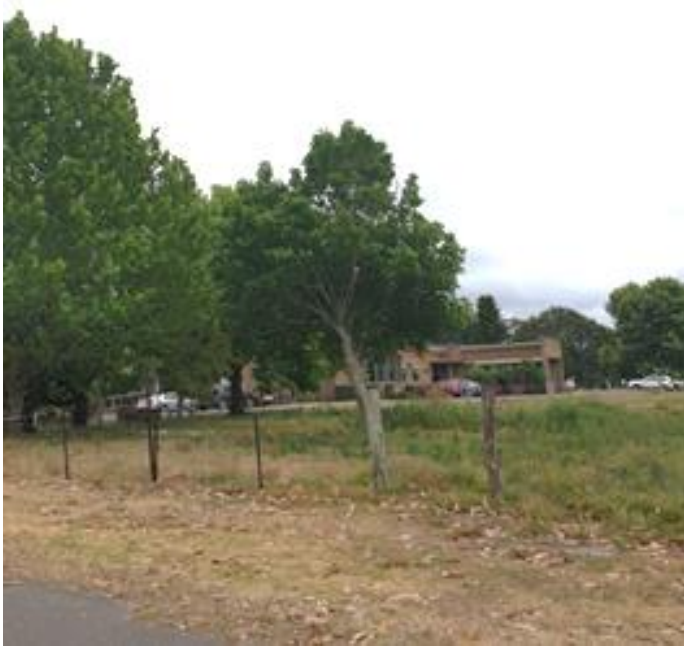
56 View looking north-west of McCabe Centre to Monterey Pine group.
Source: Taylor Brammer.

The pine tree group is representative of the establishment planting of Mount Penang where Monterey Pine was planted extensively as shade and wind belt elements in the landscape. These trees are approximately 100 years old and are approaching their senescent stage. Consideration should be made for forward plantings around these trees to maintain the landmark aesthetic value of this group.

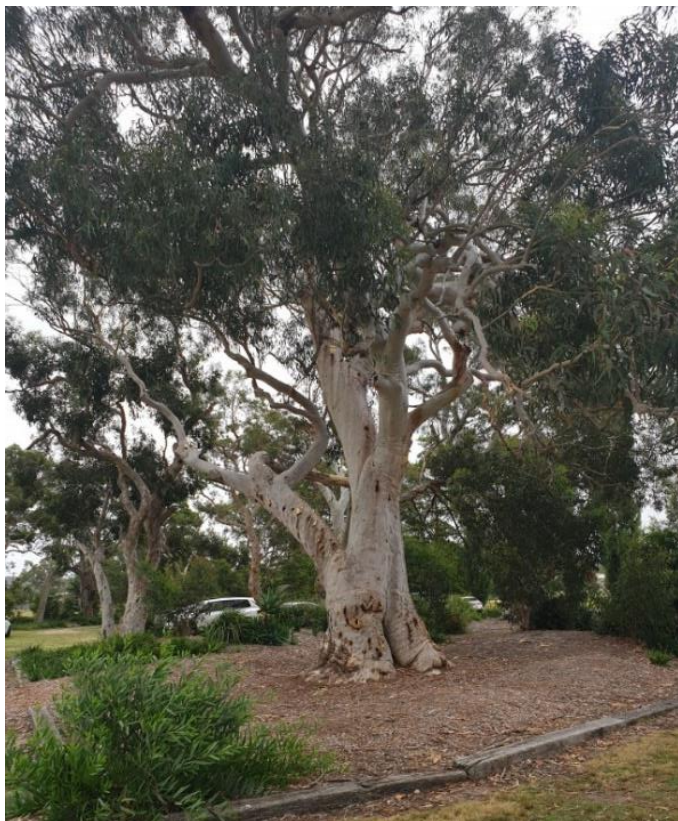
57 View looking north-west of Scribbly gum group.
Source: Taylor Brammer.

This group of trees appear to be remnant trees of the endemic vegetation of the area. These trees are mature and of good condition. The cleared areas under the trees do not allow for natural regeneration to occur and such succession plantings are not encouraged by the current maintenance practices. It is recommended that maintenance around and under the trees should facilitate native regeneration to this area.

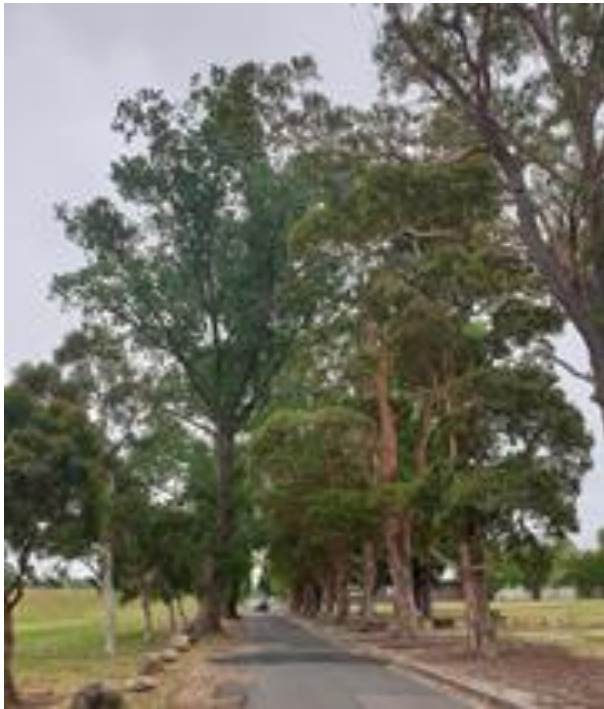
31 White Poplar Avenue.
Source: Taylor Brammer.

This avenue planting of Poplars (possibly Common Aspen '*Populus tremula*') forms part of the cultural planting layering of the site. It would appear that these trees are partial replacement plantings for the former line of Lombardy Poplars (*Populus italica*) that existed along Parklands Road as evidenced in the aerial photograph (Figure 32). These Lombardy Poplars have been removed and not replaced. Consideration should be made to reinstate this landscape form as part of the layering of the institutional plantings of the place.

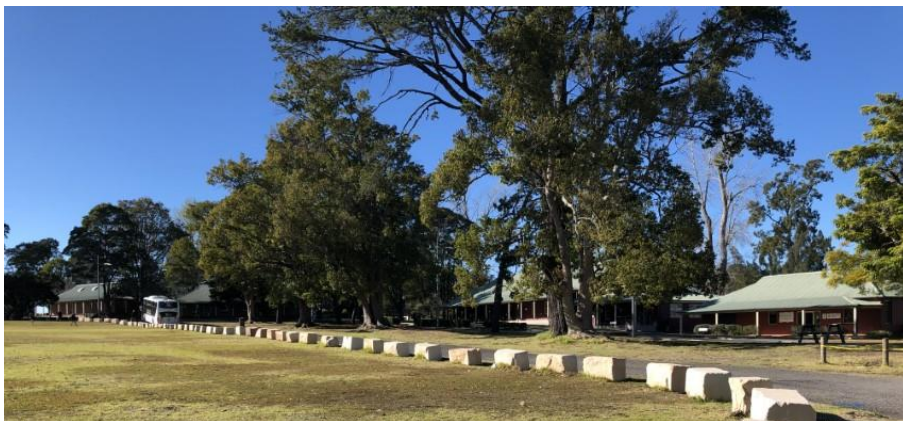
60 Perimeter Brushbox, Camphor Laurel and Pine tree plantings.

These plantings are a mature group of evergreen trees that are typical of the cultural plantings of the site. The deliberate line of planting to enclose and define the playing field is an important cultural landscape of the site. These trees are of a mature form. Consideration should be made in relation to forward planting of this group of trees to maintain the cultural landscape amenity of the site.

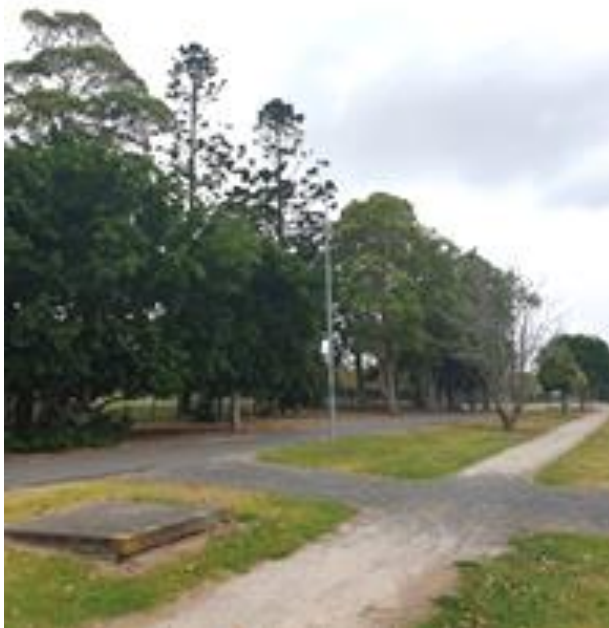
61 View south of Brushbox, Camphor Laurel and *Ficus hillii* located on the outside of the Kariong Mountains High School grounds, with *Araucaria cunninghamia* (Hoop Pine) located on the inside of the school grounds.
Source: Taylor Brammer.

The plantings consist of Brushbox (*Lophostemon confertus*) that are well established and formally planted along the road. Evergreen trees to the east of this line of trees include Hoop Pine and other plantings that visually support this planting form. It is noted that the Brushbox trees are of a mature form that is constrained by both the limited soils of the area and the exposed nature of the open ridge landscape character of the site.

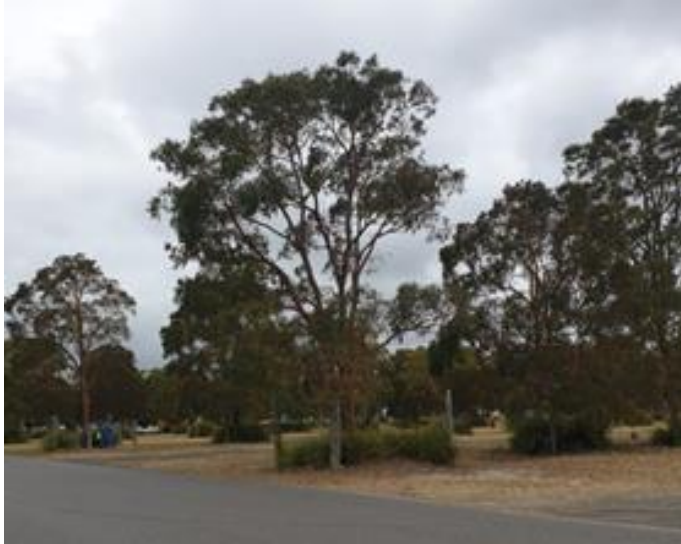
63 View looking south at Scribbly Gum group.
Source: Taylor Brammer.

Located along the Pacific Highway these trees represent the original native plantings of the area. These trees provide an important role as an evergreen screening element to the highway and define the extent of the SHR to this portion to the site.

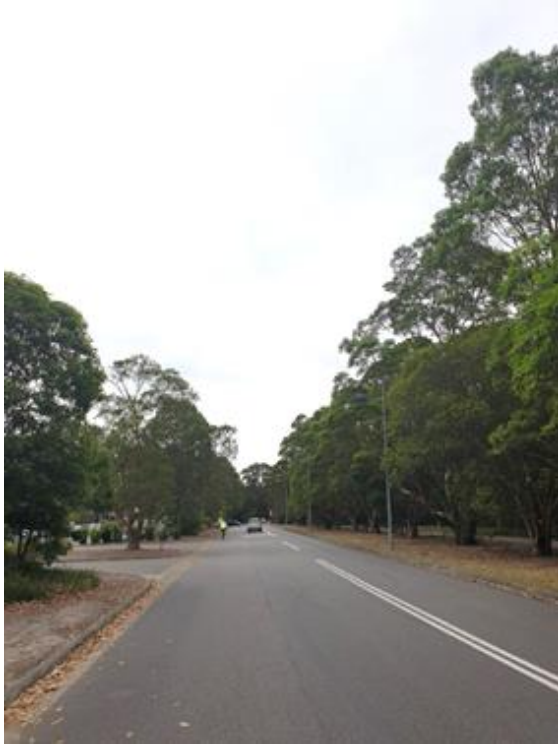
65 View looking north of entry drive, showing vegetated character of Brush box with Eucalyptus interspersed in between.
Source: Taylor Brammer.

The Brushbox trees are existent in the aerial photograph (Figure 17) as a formal line of trees that define the entry drive. It is noted that the Brushbox trees are of a mature form that is constrained by both the limited soils of the area and the exposed nature of the open ridge landscape character of the site. The Eucalypt plantings are of a later date and it would appear that they were planted as a supplementary form between the Brushbox trees by way of making the avenue to be more of a substantial form and character.

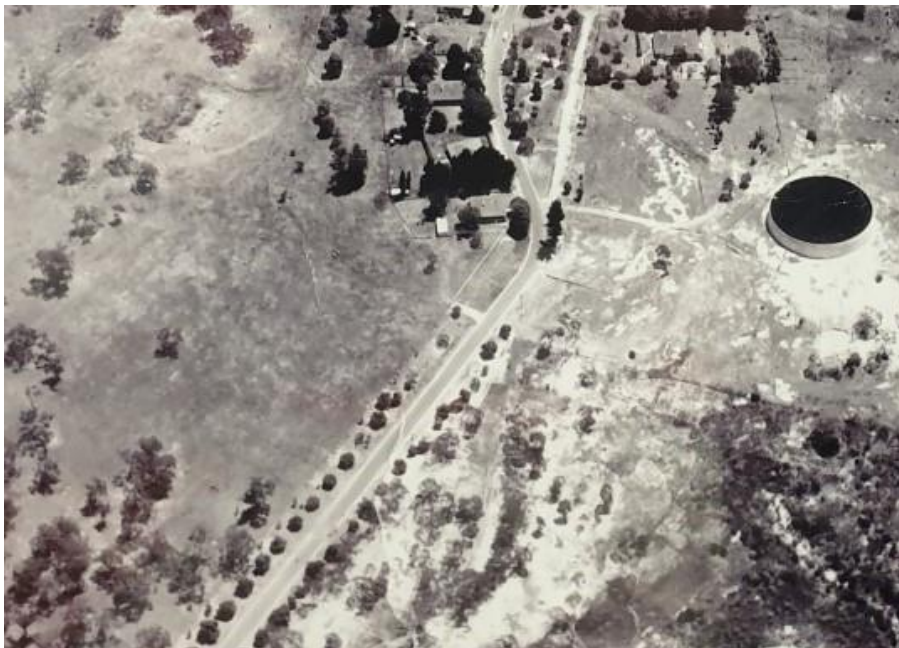
66 Portion of a circa 1970 aerial photograph showing the row of Brushbox trees along the entry drive formed by The Avenue.
Source: HCCDC.

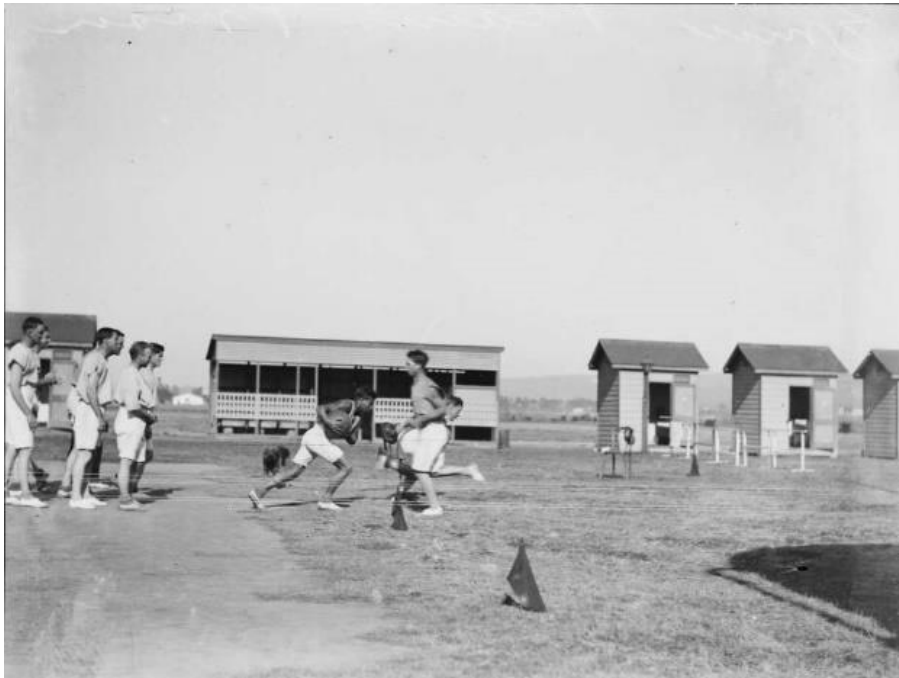
86 Detainees huts forming the sides of the quadrangle at Emu Plains Prison Farm, 1933.

78 huts in place. The huts were arranged around a quadrangle that doubled as a drill square. Detainees ate by themselves in their huts at a small table. Recreation included outdoor sports and visitors were allowed on Sundays. The Farm was not enclosed by walls and fencing, although warders performed guard duty. However, attempted escapes were uncommon.⁵³

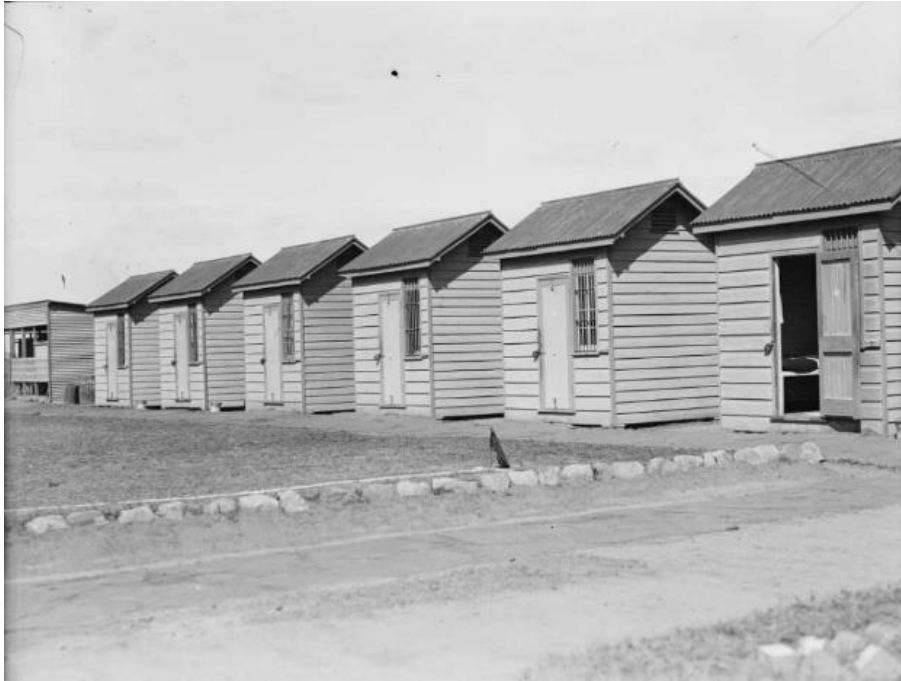
87 Detainees huts forming the sides of the quadrangle at Emu Plains Prison Farm, 1933.

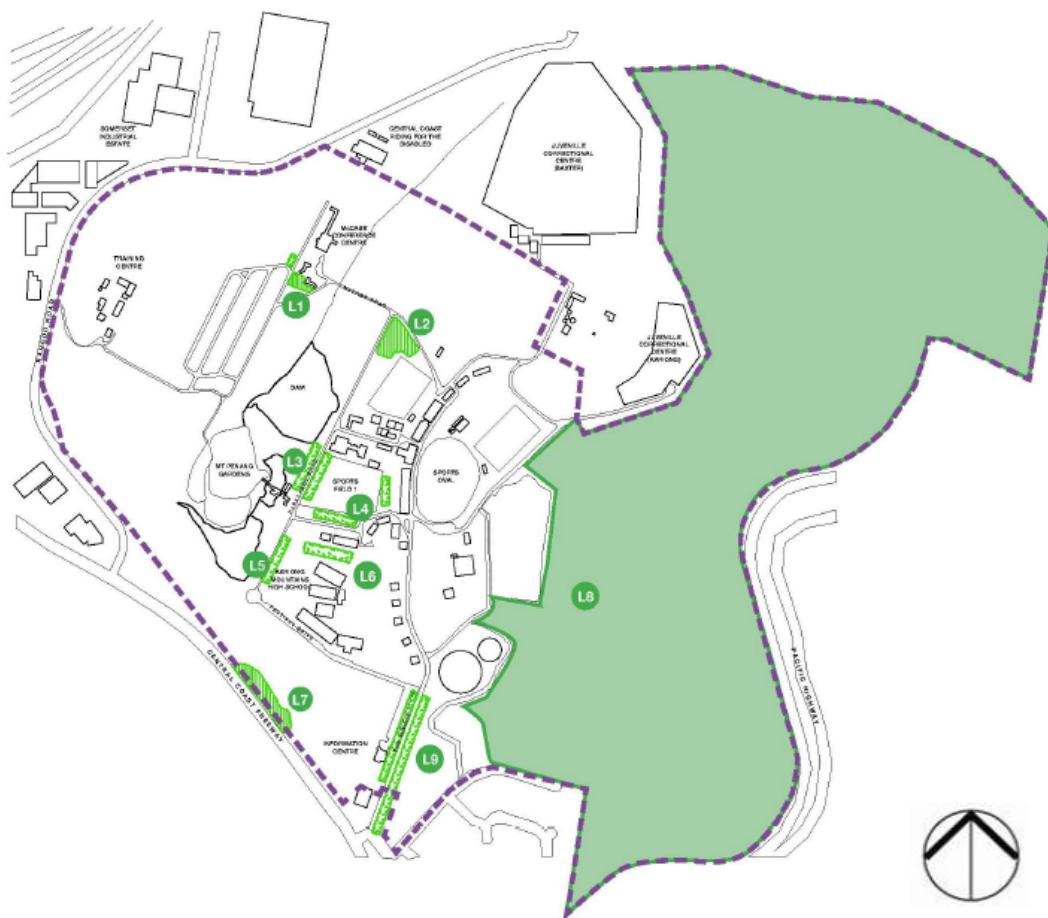
94

Significance of landscape items.

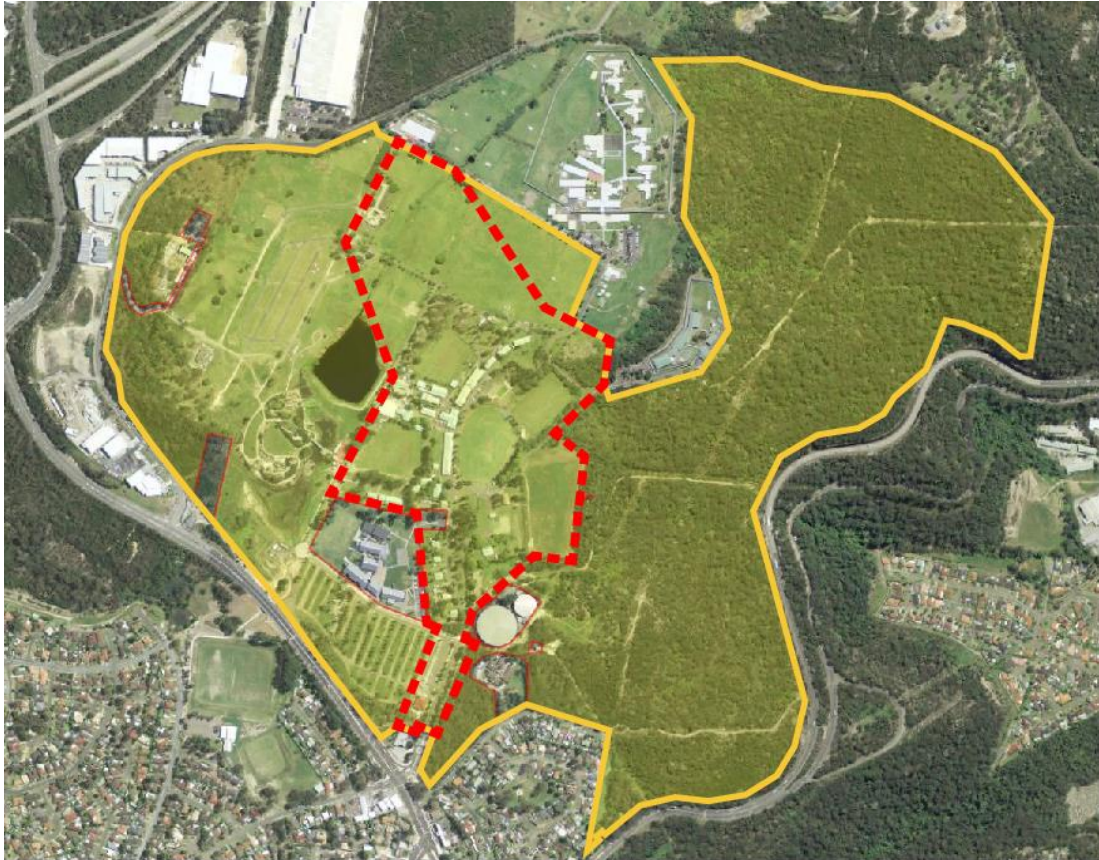
95 Curtilage diagram showing the Lot Boundary Heritage Curtilage (SHR) and the recommended Supplementary Heritage Curtilage.
Source: SIX Maps with TKD overlay

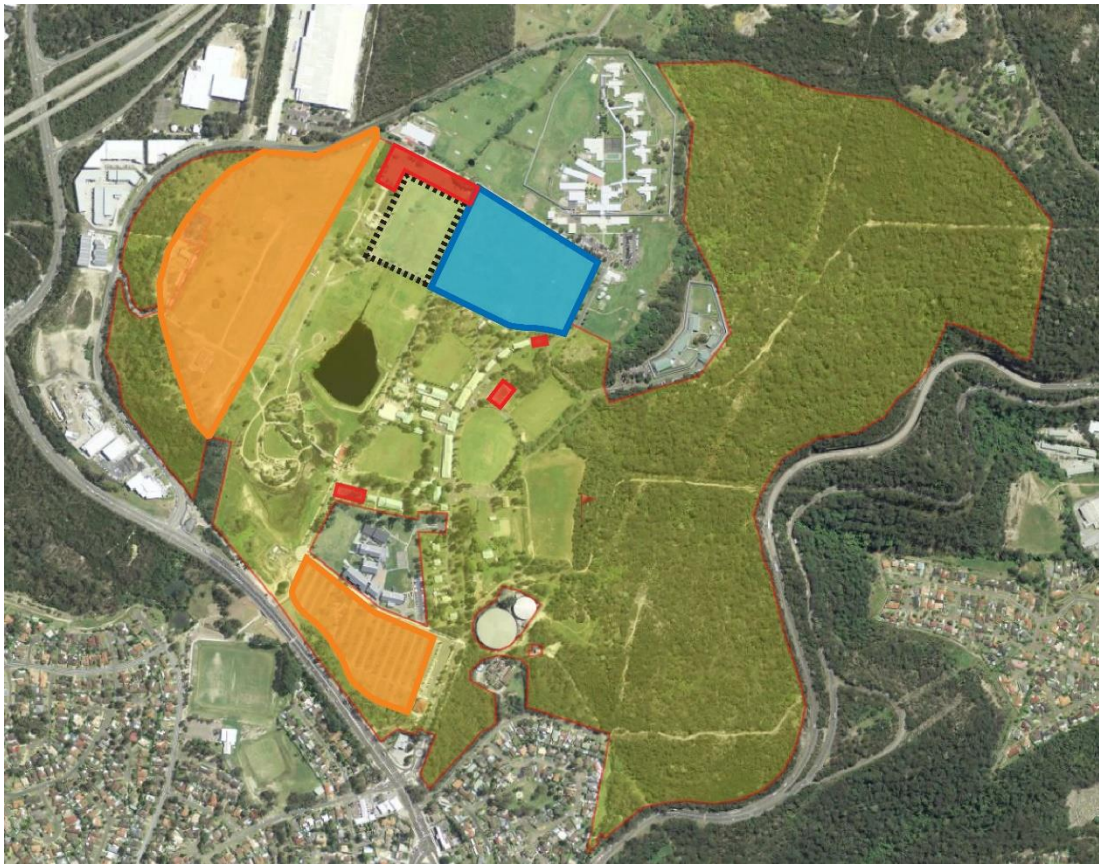
99 Recommended locations for future development at Mount Penang.

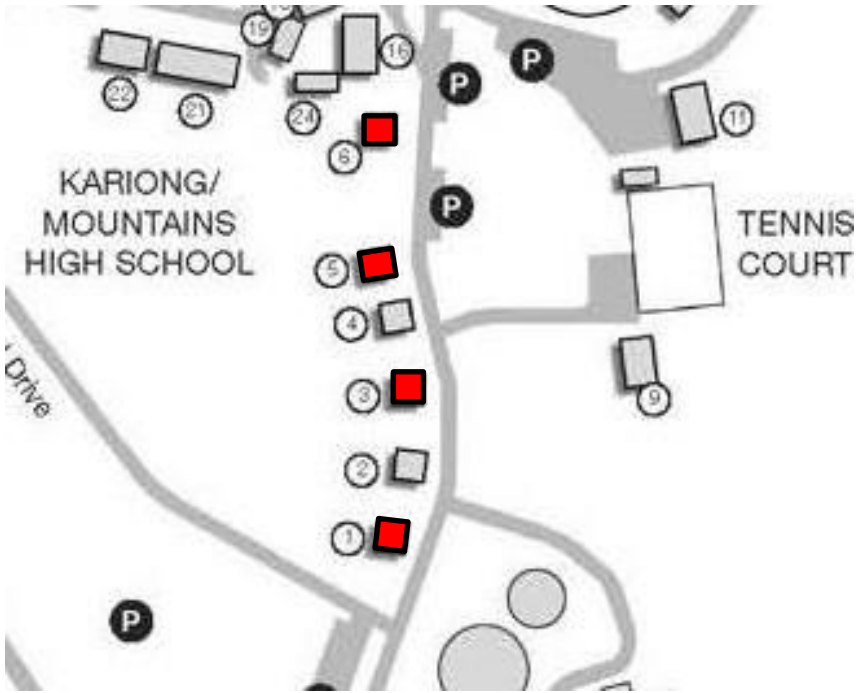
History	<p>The Residential Cottages were built in 1912-1913. The Cottages and their layout are credited to James Nangle (Rubie, p.18). They are typical of modest government staff accommodation buildings. These weatherboard buildings were constructed before the intermediate concrete cottages (Buildings 2 and 4).</p>
Description	<p>Four similar timber-framed bungalows with timber weatherboard external wall linings and hipped roofs covered by corrugated steel. The buildings originally had verandahs on all four sides but the rear verandahs and parts of side verandahs have since been enclosed with fibro sheet or weatherboards. The roofs of the buildings have small gablets at either end of the ridge and are bellcast over the verandahs. Verandahs are constructed with timber posts with bracketed at beams, timber beams, exposed rafters and, except for Building No. 5, timber balustrades. The balustrades appear to be a later modification. Windows and doors are of timber.</p> <p>Planning consists of a central corridor flanked by a room on either side at the front of the house. The corridor opens into a living area with, a room on one side. The rear of the buildings have been modified to incorporate a large open area with a kitchen at one end. Enclosed sections of verandahs include a bathroom, laundry and living/bedroom spaces. Early internal walls are of lightweight construction and lined with plaster. Pressed metal ceilings have survived in a number of rooms in the Cottages while later ceilings are flush finished plasterboard or similar and have cavetto profile cornices. Ceilings are pierced by ventilation grilles.</p>

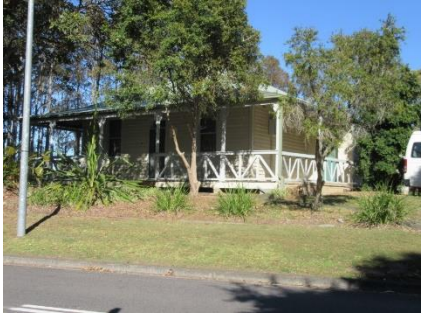
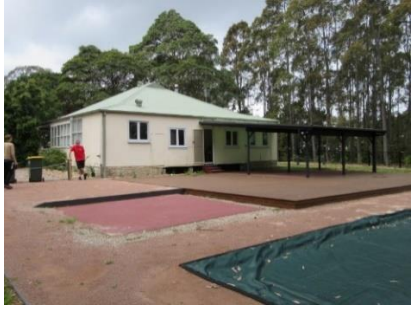
Building 1

RESIDENTIAL COTTAGES TYPE A	
	<p>Apart from the modifications noted above, other changes include the following:</p> <p>Building No. 1: a large verandah and performance area has been installed at the rear of the Cottage. The verandah floor on its north side is concrete over a brick footing wall.</p> <p>Building No. 3: the verandah floor is a concrete slab on brick footing walls. Some verandah posts have been cut off and supported on metal stirrups.</p> <p>Building No. 5: the verandah floor is concrete over a brick base. Brackets to verandah posts are missing and posts are supported on stirrups.</p> <p>Building No. 6: this is the only building in the group to have two masonry chimneys, one of which has a chimney pot. The verandah floor is supported on brick piers. Two new timber verandah posts have been introduced at the front entrance. An additional window has been installed in the northern side of the building.</p>

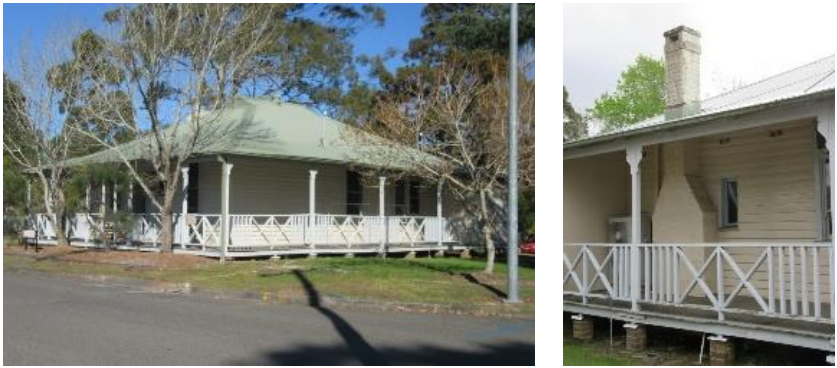
Condition	The buildings are in good condition and have been well maintained.
Significance	Buildings 1, 3, 5 and 6 are of State heritage significance. They are historically significant as original built components of Mount Penang and provide evidence of working conditions and staffing at Mount Penang during its operation as a child welfare institution. Their construction is associated with the early training activities of boys and youths at Mount Penang. The buildings are examples of modest Federation Bungalow style dwellings and an important part of the group comprising Buildings 1 to 6. Their placement along the western side of the entrance road is an important early design element on the site.
Guidelines	Retain and conserve the buildings. Continue to use for residential use or for an appropriate new use that does not require insensitive modifications that obscure their planning or overall form and fabric. Alterations and additions should not impact on the original form of the buildings or their relationships with other buildings in the group comprising Buildings 1 to 6.

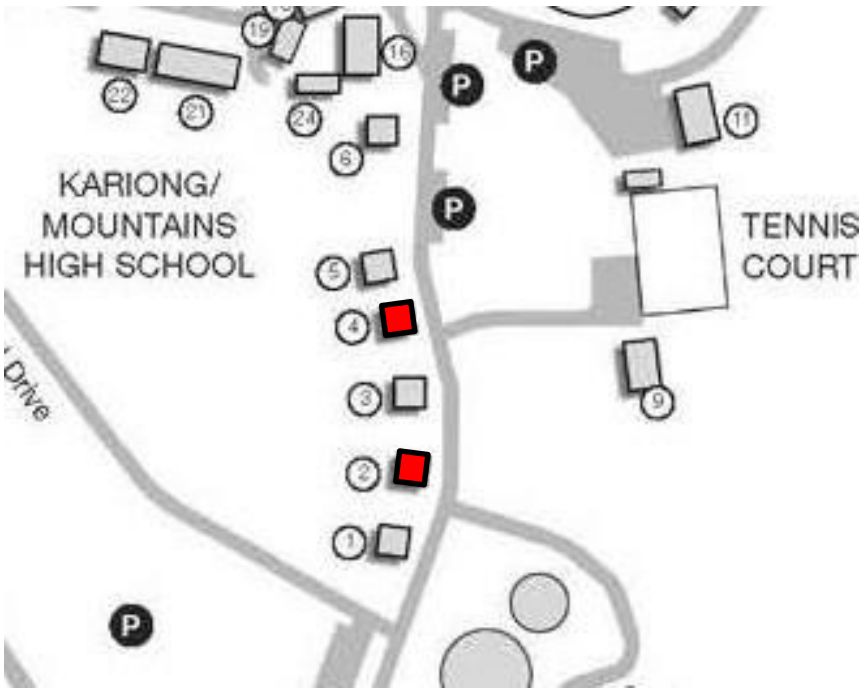
History	Buildings 2 and 4 are understood to have been constructed after 1928 – they do not show on a 1928 site drawing of the site (Department of Finance Plan Services drawing 8732). The cottages were built by the inmates of Mount Penang under trained supervision as part of their activities and skills training. The Cottages and their layout are credited to James Nangle (Rubie, p.18)
Description	<p>Buildings 2 and 4 are constructed of cement rendered concrete. They demonstrate characteristics of the Federation Bungalow style. The buildings are asymmetrically massed, with a projecting front room that has a bay window. The roofs of the buildings are hipped, with small gablets at either end of the ridge and are bellcast over the verandahs, while the roofs of the projecting room and the bay window are gabled. All roofs are covered with corrugated steel. The buildings have verandahs on their northern and eastern sides. Windows on the north-eastern corners of the buildings are mounted on the external wall faces with brackets below the sills. The cottages have timber framed windows.</p> <p>The verandah of Building 2 has timber verandah posts and lattice balustrade. The whole of the rear verandah and half of the north verandah have been enclosed in fibrous cement sheeting with aluminium and timber framed windows. The original entrance door has been replaced. Internally ceilings are lined with plasterboard. A large shade structure has been constructed at the rear of the building. An institutional kitchen has been installed at the rear of the cottage. Inspection of the building's interior was restricted because of the activities taking place at the time.</p>

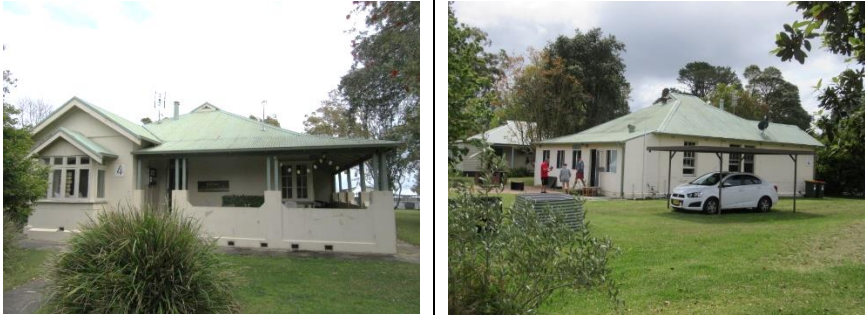
RESIDENTIAL COTTAGES TYPE B	
	<p>The verandah of Building 4 has solid masonry balustrades between brick piers supporting pairs of timber posts. The rear verandah has been enclosed and a new brick paved area and barbeque have been built at the rear of the house. The original entrance door has been replaced. Planning consists of a central corridor flanked by a room on either side at the front of the house. The corridor opens into a living area with, a room on one side. The rear of the buildings have been modified to incorporate a large open area with a kitchen at one end. The bathroom is on the northern side of the house, accessed by a hallway shared by a small bedroom. Bedrooms on the northern side of the building have doors giving access to the verandah. Enclosed sections of verandahs include a laundry and living/bedroom spaces. Ceilings are flush finished plasterboard or similar.</p>
Building 2

Condition	The buildings are in good condition and have been well maintained.
Significance	Buildings 2 and 4 are of State heritage significance. They are historically significant as original built components of Mount Penang and provide evidence of working conditions and staffing at Mount Penang during its operation as a child welfare institution. Their construction is associated with the early training activities of boys and youths at Mount Penang. The buildings are examples of modest Federation Bungalow style dwellings and an important part of the group comprising Buildings 1 to 6. Their placement along the western side of the entrance road is an important early design element on the site.
Guidelines	Retain and conserve the buildings. Continue to use for residential use or for an appropriate new use that does not require insensitive modifications that obscure their planning or overall form and fabric. Alterations and additions should not impact on the original form of the buildings or their relationships with other buildings in the group comprising Buildings 1 to 6.

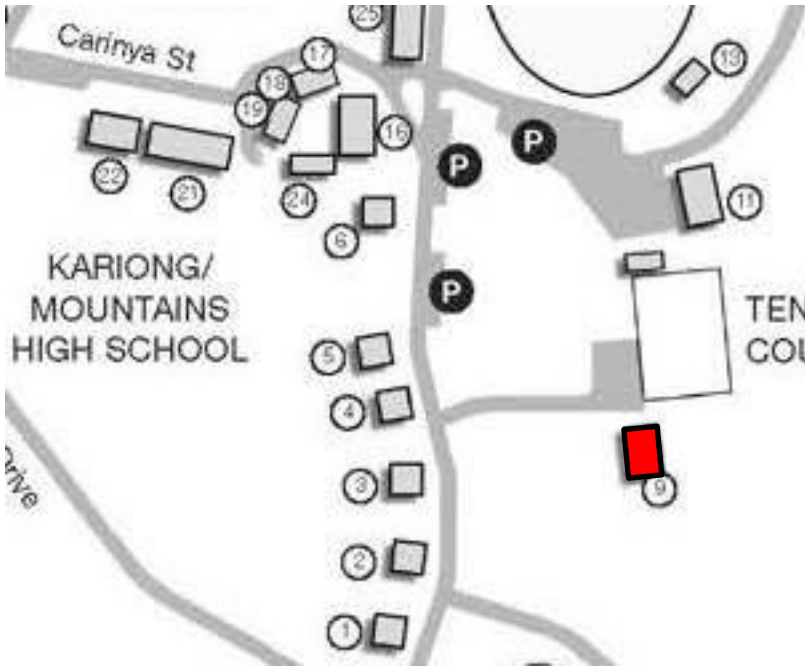
History	<p>The Deputy Superintendent's Residence was the first of the residential buildings to be completed at Mount Penang. It was originally surrounded on three sides by verandahs. Evidence provided by an archival photograph of the building suggests that another verandah was added to the rear of the building.</p>
Description	<p>Building 9 is situated on the east side of the main entry road and enclosed on the western side by a high timber paling fence. The symmetrical building demonstrates characteristics of the Federation Bungalow style and has walls of painted, cement-rendered concrete and timber verandahs on all four sides, although the side verandahs have been totally enclosed and the rear verandah is partially enclosed. The hipped roof is covered with corrugated steel and is bellcast over the verandahs. There are small gablets at the eastern and western ends of the ridge. There is a chimney on the south and north sides of the building, each with two chimney pots. Windows are a mix of timber and aluminium.</p> <p>The front entrance door and sidelights and the adjacent French doors to their south are original but the opening to their north has been enlarged and inappropriate door and sidelights cut in. The timber verandah framing may be original but original balustrading has been replaced. The verandah floor is timber and is supported on the eastern side by a brick wall and brick piers on the northern and southern sides of the building; openings between the piers have been filled in with breeze blocks.</p> <p>The interior has retained original fabric that includes decorative pressed metal ceiling linings and ceiling roses, and timber skirting boards and architraves. One fireplace has an elaborate timber chimneypiece and there is a timber fretwork arch in the hallway.</p>

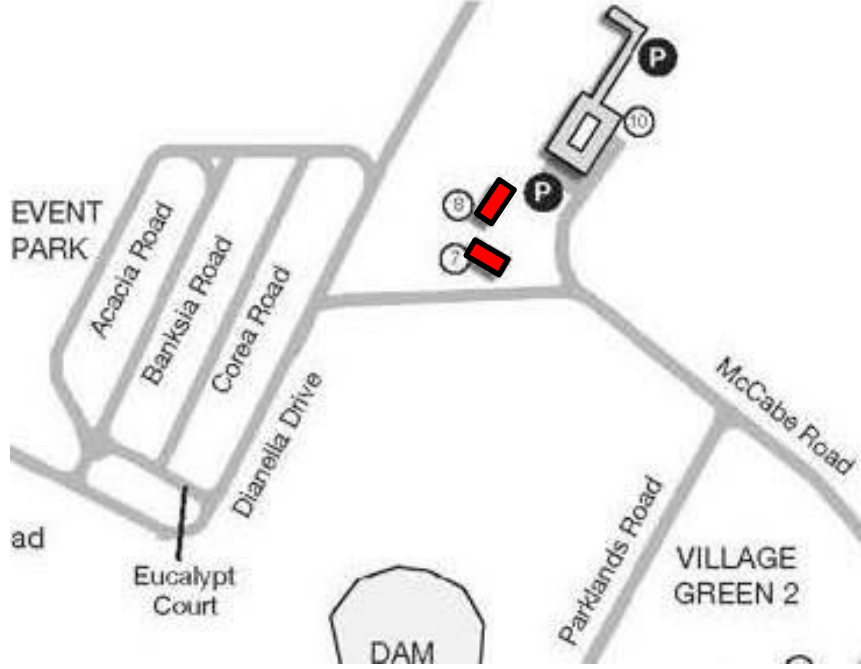
History	<p>The McCabe Complex was documented by the Government Architect's Branch of the Department of Public Works in the first half of 1943 and officially opened on 14 May 1944 by the then Minister for Education and Child Welfare, Clive Evatt as a specialist isolation unit for Mount Penang. Four years later it was converted in 'privilege' accommodation for boys soon to be discharged from the institution, and was officially opened by the Minister for Education, Robert Heffron, in May 1948.</p> <p>Buildings 7 and 8 were originally designed for staff accommodation. A Respite Cottage for disabled children was established in October 1980 in Building 8. It was set up for parents of children with disabilities who were unable to attend community functions because of the difficulty they had obtaining suitable babysitters or carers for their children. It closed when a new full-time facility opened at Narara in 1991 (Rubie, pp.162-163)</p> <p>In more recent times the McCabe Precinct Complex was utilised as a low-key government conference centre. Buildings 7 and 8 are now a residential unit for disability support services.</p>

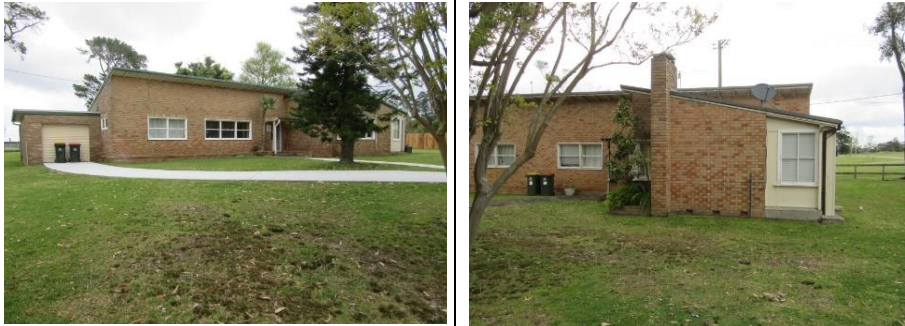
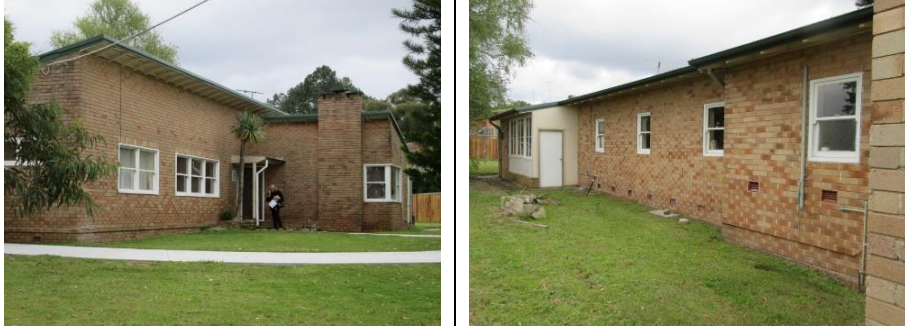
McCABE PRECINCT	
	<p>The cottages have an efficient L-shaped plan, with the principal entrance located at the internal angle of the junction of the two wings. The entrance in both is protected by a timber framed canopy supported off a timber post and enhanced by low brick planter boxes. The entry opens into a hall that separates bedrooms from living areas. The smaller of the wings contains a living room. Chimneys and fireplaces in the living rooms of the cottages are in different locations. Verandahs on one side of the living rooms have been enclosed (although this may have been done when the buildings were constructed). At the rear of the living room are a dining area opening off it, a kitchen and a laundry. The larger of the wings contains a linear arrangement of three bedrooms, along with a bathroom, all served by a shared passage. Doors are unusual, consisting of three panels containing vertical boards. Kitchens have been modified. Floors are polished timber boards.</p> <p>Both buildings have attached garages.</p>

Condition	Both buildings are in good condition
Significance	Buildings 7 and 8 are of State heritage significance. They are integral components of the McCabe complex, which is historically significant because of its role as a specialist isolation unit and then as 'privilege' accommodation from which many boys and youths were prepared for release into the outside world. The two buildings have a high level of aesthetic significance as examples of early Modernist dwellings in NSW and have retained a relatively high level of integrity. Buildings 7, 8 and 10 form a cohesive and attractive group. The cottages have associations with the Government Architect's Branch and demonstrate the progressive buildings that it was designing during the late 1930s and 1940s.
Guidelines	Retain and conserve Building 7 and Building 8. Continue to use for residential use or for an appropriate new use that does not require insensitive modifications that would obscure their planning or overall form and fabric. Alterations and additions should not impact on the original form of the buildings.

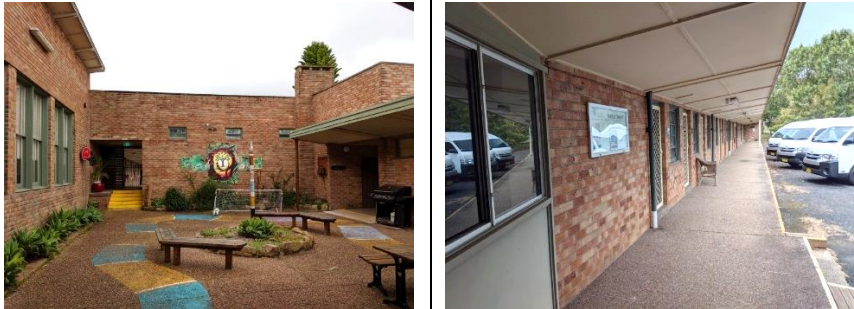
Description	<p>Building 10 is a fine example of the Inter War Functionalist style with a pronounced Modernist influence. The building has brick walls and skillion roofs covered by corrugated steel. The building consists of two main components, a rectangular block organised around a central courtyard that contains administrative spaces, communal spaces and a kitchen on three sides of the court and individual rooms, originally termed “cabins” that served as bedrooms for the boys occupying the Privilege section of Mount Penang. A semi-circular glazed bay, originally the dining room, projects from the south-eastern section of the block. A series of three rooms</p>

McCABE PRECINCT	
	<p>accessed by a verandah, which were originally detention cells, extends from the north-eastern corner of the block. A long row on “cabins” extends from the north-western corner of the block, terminating in what was a communal ablutions block and accessed from an external verandah sheltered by a cantilevered extension of the building’s roof. Flat hoods provide protection to windows and entrances. Externally and internally the building appears to have undergone relatively little change since it was completed, although the kitchen has been refurbished and the courtyard and verandahs have been finished in exposed aggregate topping.</p>

Condition	The building is in good condition and has been well maintained.
Significance	<p>Building 10 is of State significance.</p> <p>The McCabe complex of the Mount Penang Centre has historical significance as a specialist facility within the overall operation of Mount Penang, evidence of governmental initiatives associated with the conduct of Mount Penang in the middle of the century. It is historically significant as the place from which many of the boys from Mount Penang were prepared for release into the outside world. The isolation of the group from the main Centre illustrates its special operational relationship to the main Centre. Building 10 has a high level of aesthetic significance as a Modernist institutional building and has retained a relatively high level of integrity. Buildings 7, 8 and 10 form a cohesive and attractive group. The building has associations with the Government Architect’s Branch and is evidence of the progressive buildings that it was designing during the late 1930s and 1940s.</p>

Guidelines	Retain and conserve Building 10. Continue to use for institutional purposes or for an appropriate new use that does not require insensitive modifications that would obscure its planning or overall form and fabric. Alterations and additions should not impact on the original form of the buildings.

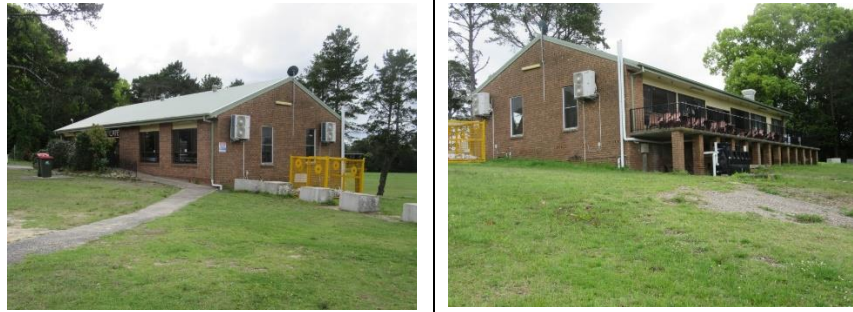
History	Built by Mount Penang residents as a clubhouse for the Kariong Sports and Recreation Club, which was established to encourage inmates' integration into the wider community (Rubie, p.151).
Description	Building 11 is a single storey brick structure with a gabled roof covered by corrugated steel. The building is on a sloping site overlooking the eastern sports field. The building has large metal framed windows on its western side, flanking the main entrance, narrow double hung windows in side elevations and a series of wide sliding door and window sets on its eastern side that open onto a deck supported on brick piers overlooking the sporting field. Air conditioning units have been mounted on the southern side of the building.

Condition	Building 11 is in good condition.

Significance	Building 11 has little heritage significance.
Guidelines	Retain, recycle, replace or demolish as required. Archival record prior to demolition.

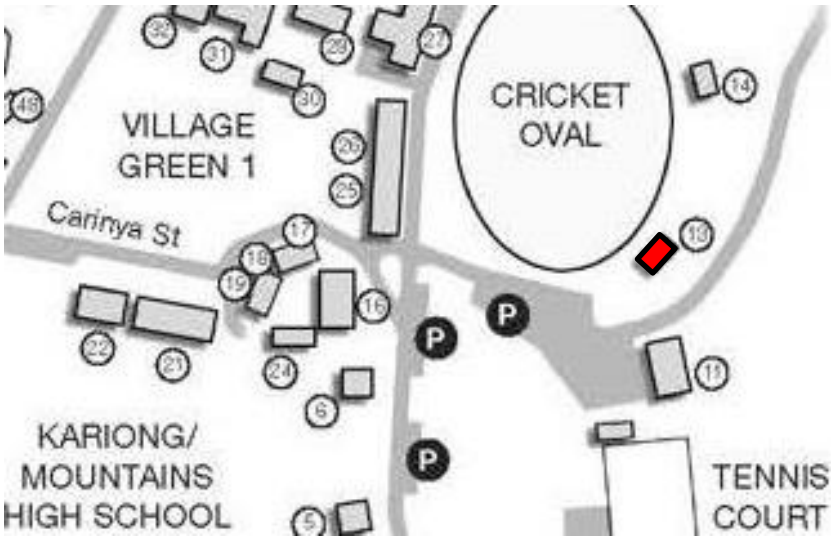
History	
Description	Single storey metal clad structure with a gabled roof. Large opening in its southern elevation.

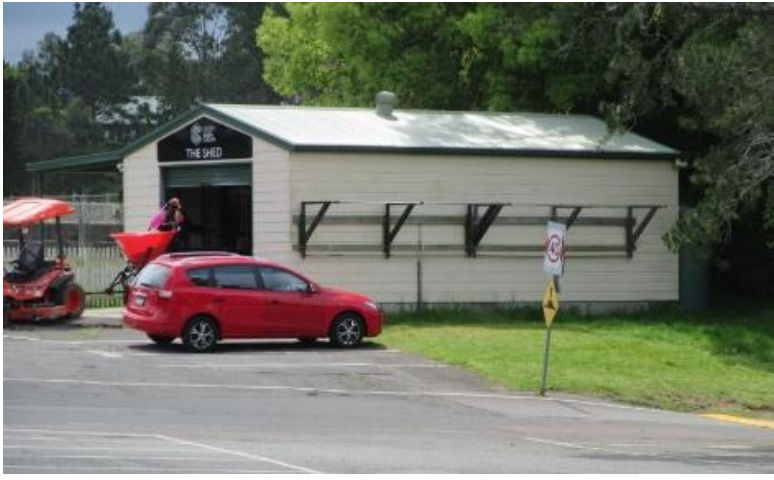
Condition	Building 13 is in good condition.
Significance	Building 13 has little heritage significance.
Guidelines	Retain, recycle, replace or demolish as required. Archival record prior to demolition.

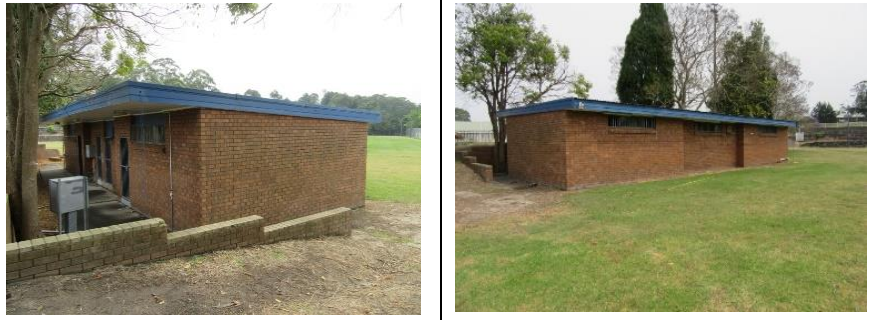
History	
Description	Used by Central Coast Sports College students when making use of the playing fields, the amenities block is a single storey brick building with a shallow pitched skillion roof.

Condition	The building is in good condition.
Significance	Building 14 has Little heritage significance
Guidelines	Retain, recycle, replace or demolish as required. Archival record prior to demolition.

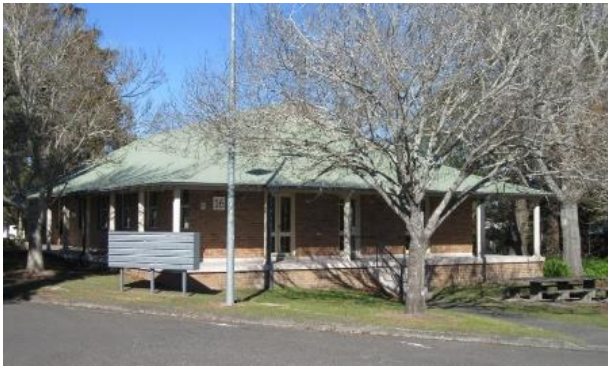
History	Constructed as a new office and administration block in the late 1970s. It originally contained offices for the superintendent, four deputy superintendents and a salaries clerk, a general office area, police interview room and conference room. The executive staff relocated from the old administration building (Rubie, p.134).
Description	Designed to be in keeping with the style of the original dormitories (Buildings 25 and 26), the single storey brick building has a hipped roof that is bellcast over the verandahs that surround it. The verandah is supported off square timber posts. Windows are aluminium framed.

Condition	The building is in good condition

Significance	Building 16 has Little heritage significance
Guidelines	Retain, recycle, replace or demolish as required. Any future development on the site should maintain the scale and general form of the existing building. Archival record prior to demolition.

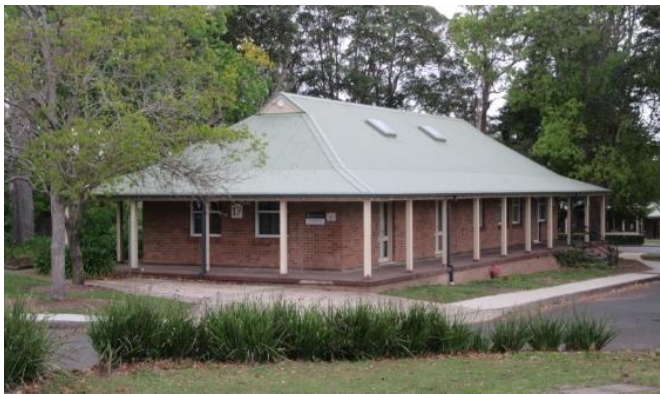
History	<p>Building 17 is constructed on the site of the original timber hospital building and matrons' flats. At the rear of the building are the sites of the first isolated detention block and the first rural school building. The building was designed in the Government Architect's Branch of the Department of Public Works and constructed at the end of the 1970s. It originally contained a general ward and isolation ward, a waiting room, surgery and doctor's office, a dental clinic and ancillary spaces.</p>
Description	<p>Single storey brick building designed to harmonise with the original buildings on the site. The hipped roof has gablets at either end of the ridge and is bellcast over the verandahs that surround it. Windows are aluminium framed, verandah posts are timber. There are skylights on the northern and southern sides of the roof. The plan of the building is essentially unchanged.</p>

Condition	The building is in good condition.
Significance	Building 17 has little heritage significance
Guidelines	Retain, recycle, replace or demolish as required. Any future development on the site should maintain the scale and general form of the existing building. Archival record prior to demolition.

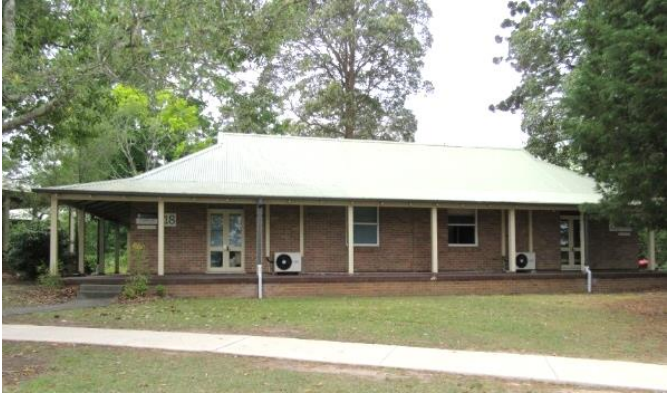
FORMER NURSING STAFF FLATS

History	Constructed in the late 1970s as two flats for nursing staff were built near the new hospital building. These replaced the two flats which were in the old hospital building and which were formerly used by the matron and deputy matron (Rubie, p.134). The building contained two flats with identical reversed plans containing a living/dining area, a bedroom, office, kitchen and bathroom. The building no longer serves a residential function and the plan has been modified to suit later uses.
Description	Single storey brick building designed to harmonise with the original buildings on the site. The hipped roof has gables at either end of the ridge and is bellcast over the surrounding verandahs. Windows are aluminium framed, timber verandah posts.

Condition	The building is in good condition.
Significance	Building 18/19 has little heritage significance.
Guidelines	Retain, recycle, replace or demolish as required. Any future development on the site should maintain the scale and general form of the existing building. Archival record prior to demolition.
