Mount Penang Parklands

Central Coast Highway, Kariong
(SHR listing number 01667)

Conservation Management Plan

November 2020 • Issue D
Project number 19 0069

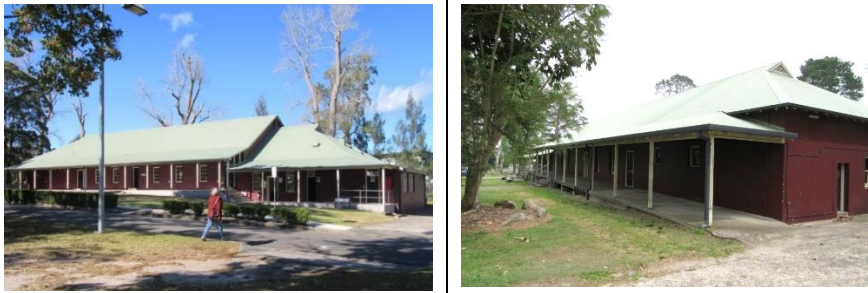
CARINYA	
	<p>has two components – the eastern section (Block A), which served as a dormitory, and the lower western section (Block B), which houses amenities and storage spaces.</p> <p>Both sections are constructed of unreinforced mass concrete that has been cement rendered externally. Block A has a hipped roof that is gabled at the western end where Block B, which also has a hipped roof, abuts. The roofs have gablets at ridge ends and are bellcast over the verandahs on the north and south sides of both blocks and along the western side of Block B, part of which has been infilled. Roofs are covered by corrugated steel. Windows, which consist of double hung timber framed sashes with six lights per sash, and doors are regularly spaced. The verandah roofs are supported by timber posts and beams. Rafters are exposed. Verandah floors are a mix of timber and concrete on the south side and concrete on the north side.</p> <p>Originally Block A consisted of one large room. Its interior has been subdivided to some extent and amenities have been added at one end. In common with other early dormitories, roof framing consists of a type of hammer beam truss with tie rods. The tie rods have turnbuckles; sag rods have hooked lower ends Ceiling linings follow the rake of roof at the sides and are flat over the central section. Wall surfaces are painted. Flooring is of timber, as are architraves to windows and doors. Tape and other material inscribed with graffiti relating to the last years of the Juvenile Justice Centre is located at the eastern end of the building. The interior of Block B has been modified and little early fabric remains.</p>

Condition	The building is in good condition.
Significance	Building 21 is of State heritage significance. It has High heritage significance. It is one of five dormitory buildings that form the historic and operational core of Mount Penang. The buildings are historically significant as evidence of boys' reformatory establishments in NSW and are aesthetically significant because of their proportions, scale, relationship to the site and structural expression internally, particularly the use of hammer beams and the volumes of former dormitory spaces. The buildings are associated with significant architect James Nangle. Their construction methodology reflects the historical constraints of the site and labour provided by the boys.
Guidelines	Retain and conserve Building 21. Continue to use for institutional purposes or for an appropriate new use that does not require insensitive modifications that would obscure its planning or overall form and fabric. Alterations and additions should not impact on the original form of the buildings.

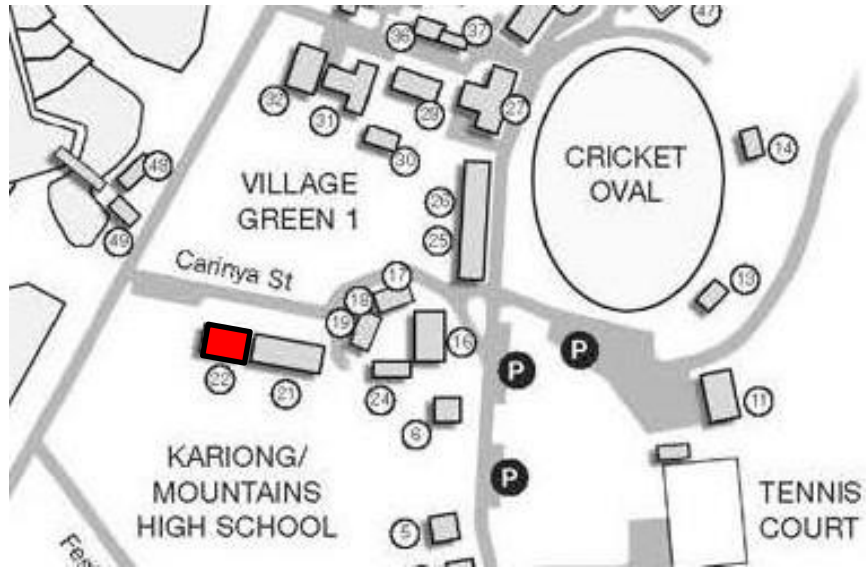
History	Understood to have been built as a maintenance and storage building, descriptions of the work completed by 1915 suggest that this building may be one of the very oldest in the complex and was possibly built as the kitchen at the time that the original group of boys were housed in tents nearby. In the 1940s, it appears to have housed showers and the laundry. At some undetermined period after 2000 the building was adapted for use as office space
Description	Building 22 is a relatively small rectangular building with a verandah on the north side only. The verandah has a concrete floor. The walls are of mass concrete, plastered internally and externally. The building has a hipped roof with gablets at either end of the ridge and is covered by corrugated steel. The original northern elevation was symmetrical, since lost because of an extension on the eastern side of the building. There is evidence of openings being relocated on the south elevation. Eaves are lined with timber boarding above rafters. Windows are double with horizontal glazing bars. Internally, floors are concrete. Marks on exposed timber ceiling joists indicate that a plaster ceiling has been removed. The interior has been refurbished to suit contemporary needs

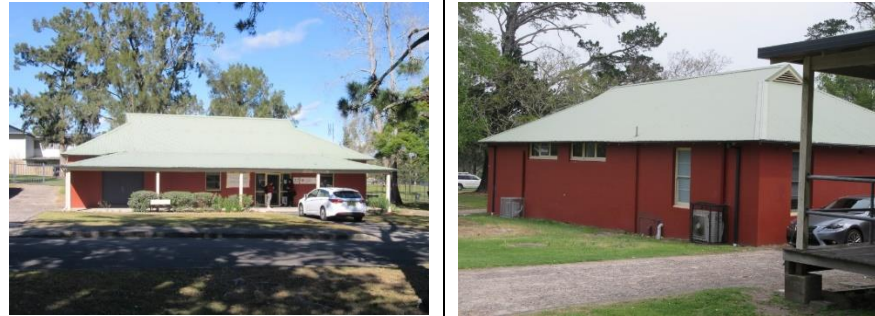
HCCDC	
Condition	The building is in good condition.
Significance	Building 22 is of State heritage significance. It has historical significance as one of the earliest permanent buildings on the site and aesthetic significance because of its visual relationships to other early buildings, including dormitories and the administrative building.
Guidelines	Retain and conserve Building 22. Continue to use for institutional purposes or for an appropriate new use that does not require insensitive modifications that would obscure its planning or overall form and fabric. Alterations and additions should not impact on the original form of the buildings.

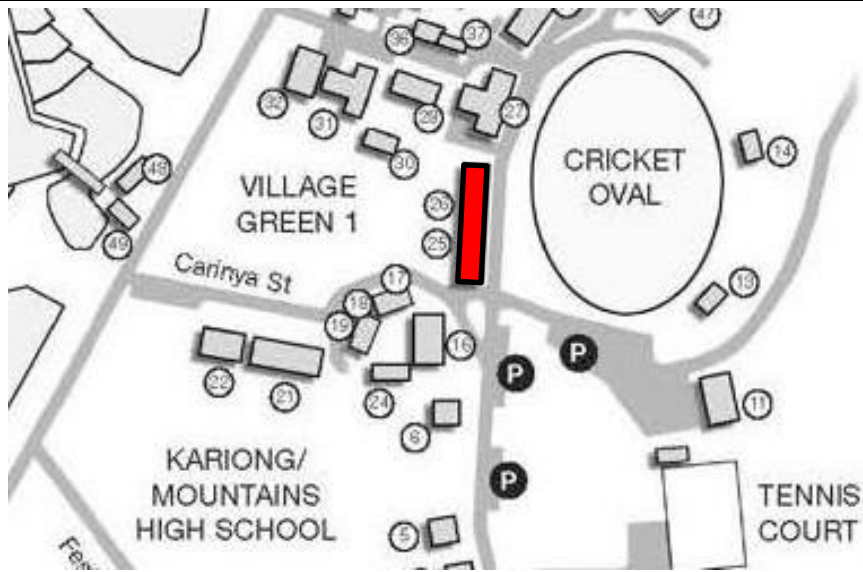
History	Building 26 was the first dormitory to have been completed at Mount Penang. Building 25 was completed during the 1920s. They are two of the five dormitories that were built between 1911 and the mid-1920s by the inmates of Mount Penang under trained supervision as part of their activities and skills training. The buildings are understood to have been designed by lecturer-in charge of Sydney Technical College's department of architecture and a member of the Advisory Committee for the construction of the new facility at Gosford
Description	Buildings 25 and 26 are located along the top of the ridge on the western side of The Avenue. The buildings are simple rectangular structures surrounded by wide verandahs. They have hipped roofs with gablets at the ends of ridges that are bellcast over verandahs and covered with corrugated steel. Verandah roofs are supported off timber posts and beams. Walls are constructed of mass concrete and their surfaces

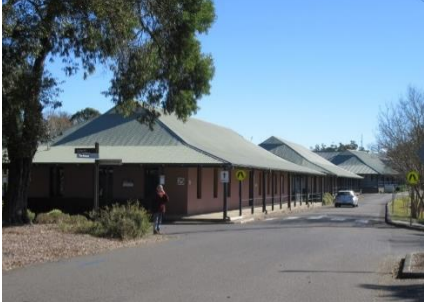
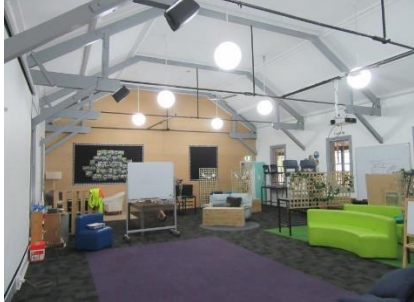
<p>Building 25</p>

SOBRAON and WALPOLE	
	<p>plastered and painted. Verandah floors are timber, although in some places concrete has been installed (Building 25). Timber steps connect the verandahs to the ground. Window and door openings are regularly spaced. Windows consist of timber framed double hung sashes with six lights per sash. Doors are generally of solid timber. Later French doors are half glazed and embellished with applied mouldings. A foundation stone laid by the Minister for Public Instruction, the Hon Campbell Carmichael, on 9 December 1912 is mounted on the northern elevation of Building 26. Both buildings are linked by a later amenities block.</p> <p>Internally both buildings were essentially one large room, but interiors have been subdivided and amenities areas installed. Floors are timber. Hammer beam roof trusses are exposed; ceiling linings are raked on either side of spaces and flush over the centre of the buildings. Windows have retained original architraves and mouldings.</p>

SOBRAON and WALPOLE	
<p>Building 26 - plan</p>	
Condition	<p>The buildings are in good condition, with many intact original elements.</p>
Significance	<p>Buildings 25 and 26 are of State heritage significance. Building 25 has particular significance as the first dormitory building at Mount Penang. Both have aesthetic significance because of its visual relationships to other early buildings, including dormitories and the administrative building. Building 25 and 26 are significant components of the group of buildings along The Avenue overlooking the cricket oval</p>
Guidelines	<p>Retain and conserve Building 25 and Building 26. Continue to use for institutional purposes or for an appropriate new use that does not require insensitive modifications that would obscure its planning or overall form and fabric. Alterations and additions should not impact on the original form of the buildings.</p>

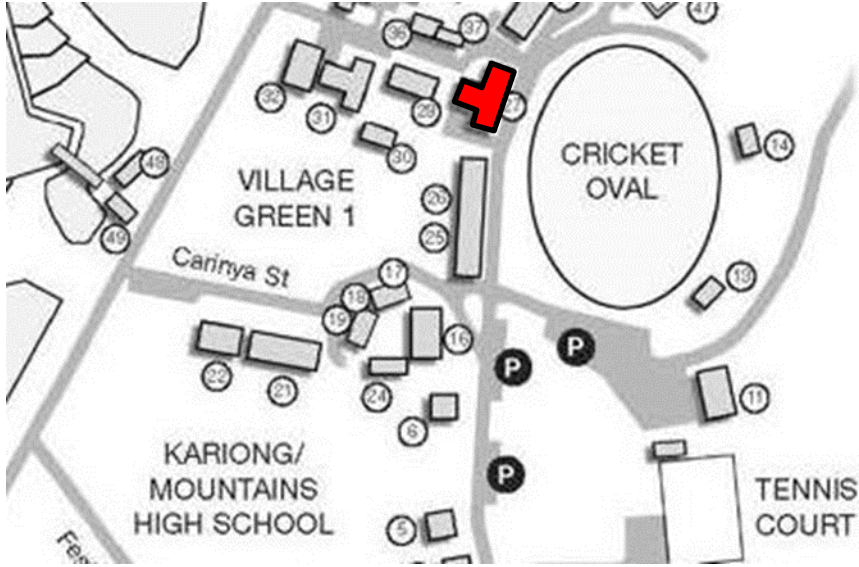
History	<p>Building 27 was built in two stages. The western wing was constructed in 1913 and initially used as an admissions block, becoming known as the “household block”. The eastern component was completed by 1928 and contained the institution’s recreational hall. Internal modifications and new external steps and planting boxes on the southern side of the building were undertaken in the early 1950s (Department of Finance Plan Services drawing number CW2/4 dated 9 January 1950). The recreation hall was converted into a theatrette during the second half of the 1980s to be used by a local drama group (Rubie).</p>
Description	<p>Building 27 is a single storey brick building with a T-shaped footprint. L-shaped building. It is generally similar in appearance to the dormitory buildings (Buildings 25, 26, 39 and 40), with mass concrete walls and hipped roofs covered by corrugated steel, and encircling verandahs. However, the roof over verandahs on the western wing is a continuation of the main roof plane and is not bellcast. There is a gabled porch in the centre of the east wing. Windows in the west elevation of the west wing are protected by a canopy supported off timber brackets, which appears to be a later addition. Many windows in the west wing have been altered.</p> <p>Internally there is a raised hardwood stage at the north end of the east wing. Much of the original space is still in place, with exposed hammer beam trusses and ceiling linings that follow the rake of the roof at the sides and are flush in the centre of the wing. By contrast, the ceilings in the west wing are flush-finished plasterboard with cavetto cornices. Pressed metal ceilings are still in place above the new ceilings.</p>

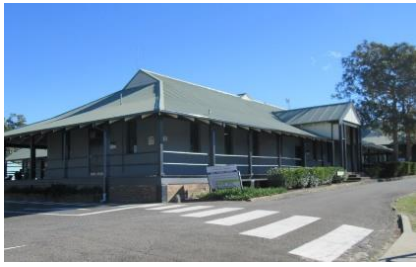
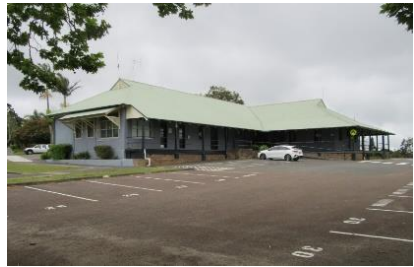
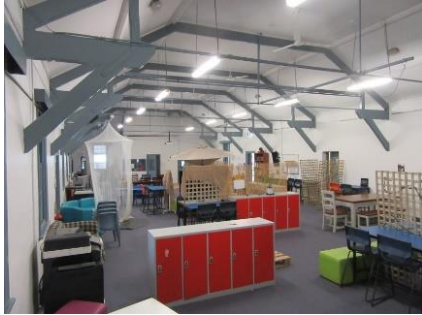
QUARTERDECK

<p style="font-size: small;">Heritage Note The location of the built form is noted in the plan.</p>
Condition	The building is in good condition, with many intact original elements.
Significance	Building 27 is of State heritage significance. It is an important building from the first phase of development at Mount Penang and evidence of the nature and extent of the facilities originally provided for the establishment. The building has strong visual associations with the early dormitories and is an important component of the building group on The Avenue overlooking the cricket oval.
Guidelines	Retain and conserve Building 27. Continue to use for institutional purposes or for an appropriate new use that does not require insensitive modifications that would obscure its planning or overall form and fabric. Alterations and additions should not impact on the original form of the buildings.

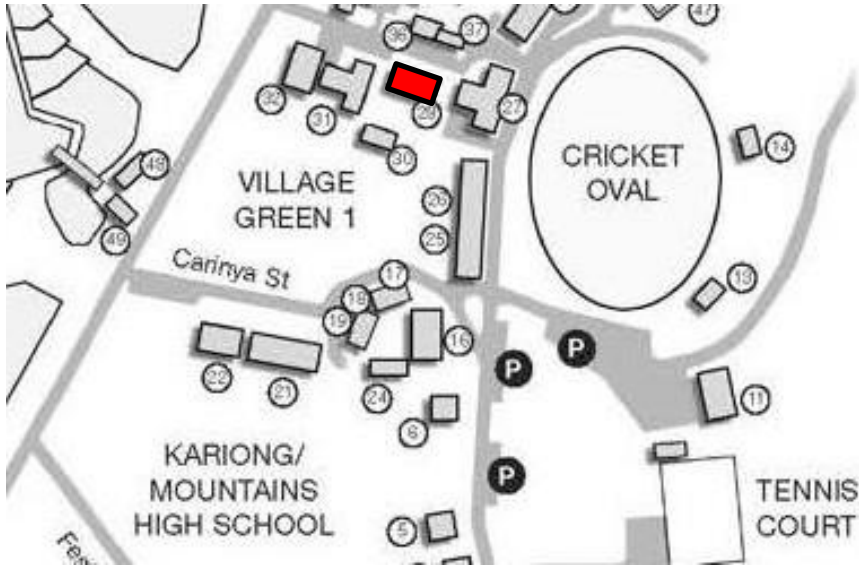
History	Building 28 was designed and documented in the Government Architect's Branch during 1945. It was extensively modified after 1999.
Description	<p>Building 28 is a single storey brick building with a hipped roof covered by corrugated steel. External wall surfaces have been cement rendered and painted. A verandah supported off timber posts has been added to the southern side of the building, which has a concrete floor at the east end and a timber floor over brick piers at the western end. The building has timber framed double hung windows, the sashes of which are divided horizontally by a slender glazing bar.</p> <p>The interior of the building consists of two unequally sized rooms and a suite of lavatories and airlock served by a short corridor.</p>

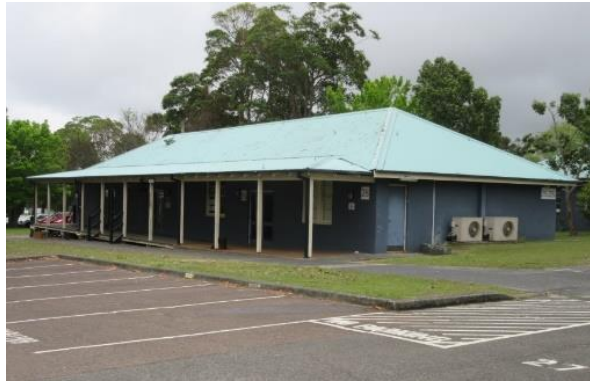
Condition	The building is in good condition
Significance	Building 28 has Moderate heritage significance, notwithstanding its interior has been extensively modified. It provides evidence of the consolidation of the correctional facility during the 1940s.
Guidelines	Retain and conserve Building 28. Future uses should be appropriate to the building and not require insensitive modifications that would obscure its overall form and external fabric. Any additions should not impact on the original form of the building or on neighbouring buildings.

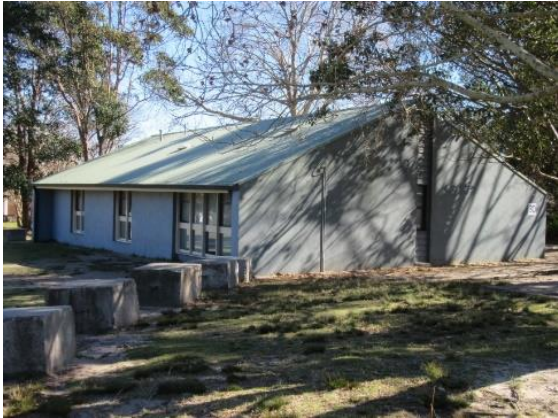
History	Designed as a stores and amenities building by the Government Architect's Branch in 1976 (Department of Finance Plan Services CW2/49).
Description	Building 30 is a single storey brick building with a gabled roof covered by corrugated steel. Windows and glazed doors are timber framed. External brick surfaces have been painted.

Condition	The building is in good condition.
Significance	Building 30 has Little heritage significance.
Guidelines	Retain, recycle, replace or demolish as required. Archival record prior to demolition.

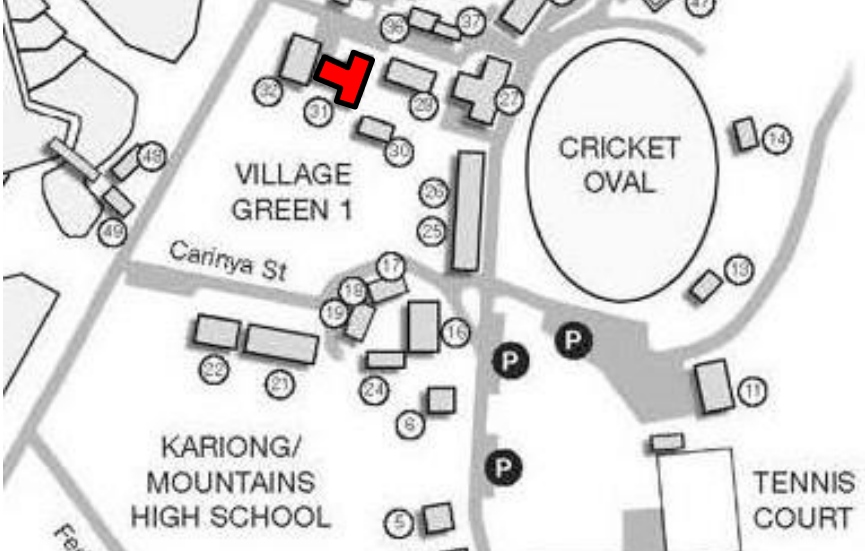
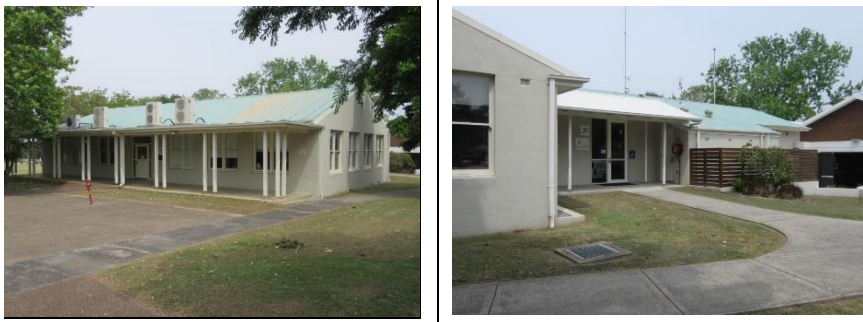
History	Former dining room and main kitchen that were documented by the Government Architect's Branch in 1950 (Department of Finance Plan Services CW2/10). The original north-western section of the building has been demolished
Description	Two storey brick building with a T-shaped footprint. The building has a gabled roof covered by corrugated steel. Windows consist of timber framed double hung sashes. Verandahs added to the northern and eastern sides of the building. External wall surfaces have been cement rendered.

Condition	Building 31 is in good condition.
Significance	Building 31 has Moderate heritage significance.
Guidelines	Retain and conserve Building 28. Future uses should be appropriate to the building and not require insensitive modifications that would obscure its overall form and external fabric. Any additions should not impact on the original form of the building or on neighbouring buildings.

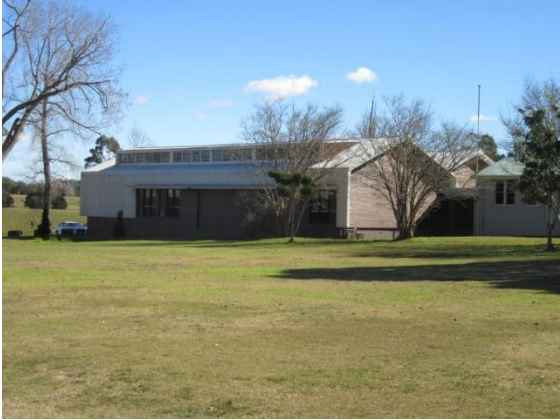
NAISDA DANCE COLLEGE	
Description	Building 32 consists of two linked pavilions with gabled roofs. The roofs, which are clad in corrugated steel, are extended down the sides of the pavilions. The end (eastern and western) walls are lined with timber. A verandah extends along the northern side of the northern pavilion. The southern pavilion incorporates a raised roof section containing ventilation grilles.

Condition	The building is in good condition.
Significance	Building 32 has Little heritage significance.
Guidelines	Retain, recycle, replace or demolish as required. Archival record prior to demolition.

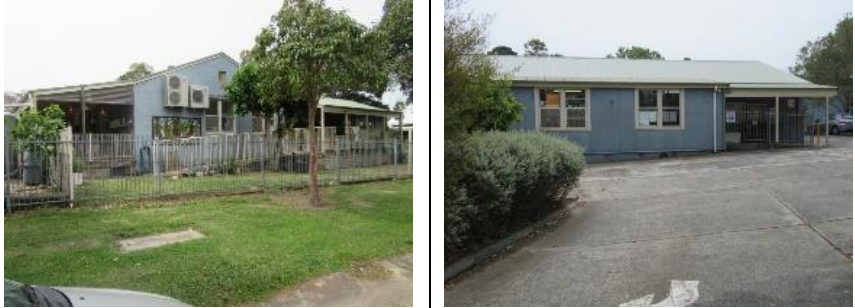
KARIONG COMMUNITY PRE-SCHOOL	
Description	<p>Building 34 is a single storey building with an L-shaped footprint. It is constructed of brick and has gabled roofs covered by corrugated steel. External brick surfaces have been painted. Verandahs have been added to three sides. A number of double hung windows appear to have been retained.</p> <p>There is a small concrete block utilities shed with a gabled roof to the north of the building.</p>

Condition	The building is in good condition.
Significance	Building 34 has Little heritage significance. It has been modified and there is little apparent evidence of its early use.
Guidelines	Retain, recycle, replace or demolish as required. Archival record prior to demolition.

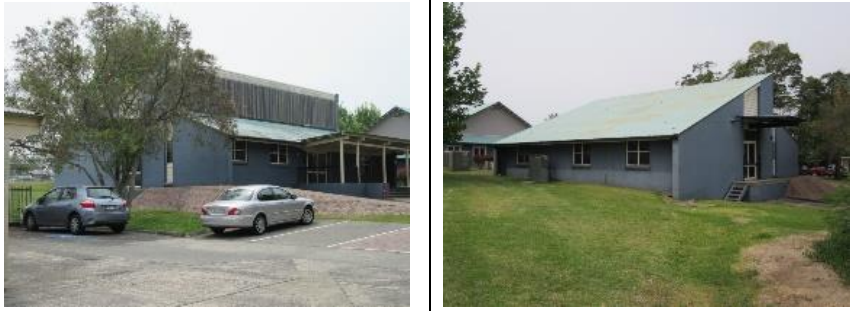
STORES BUILDING	
Description	Single storey brick building with steeply pitched skillion roofs covered by corrugated steel. External brickwork has been painted. The clerestory on the southern side of the northern roof, which was designed with fixed panes of glass and glass louvres for ventilation, is c=screened by closely spaced timber battens.

Condition	The building is in good condition.
Significance	Building 35 has Little heritage significance.
Guidelines	Retain, recycle, replace or demolish as required. Archival record prior to demolition.

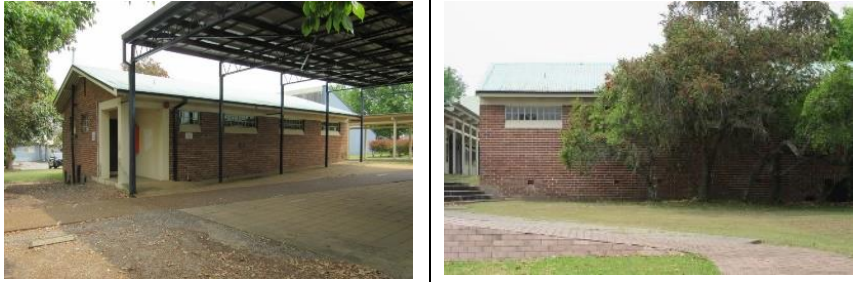
FORMER DETENTION BLOCK	
Description	Rectangular face brick building, with a gabled roof covered by corrugated steel. A small porch, lined with painted cement render, is situated on the north-eastern corner of the building. Individual spaces in the building are lit and ventilated by high windows on its northern and southern sides. The building is intact internally.

Condition	Building 36 is in good condition.
Significance	Building 36 has Moderate heritage significance. It provides evidence of the consolidation of the correctional facility during the 1950s and of disciplinary procedures at the institution.
Guidelines	Retain and conserve Building 36. Future uses should be appropriate to the building and not require insensitive modifications that would obscure its overall form and external fabric. Any additions should not impact on the original form of the building or on neighbouring buildings.

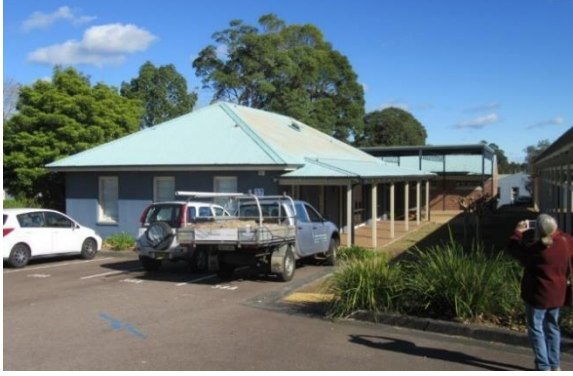
FORMER WORKSHOP AND STORE	
	hipped roof covered by corrugated steel. A verandah has been added to its northern side. Windows consist of timber framed double hung sashes. The building has been refitted internally as offices and the large door opening at the western end infilled.

Condition	Building 37 is in good condition.
Significance	Building 37 has Moderate heritage significance. It provides evidence of a key period of consolidation and upgrading of facilities at Mount Penang after World War II.
Guidelines	Retain and conserve Building 37. Future uses should be appropriate to the building and not require insensitive modifications that would obscure its overall form and external fabric. Any additions should not impact on the original form of the building or on neighbouring buildings.

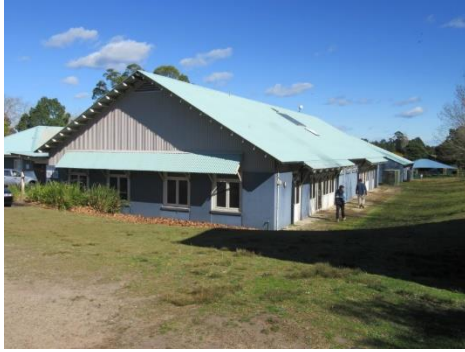
BUILDING 38	
History	Building 38 was constructed by the Festival Development Corporation.
Description	Long single storey building with painted brick walls and steeply pitched gabled roof covered by corrugated steel.

Condition	The building is in good condition.
Significance	Building 38 has Little heritage significance.
Guidelines	Retain, recycle, replace or demolish as required. Archival record prior to demolition.

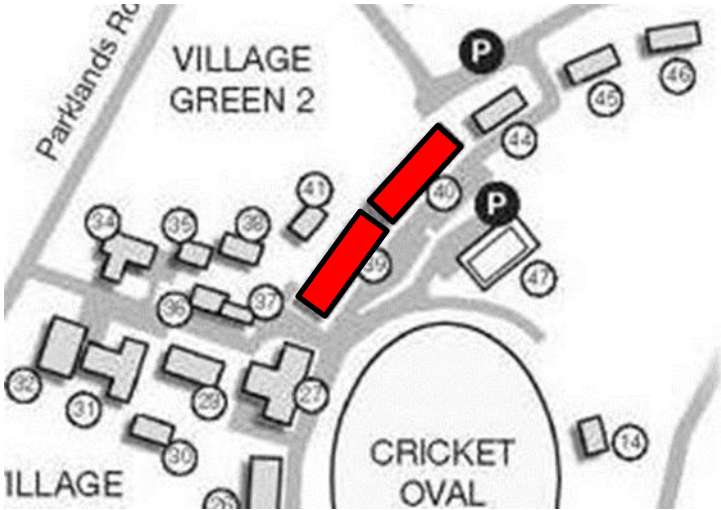
History	Building 39 and Building 40 are two of five dormitories built between 1911 and the mid-1920s by the inmates of Mount Penang under trained supervision. Construction of these and other buildings formed part of their and skills training.

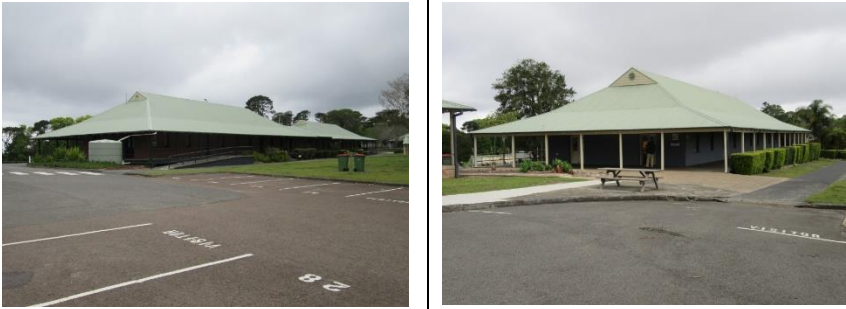
Building 39 (left) Building 40 (right)

VERNON HOUSE, WOOD HOUSE	
	<p>The building is understood to have been designed by James Nangle, lecturer-in charge of Sydney Technical College’s department of architecture and a member of the Advisory Committee for the construction of the new facility. Dormitory use was succeeded by use for teaching. Building 40 was a trades vocational training centre until the mid-1980s.</p>
Description	<p>Buildings 39 and 40 are long rectilinear buildings surrounded by verandahs on three sides, with hipped roofs that are bellcast over the verandahs. Walls are constructed of mass concrete, roofs have small gablets at ridge ends and are covered by corrugated steel. The two buildings are linked by a later amenities block, which resulted in the loss of the verandahs at the end of each building.</p> <p>Internally the original form of the buildings is still very evident. The hammer beam trusses are exposed and ceiling linings are raked with a flat section over the middle of the building.</p>

Condition	The buildings are in good condition.
Significance	Building 39 and Building 40 are of State heritage significance. Building 39 has historical significance as one of the earliest permanent buildings on the site and both have aesthetic significance because of their visual relationships to other early buildings, including dormitories and the administrative building.
Guidelines	Retain and conserve Building 39 and Building 40. Continue to use for institutional purposes or for an appropriate new use that does not require insensitive modifications that would obscure their planning or overall form and fabric. Alterations and additions should not impact on the original form of the buildings.

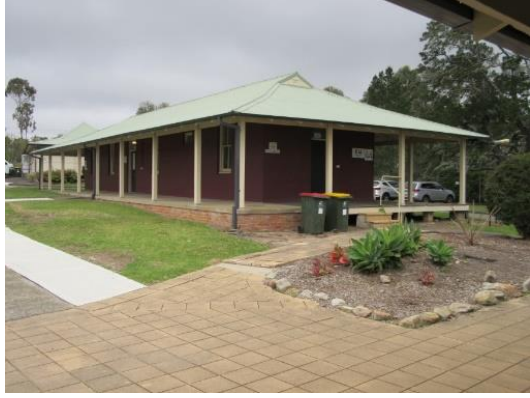
KINDERGARTEN UNION CHILDREN'S SERVICES	
	<p>corrugated steel. Verandah floors are concrete on the northern and western sides of the building, timber on the southern and eastern sides. Original windows are timber framed double-hung sashes in four lights with vertical glazing bars. Larger windows have been cut into the south end of the east elevation. Windows at north end of the east elevation are not original and are understood to have replaced French doors.</p>

Condition	Building 44 is in good condition.
Significance	Building 44 has Moderate heritage significance. It, along with other remaining buildings constructed during the first two decades of the Gosford Farm Home, provides important evidence of the nature and extent of the facilities originally provided for the establishment. The building has strong visual associations with the arc of buildings consisting of Buildings 25-27, 39-40 and 44-46, which as a group organised along The Avenue have historical and aesthetic significance

Guidelines	Retain and conserve Building 44. Future uses should be appropriate to the building and not require insensitive modifications that would obscure its overall form and external fabric. Any additions should not impact on the original form of the building or on neighbouring buildings. Consider reconstruction of verandahs should the opportunity to do this arise.

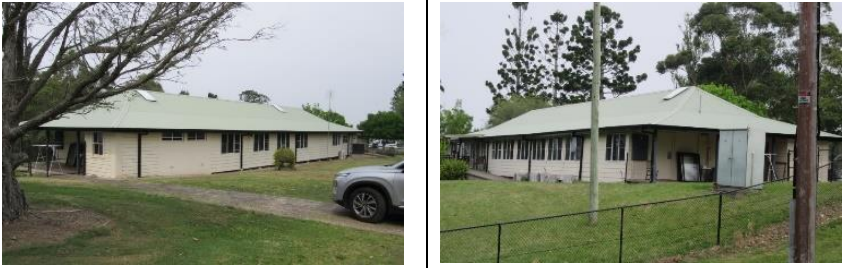
OPTIONS DISABILITY SUPPORT	
	weatherboards. Internally the building has been subdivided into a series of small rooms accessed off the enclosed eastern verandah. There are toilets and showers at the north end and a kitchen and common room at the south end.

Condition	The building is in good condition.
Significance	Building 46 has Moderate heritage significance. It, along with other remaining buildings constructed during the first two decades of the Gosford Farm Home, provides important evidence of the nature and extent of the facilities originally provided for the establishment. The building has strong visual associations with the arc of buildings consisting of Buildings 25-27, 39-40 and 44-46, which as a group organised along The Avenue have historical and aesthetic significance
Guidelines	Retain and conserve Building 46. Future uses should be appropriate to the building and not require insensitive modifications that would obscure its overall form and external fabric. Any additions should not impact on the original form of the building or on neighbouring buildings. Consider reconstruction of verandahs should the opportunity to do this arise.

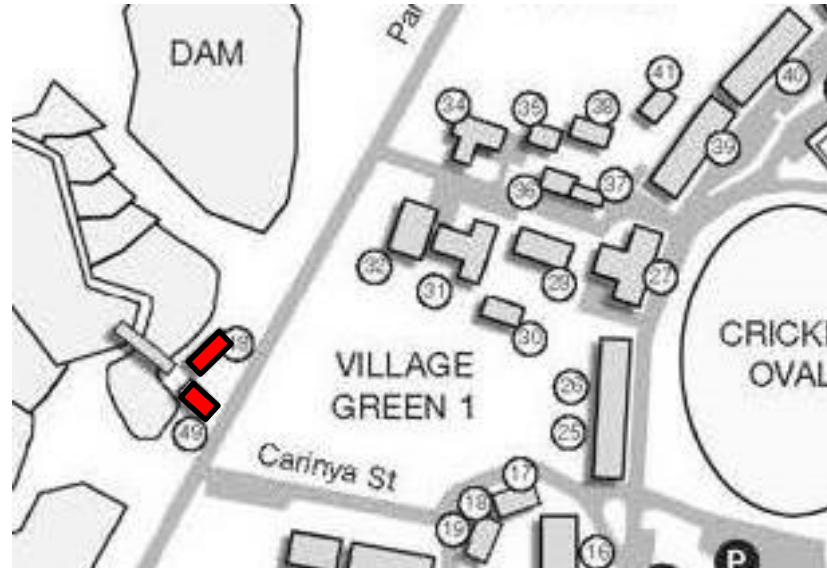
History	Constructed as ancillary structures to Mt Penang Gardens. The buildings are understood to have been designed by Anton James, the designer of Mt Penang Gardens.
Description	<p>Rectangular lightweight flat roofed buildings. Building 48 contains a café. It is extensively glazed on its northern, eastern and western sides and has verandahs on its eastern and western sides.</p> <p>Building 49 consists of two pavilions – the northern pavilion provides storage space and the southern pavilion contains lavatories. The pavilions are framed in steel; some external walls are lined with enlarged photographs; southern walls are reflective. Vertical timber battens provide screening.</p>
Building 48

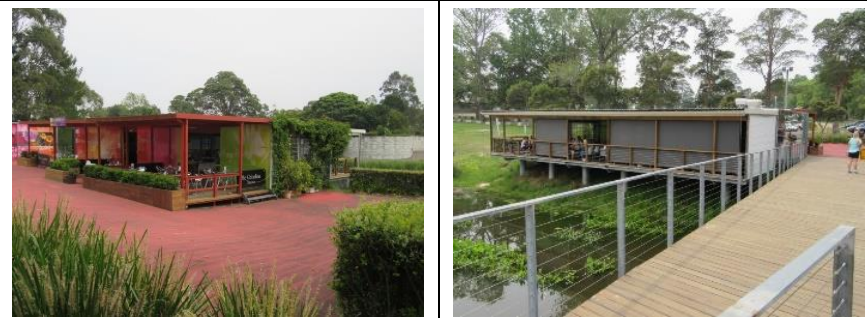
WATERFALL CAFE	
Building 49	 
Condition	The buildings are in good condition.
Significance	Building 48 and Building 49 have Little heritage significance.
Guidelines	Retain, recycle, replace or demolish as required. Archival record prior to demolition.

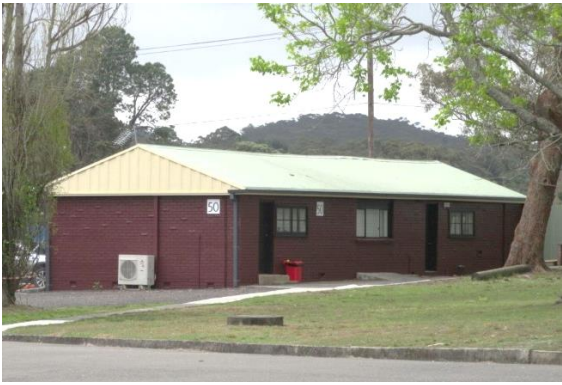
FORMER BOOTSHOP

History	Purpose built as a bootshop in 1948, the building subsequently served as a small motors and bricklayers' classroom, was refurbished in the late 1970s or early 1980s for use as a craft room (Rubie, pp.xi, 85, 136).
Description	Building 50 is a utilitarian single storey brick building with a gabled roof covered with corrugated steel. External brick surfaces have been painted. There are timber framed and aluminium framed windows in its eastern and western elevations. An open covered structure has been constructed on its western side.

Condition	The building is in good condition.
Significance	Building 50 has little heritage significance.
Guidelines	Retain, recycle, replace or demolish as required. Archival record prior to demolition.

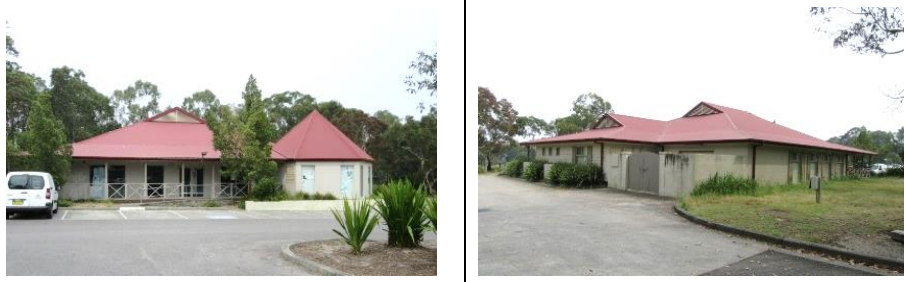
CENTRAL COAST VISITOR INFORMATION CENTRE

History	
Description	Single storey building with a hipped roof that has ventilated gablets at ridge ends. The roof is bellcast to cover verandahs on three sides of the building. There is a hexagonal wing at the north-western corner of the building. All roofs are covered in corrugated steel. There is a recessed verandah on the western side of the building. External wall linings consist of flush fibre cement sheet or similar, or horizontal weatherboards. Doors are timber, windows are framed in aluminium.

Condition	The building is in fair condition overall, with some damage or deterioration to external wall linings on its western side.
Significance	Building 52 has Little heritage significance.
Guidelines	Retain, recycle, replace or demolish as required. Archival record prior to demolition.

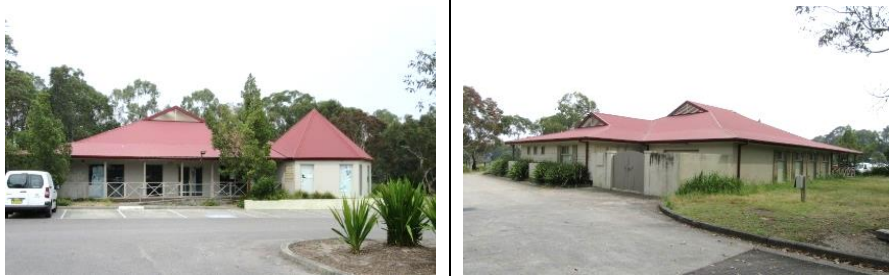
History	
Description	<p>Single storey building with a hipped roof that has ventilated gablets at ridge ends. The roof is bellcast to cover verandahs on three sides of the building. There is a hexagonal wing at the north-western corner of the building. All roofs are covered in corrugated steel. There is a recessed verandah on the western side of the building. External wall linings consist of flush fibre cement sheet or similar, or horizontal weatherboards. Doors are timber, windows are framed in aluminium.</p>

Condition	The building is in fair condition overall, with some damage or deterioration to external wall linings on its western side.
Significance	Building 52 has Little heritage significance.
Guidelines	Retain, recycle, replace or demolish as required. Archival record prior to demolition.

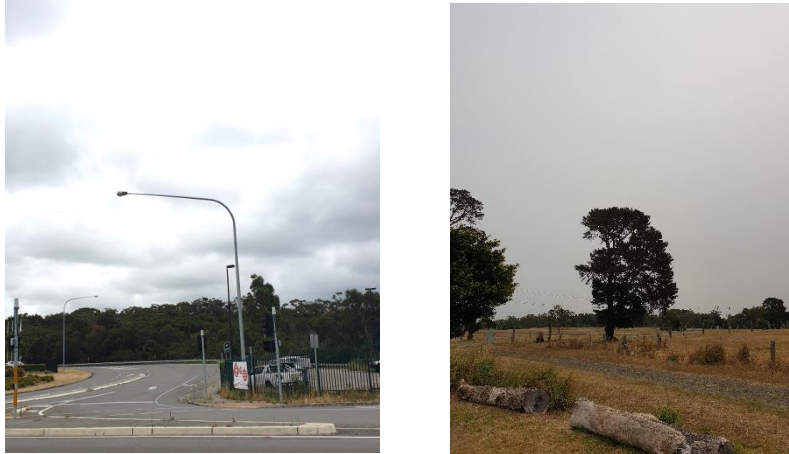
Images

History	This area was cleared as part of the establishment phase of the site and has been formerly used as areas for grazing of cattle and milking cows. The vegetated buffer is remnant bushland that has some incursions for vehicular access. The area was developed as unmarked overflow car parking and service area for events
Description	This precinct is characterised by an extensive, relatively flat, open grassed landscape and is a central zone for the Festival activities with substantial areas marked out for car parking. The precinct is located on a minor ridge to the west of the central Heritage Precinct with regional views gained to the east, west and south to vegetated hills. To the western boundary is established bushland that provides an enclosing vegetated element.

Condition	The condition of the precinct is good with well-maintained grassed areas and bushland
Significance	Moderate
Guidelines	Maintain as is, regular mowing to grassed areas to ensure suppression of weeds and reduction of fuel load, maintain bushland in a healthy and sustainable state using bush care principles as per Ecological Australia guidelines.

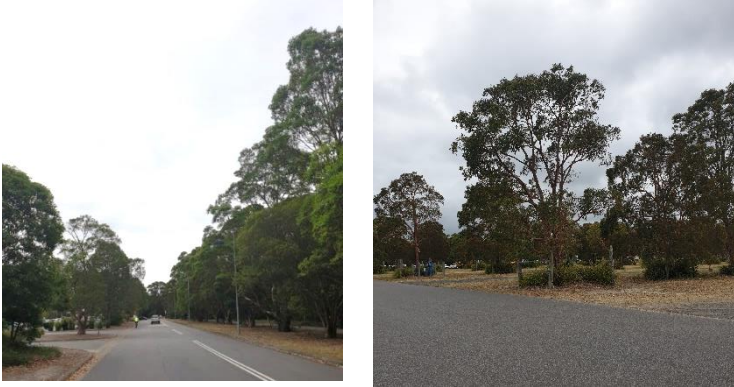
Images

History	This area was developed as a festival carpark in 2009. Prior to that period, it consisted of semi cleared bushland.
Description	Occupying an area to the entry portion of the southern portion of the overall site, this precinct is characterised by an extensive gravel car park with native plantings between car parking bays. To the eastern boundary of the precinct is an established avenue of Brushbox trees with Eucalypt trees interspersed in between. These landscape elements define the entry driveway. To the northern portion of the precinct, Festival Drive forms the intermediate boundary between the school and the car park. These works formed part of the Mt Penang Gardens in early 2000. To the southern boundary is established bushland that screens the site from the Pacific Highway.

Condition	The condition of the precinct is good with appropriately maintained carpark, gravel surfaces and native planting.
Significance	Moderate
Guidelines	Maintain as overflow parking, ensure suppression of weeds and maintenance of remnant bushland using bush care methods as per Ecological Australia guidelines.

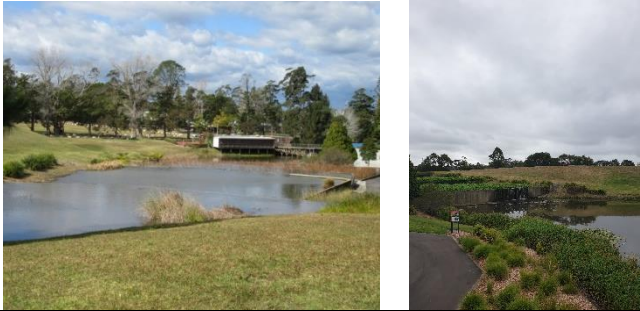
Image

History	Prior to 2001, this precinct formed part of the open pasture of the facility. In 2001, the Mt Penang Gardens were instigated and the precinct developed with further water bodies, café and visitors centre.
Description	This precinct is broadly defined as a broad open area between the minor ridges of the Heritage Precinct and the Kangoo Commercial Precinct. The landscape character consists of open former pasture, gravel surfaced car parking, Mt Penang Gardens, the McCabe Centre and a substantial dam. This precinct was the site for both productive purposes (vegetable beds and the like) and pasture for dairy cattle. There is no evidence of these former activities.

Condition	Condition of the precinct is good with well-maintained grounds and horticultural expression of the gardens.
Significance	Moderate
Guidelines	Maintain precinct as is, ensuring waterbody health, management of gardens clearly highlighting the horticultural expression and design intent. Check on landscape structures on a yearly basis for integrity.

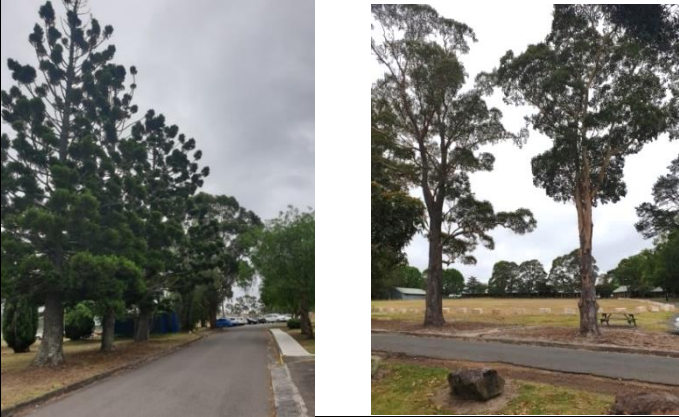
Images

History	Core precinct with establishment of housing, dormitories, halls and associated open space and structured plantings. Further supplementary garden beds and plantings from the 1970s.
Description	This precinct is characterised by a mature landscape curtilage of cultural plantings that reflect the development of the site over the last hundred years. Mature plantings of Radiata Pine, Brushbox, Camphor Laurel, Hoop Pine and Eucalypts reflect the evolution of landscape design over the 20th century. These plantings are aligned with the built form creating an institutional environment that reflects the purposes and outcomes of government educational policy over time. The sports field that forms part of the Heritage Precinct is typical of the integrated character of the place, defined by perimeter roads with mature planting mainly of Brushbox and Eucalypts and one and two storey form of built elements to the periphery of this precinct. A series of rectangular sandstone blocks are located adjacent to the road so as control vehicular access to the field. These form a discordant element.

Condition	Condition is good with well-maintained grounds
Significance	Exceptional
Guidelines	Maintain existing structured landscape of mature tree rows and avenues. Consider forward plantings adjacent to mature plantings to ensure continuum of landscape character and form.

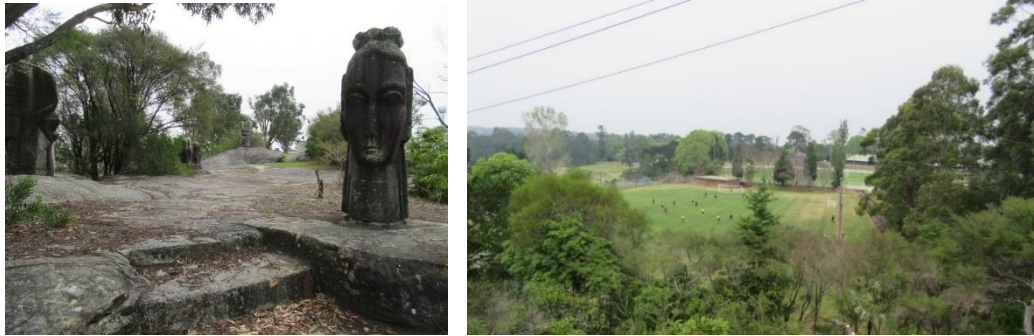
Images

History	This precinct formed part of the original layout of Mount Penang with the forming of the sporting fields and open space. Has been continually used as an active sporting precinct. The second Wondabyne sculpture symposium elements were relocated on the rock outcrop in the 1988.
Description	The Sports Precinct forms a well-used open space that is used for active recreation. It is located between the Heritage Precinct and the Bushland Precinct. This precinct is formal in nature with developed sports turf, nettings and other elements associated with active and formal recreational purposes. The area is defined by a substantial cut into the sandstone ridge that forms the edge of the Heritage Precinct and the extent of the formal fields to the bushland to the east.

Condition	Condition is good with well-maintained sports ovals and ancillary structures and spaces.
Significance	High
Guidelines	Maintain as sports fields and existing landscape framework.

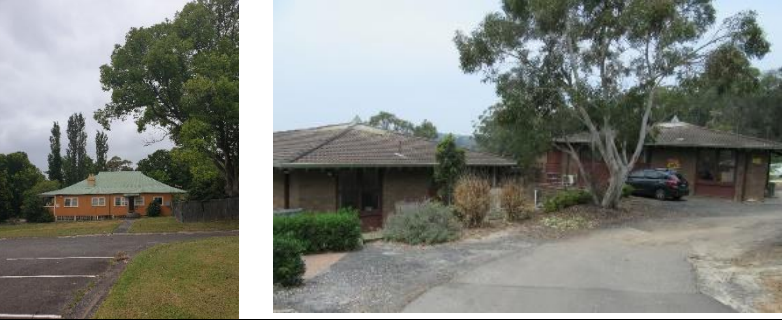
Images

History	This precinct has formed an essential part of the infrastructure for Mount Penang as the location of the main potable water supply for the complex. Much of the precinct was cleared of vegetation as evidenced by the aerial photograph of the 1970s (Fig 39) in the establishment period of the complex. The existing vegetation is essentially regrowth of native vegetation with selected and random cultural plantings established with the building of Philip House in the 1980s.
Description	Located on the minor ridge adjacent to the entry drive, this precinct has a major water reservoir that is screened by the trees that form part of the cultural plantings to the site. Philip House is situated in a more immediate cultural landscape within the broader context of this precinct.

Condition	Generally, the precinct is stable with both cultural landscape and regrowth of existing flora. There are remnant plantings of the Australian native planting scheme around Philip House. Cultural exotic plantings located to the north western portion of the precinct. Existing weeds are contained in ecotonal areas.
Significance	High
Guidelines	Continue to maintain the bushland as per Ecological Australia guidelines. Assess cultural plantings and remove over time cultural plantings as they decline. Assess new plantings to screen infrastructure and Philip House immediate surrounds.

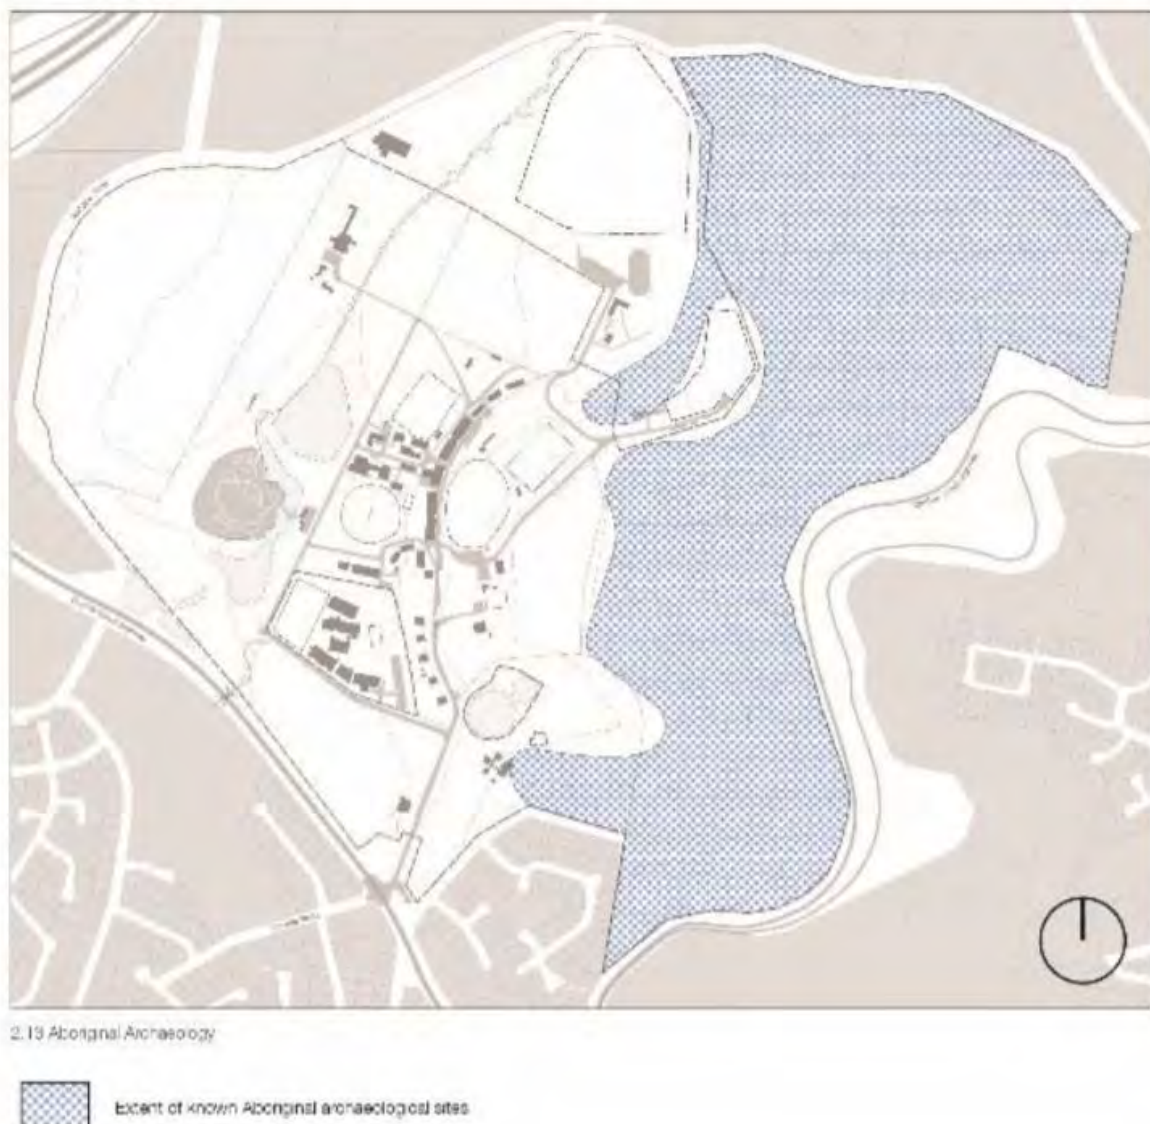
Figure 4: Aboriginal heritage mapping in the Gosford DCP 2014

Mapping is provided that highlights the entirety of the Bushland Precinct of the parklands as being the 'extent of known Aboriginal archaeological sites' within the area (Figure 4).

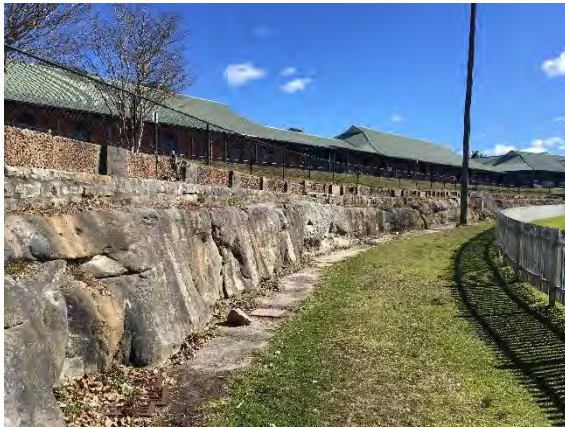
Figure 6: Exposed sandstone associated with grading to create a sports field, facing northwest

Site survey identified considerable levels of disturbance across a majority of the Mt Penang Parklands associated with historical land-use and development of the juvenile justice centre. Terracing of the naturally sloping landscape is visible in several areas across the parklands (Figure 6). Additionally, disturbance from landscaping has also occurred across the study area associated with the construction of carparks (Figure 7), dams (Figure 8) sports fields (Figure 9) and the construction of the Mt Penang gardens and Event Park (Figure 10). Large spoil piles were located in the western portion of the study area (Figure 11) that are likely associated with landscaping for the Mt Penang Gardens.

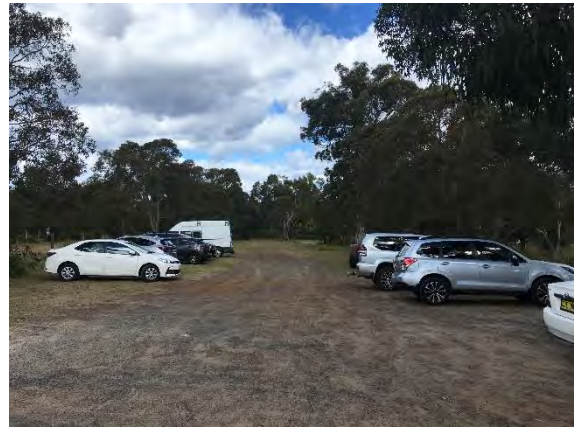
Figure 7: Large carpark located in the south of the study area, facing south

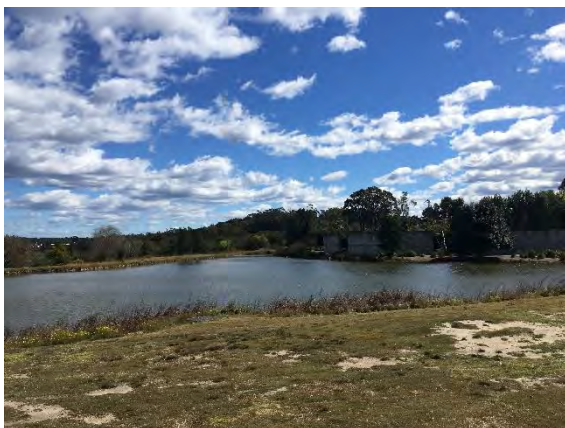
Figure 8: Large dam associated with the nearby Mt Penang Gardens, facing northwest

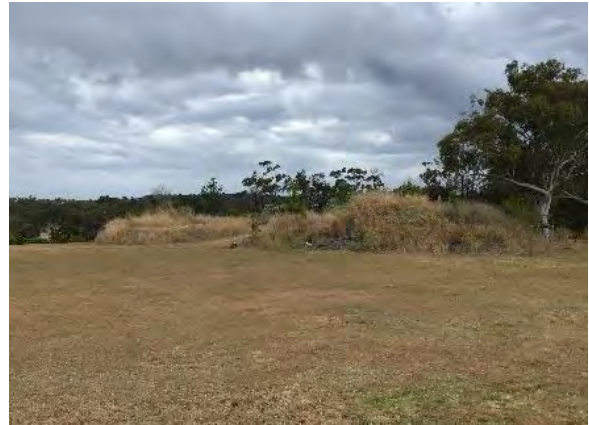
Figure 11: Large spoil piles located in the western portion of the study area, facing southwest

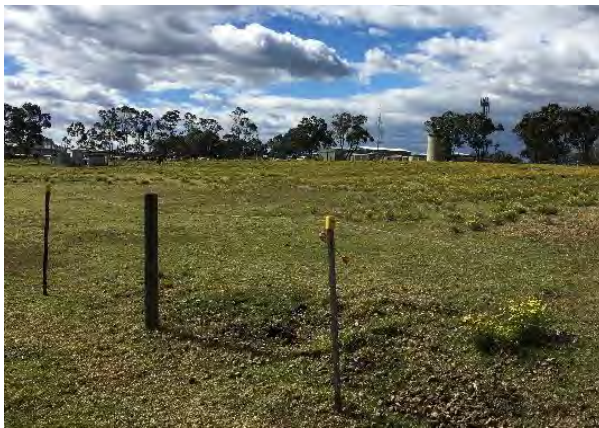
Figure 12: Pastoral land located in the north of the study area, facing north

Areas that have been exposed to less disturbance consist of large, open fields that are contained primarily within the north and north east of the study area. These areas are currently used primarily for pastoral purposes (Figure 12), with one open area previously used for music festivals that has been impacted by levelling and construction of asphalt roads (Figure 13).

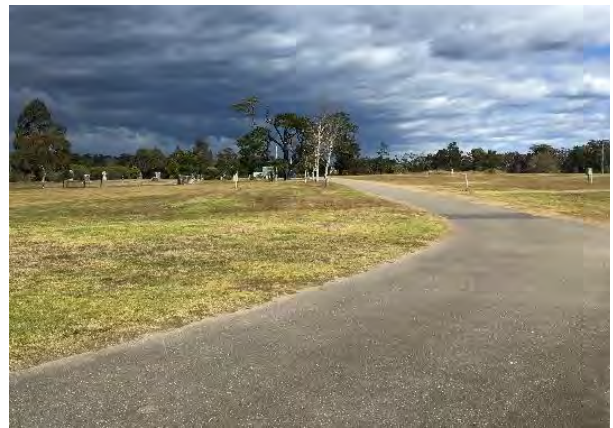
Figure 13: Asphalt road running through the festival site, facing west
