Mount Penang Parklands

Central Coast Highway, Kariong
(SHR listing number 01667)

Conservation Management Plan

November 2020 • Issue D
Project number 19 0069

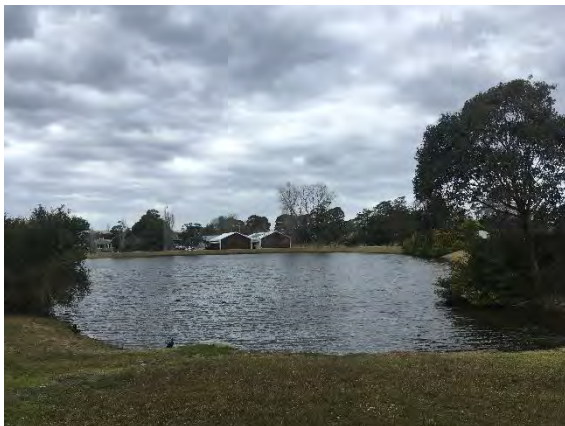
Figure 14: The dam located in the central portion of the study area, facing north

The first-order creek line that runs through the Mt Penang Parklands runs adjacent these open fields and feeds into a dam located in the centre of the study area (Figure 14). The drainage line has been subject to some disturbance, primarily in the northern part of the study area where the drainage line has been channelised and straightened. A number of bridges have been constructed as crossing points over the river (Figure 15) and include concrete piping.

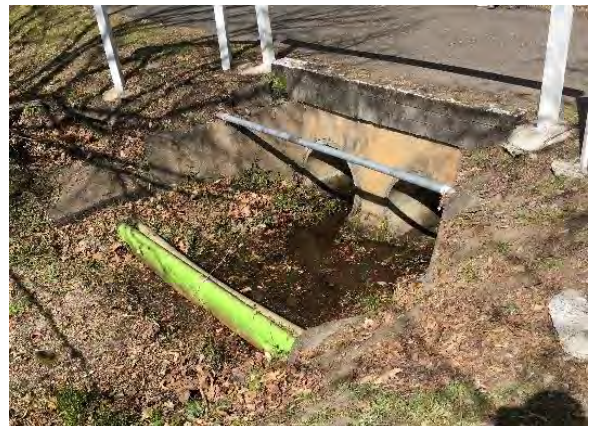
Figure 15: Crossing point across the first-order drainage line

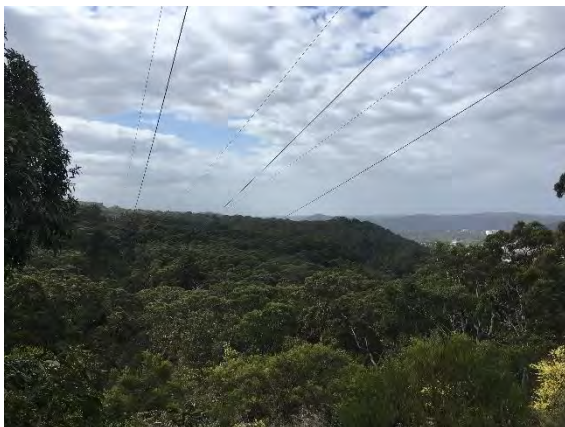
Figure 16: Overview of the Eastern Bushland Precinct. The only visible ground disturbance is from the construction of a transmission line and fire trails

Although no development is proposed for the eastern Bushland Precinct of the Mt Penang Parklands, a portion of this area was inspected for archaeological potential and an attempt was made to relocate the AHIMS sites previously recorded in the area. Access into the eastern Bushland Precinct was limited, and the area containing the previously recorded AHIMS sites was unable to be accessed. The site inspection confirmed the bushland precinct as being an area of archaeological sensitivity, due to a lack of disturbance (Figure 16), an abundance of sandstone outcrops (Figure 17) and the presence of multiple first and second-order creek lines in the northern portion of the precinct.

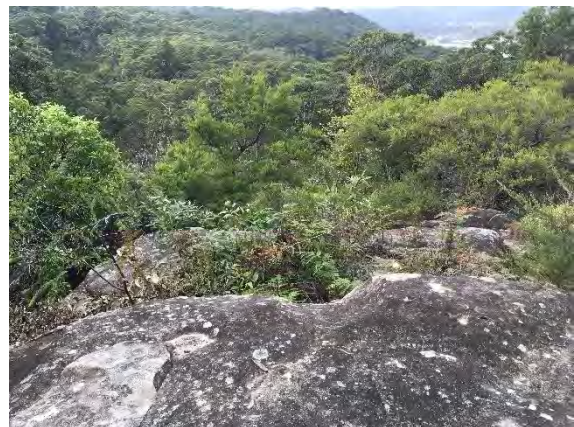
Figure 17: Sandstone in the Eastern Bushlands Precinct, facing northeast

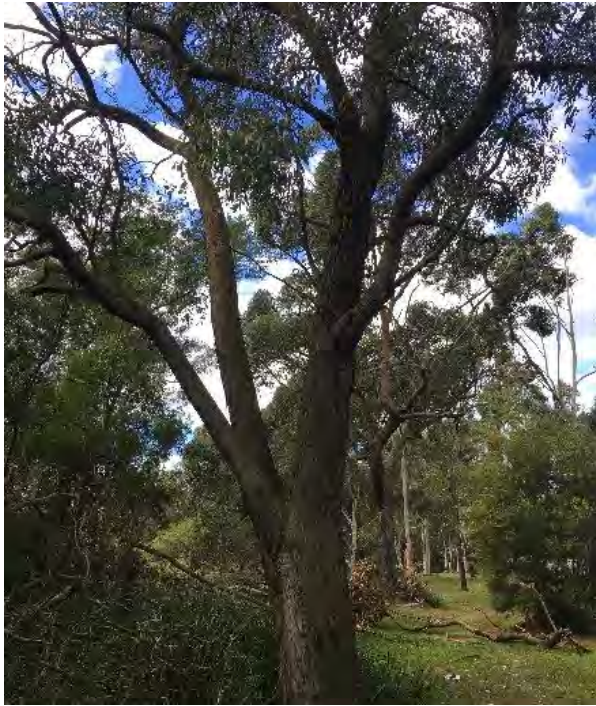
Figure 18: Scarred tree site #45-3-4044

An attempt was made to relocate the remaining registered AHIMS sites located within the Mt Penang Parklands. The only AHIMS site able to be relocated by ELA Archaeologists was the scarred tree site located in the study areas south (#45-3-4044; Figure 18; Figure 19). Further inspection of the scarred tree site led ELA archaeologists to conclude that it is not an Aboriginal site, due to the location of the scarring and the tree not possessing any hollows, contrary to the arborist report on the tree (UTMA 2018). The two rock engraving sites located in the parklands (#45-3-0037 and #45-3-1289) were unable to be relocated. As stated in the 2000 AMBS report, it is likely that the coordinates for AHIMS #45-3-0037 are incorrect. The coordinate location for AHIMS #45-3-1289 is situated within dense regrowth vegetation in the study areas west, with no exposed sandstone visible within this area, suggesting there is also potential for a recording error for the coordinates of AHIMS #45-3-1289.

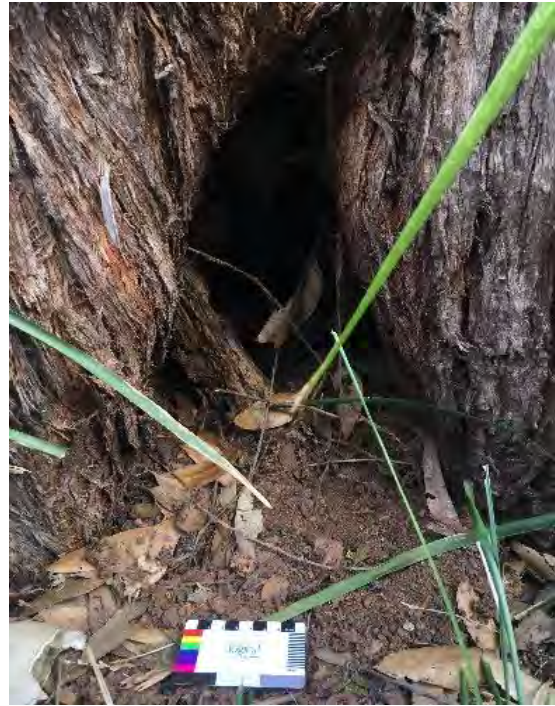
Figure 19: Scarring located at the bottom of AHIMS #45-3-4044

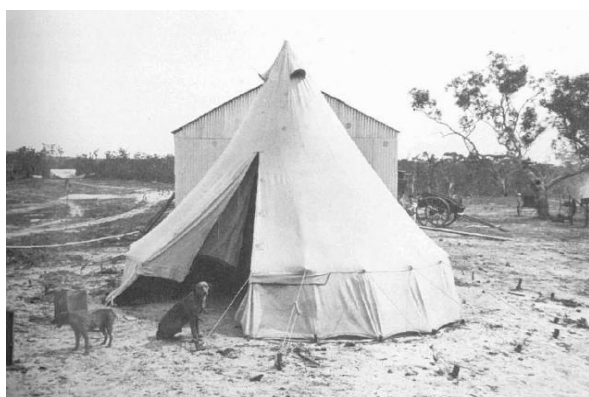
Figure 3: Tent and temporary structure 1912 (Rubie 2003: 19)

The initial 100 boys sent to the camp were tasked with the clearance of the land and construction of the early buildings. The boys camped in tents until a few temporary hardwood timber and galvanised iron structures were built. Some boys were still living in tents two years later. Most expenditure and labour during 1912 was on temporary structures and construction materials, equipment and stores were bought in by bullock, while the main building materials such as stone and timber were made or sourced on site. The quarry was an outcropping of sandstone to the north of the main building group.

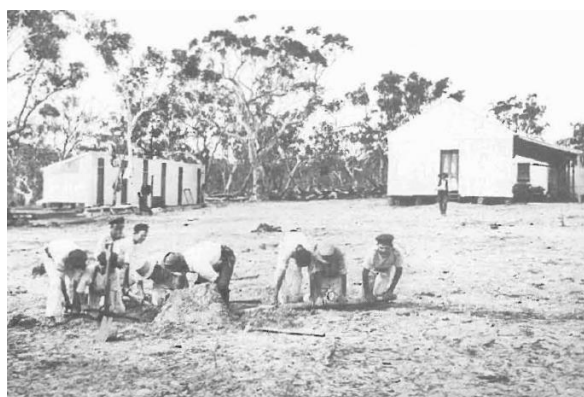
Figure 4: Temporary buildings on the site 1912 (Rubie 2003: 20)

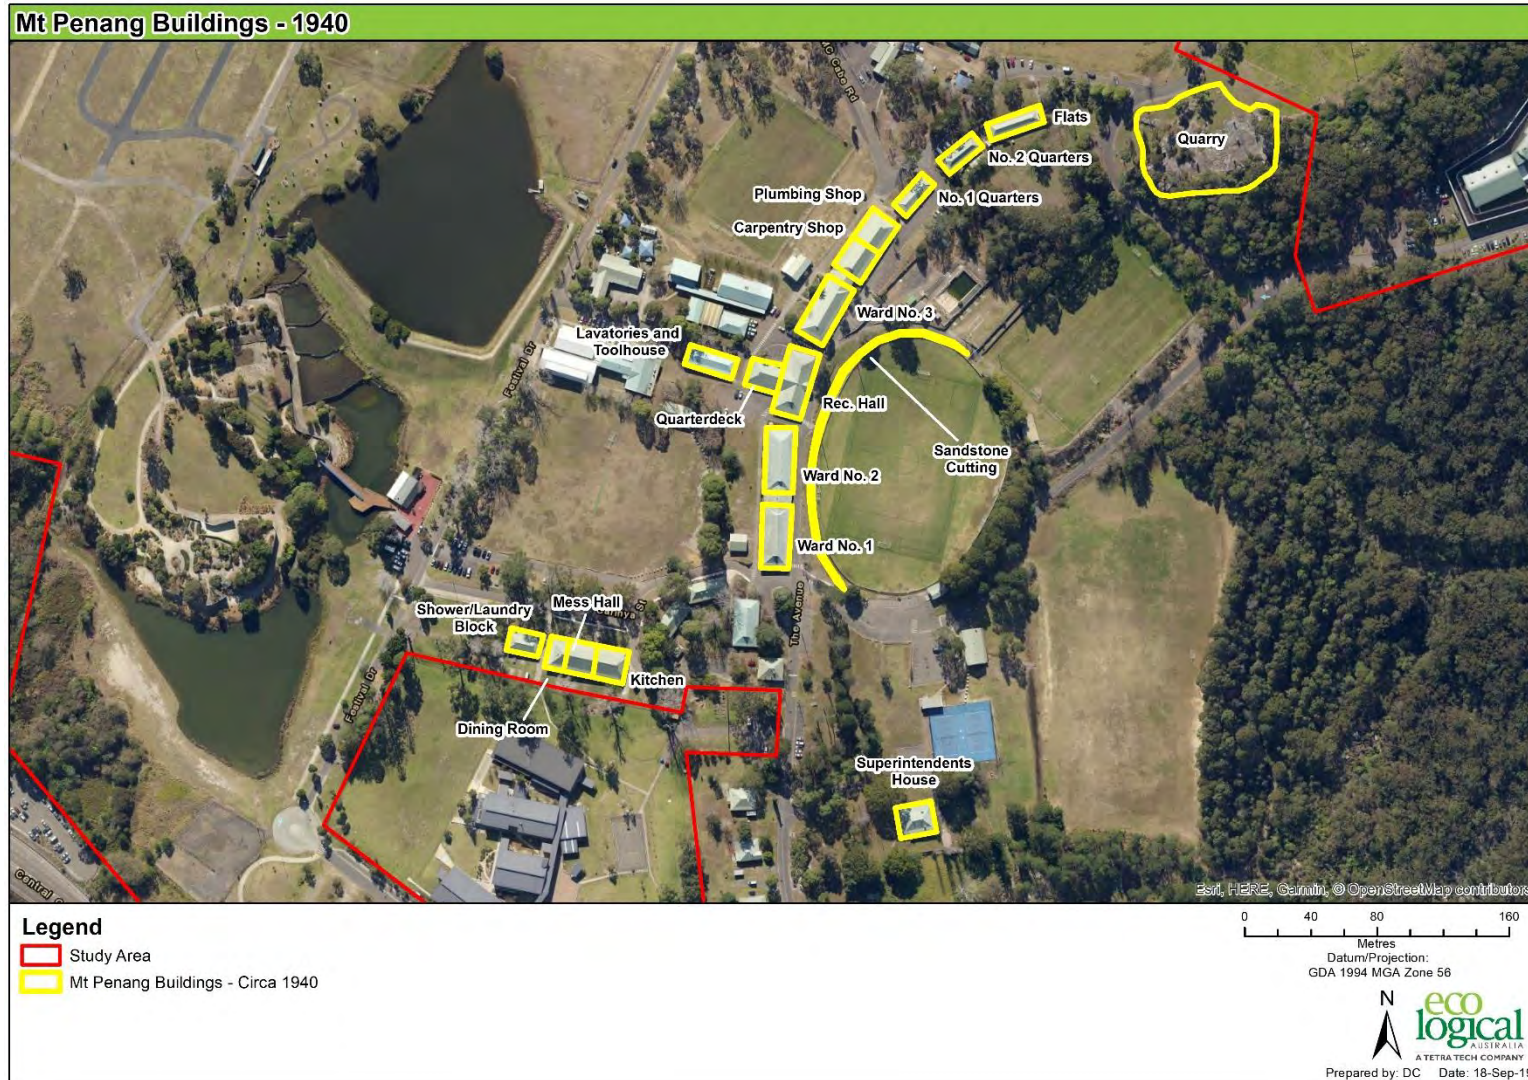
Figure 5 Location of buildings and features present on the site by 1940 (yellow outline)

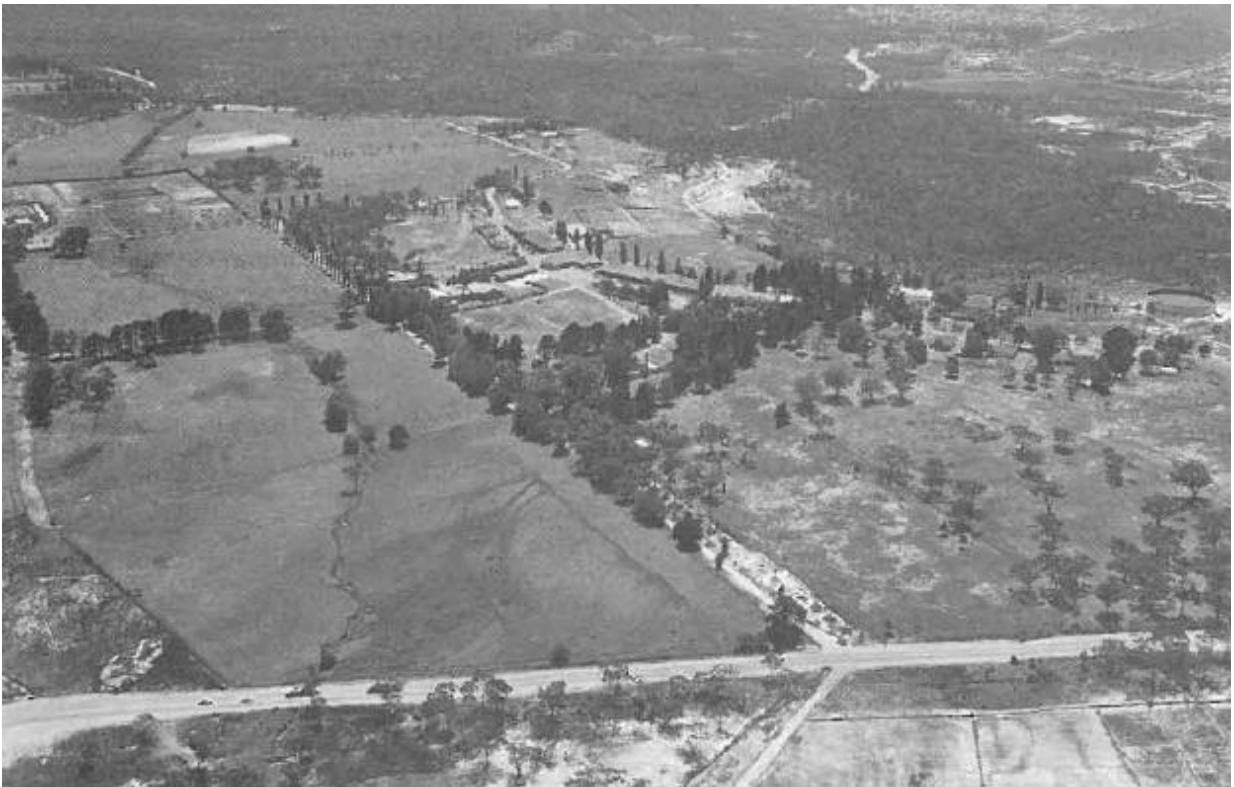
Figure 6 Late 1960s aerial image of the study area with Pacific Highway at the bottom, view north (Rubie 2003:10)

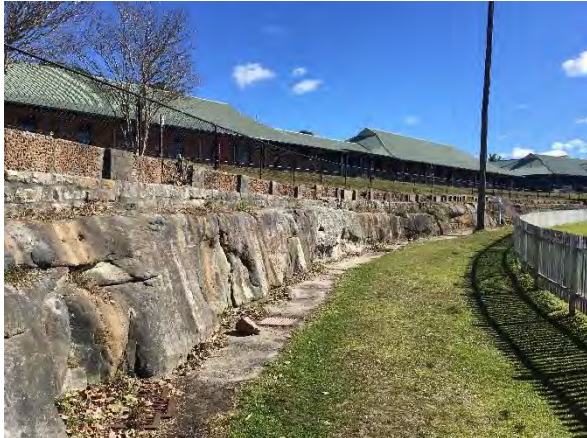
Figure 7: Cutting adjacent to the oval with dormitories behind

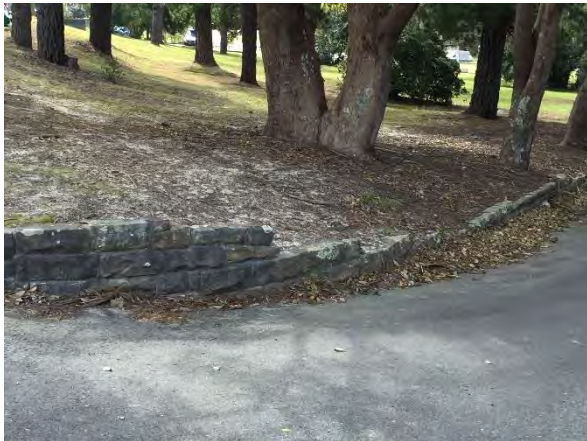
Figure 9: Stone retaining wall adjacent to The Avenue

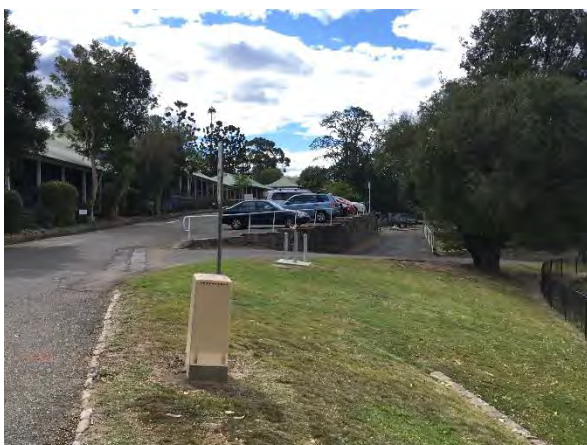
Figure 11: The Avenue, dormitories to the left and oval to the right demonstrating the fall of the land to the east

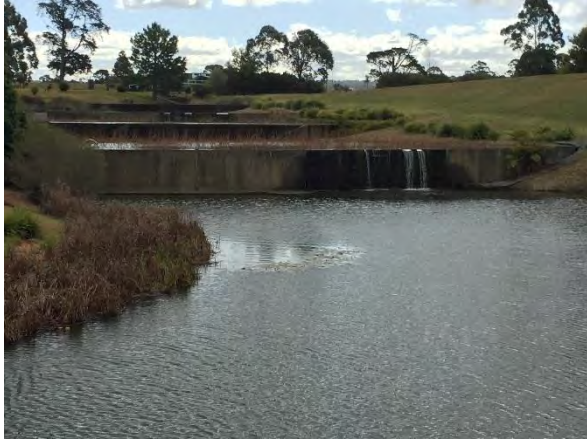
Figure 13: Tiered dam in the Parklands, view north

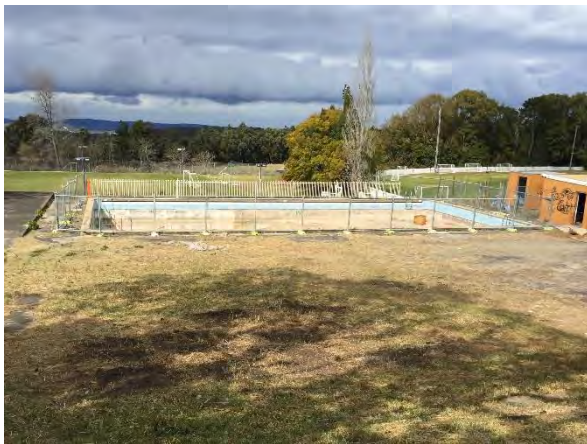
Figure 15: Disused swimming pool and eastern bushland view east toward Gosford

6. Sport Precinct, east of the Heritage Precinct, contains the original oval, playing field, open space, the former swimming pool, and the Former Superintendents House. Historically this area was heavily modified to accommodate the steep slope (Figure 15).

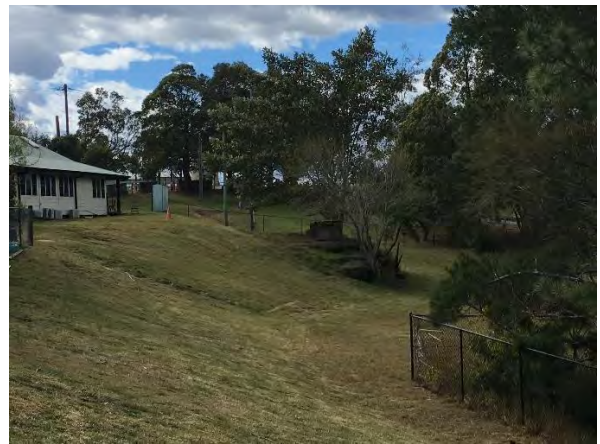
Figure 23: Far northern end of the Avenue and outcropping sandstone that has been quarried

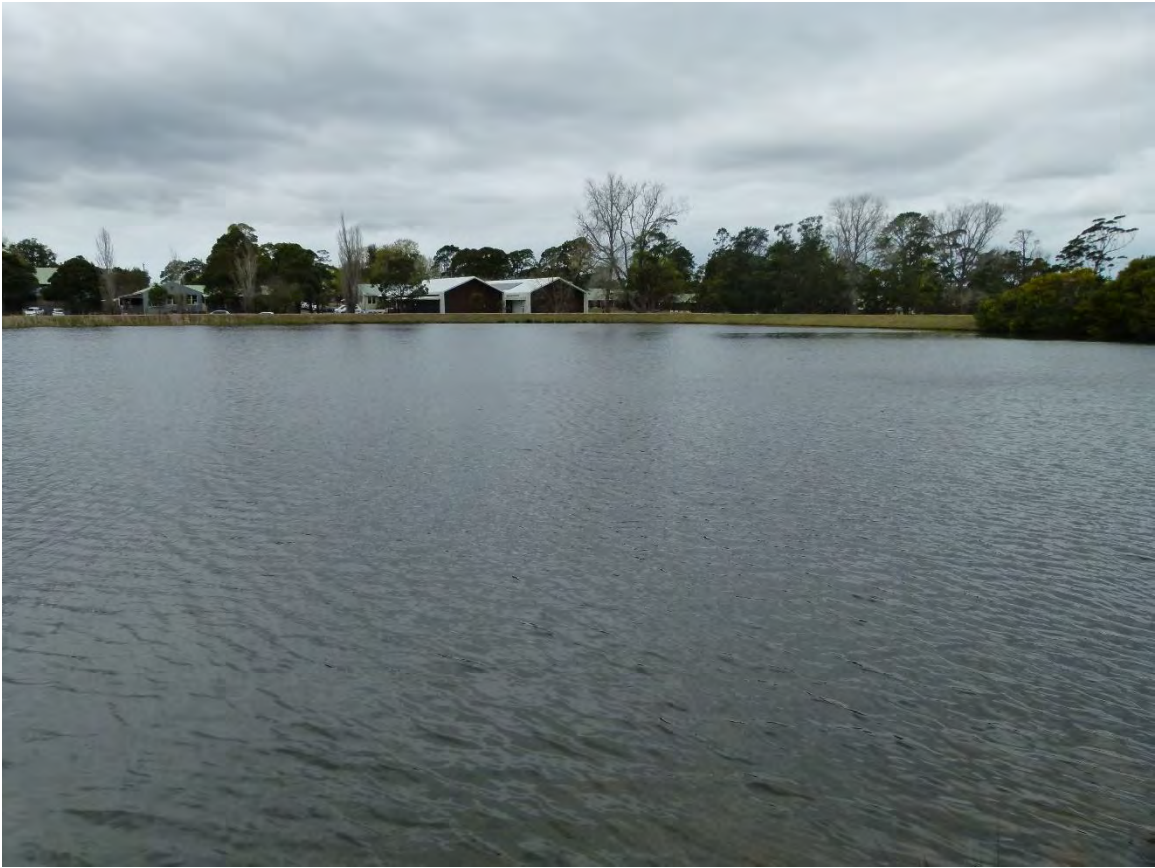
Figure 13: Heritage listed dam

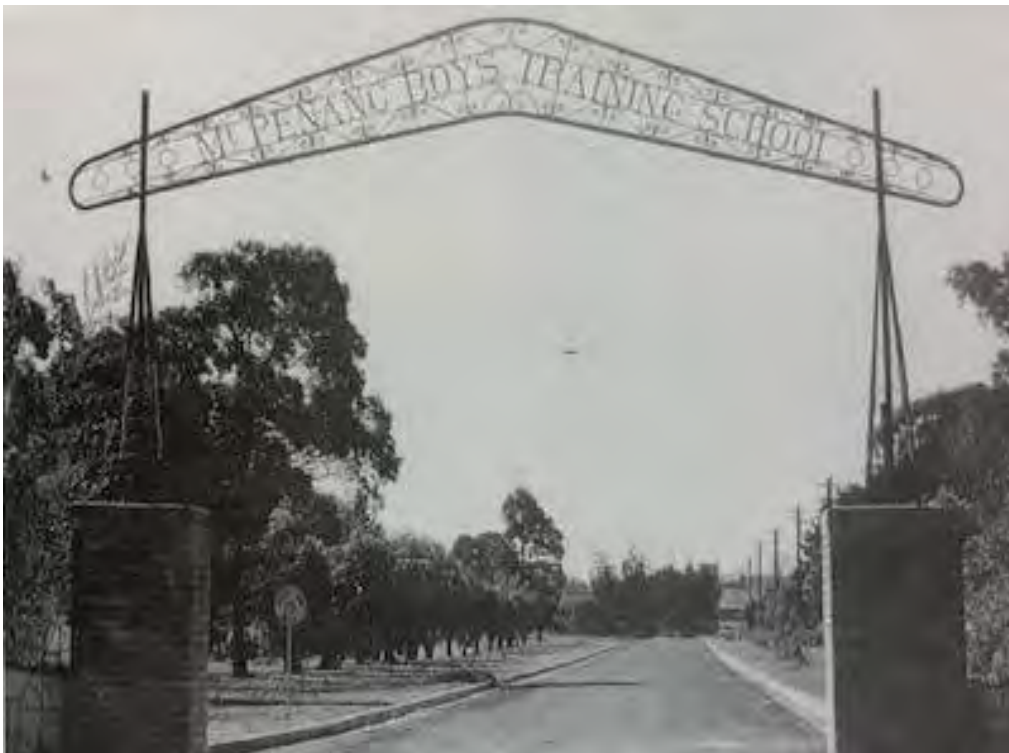
Figure 6: The sign at the entrance to Mount Penang training School for Boys, circa 1950 was made on site by the young men but had to be dismantled because it precluded trucks with a height clearance exceeding the allowance, from entering the site. (Image Find and Connect).

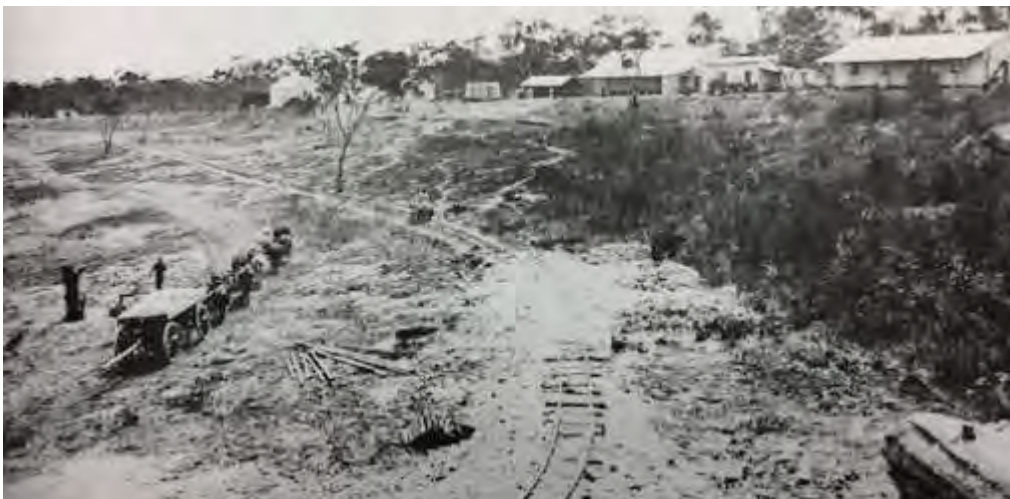
Figure 8: A tramline was constructed to move the quarried stone to the site under construction (Image Department of Community Services and Department of Juvenile Justice Historical Collection [Image DCS/ DJJ HC])

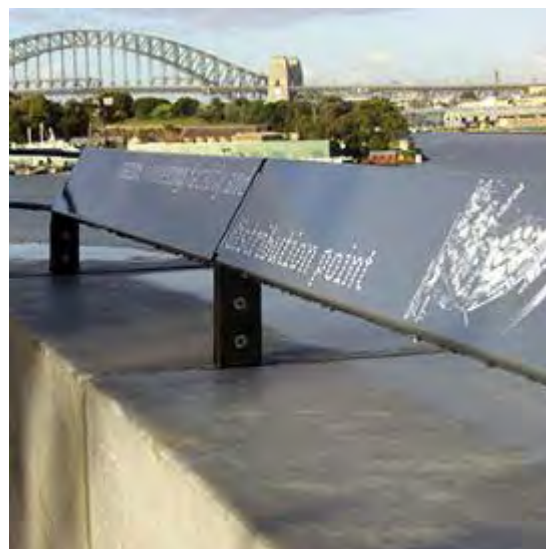
Figure 46: Metal signage provides a sturdy substrate for depicting images and text and can successfully interpret wider views about a site in an outdoor setting (Image accessed on the internet)

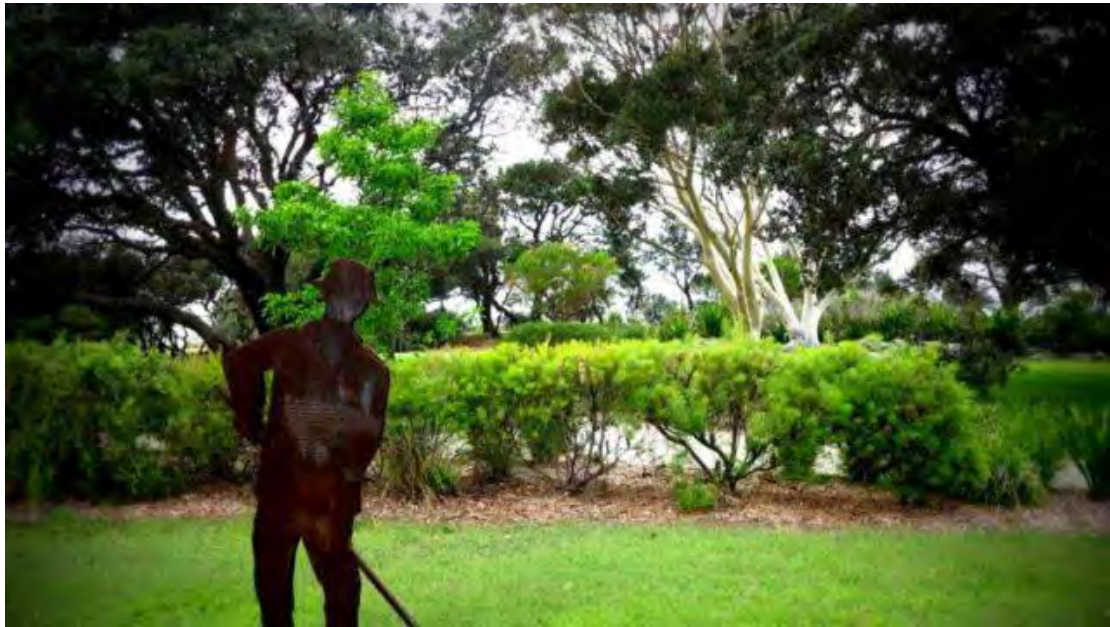
Figure 47: Bob a Day Park at Little Bay has a corten steel cut-out depicting a labourer in the Coast Hospital grounds, nicknamed for the payment of a shilling a day for his work (Image Randwick City Council)

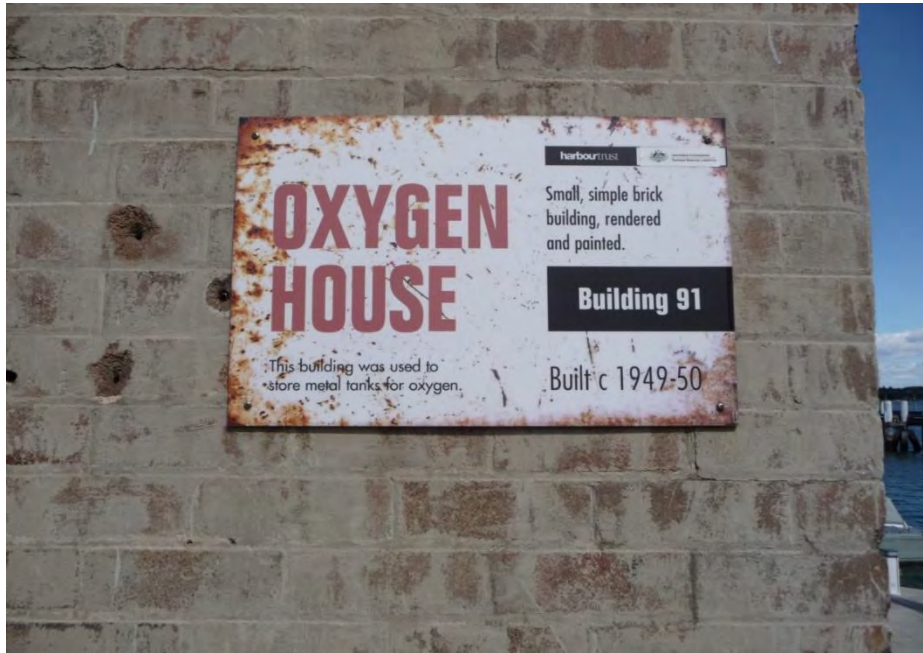
Figure 49: Building identification signage is useful as site orientation and can incorporate heritage information. This example is located at Cockatoo Island. (Image M Betteridge 2017)

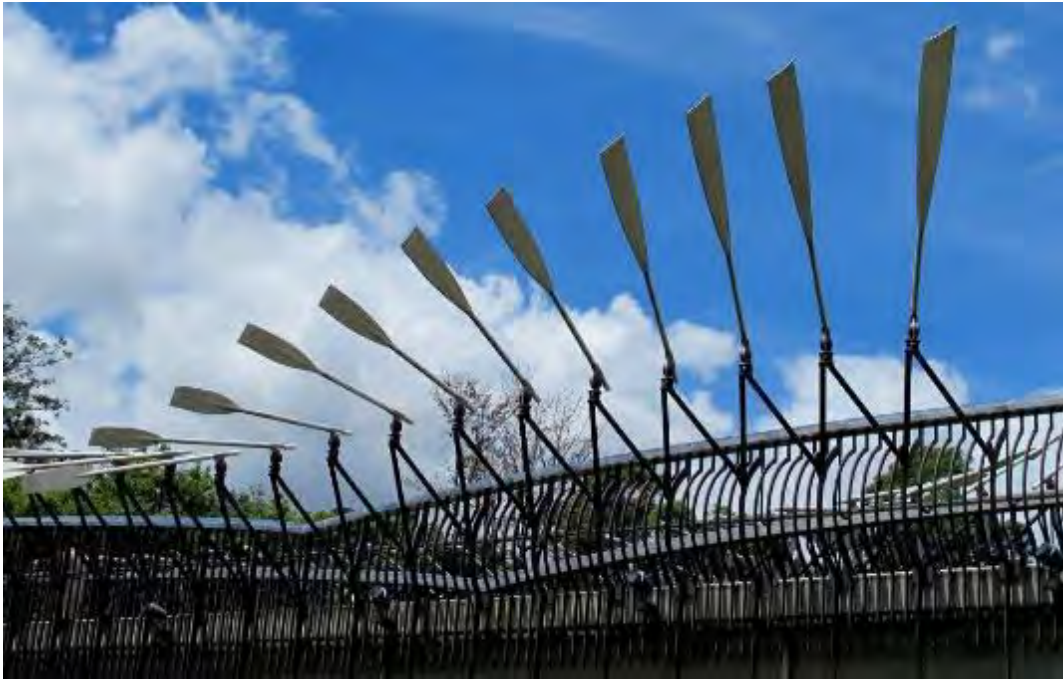
Figure 53: *Wake*, constructed in 2003 as a footbridge over the Parramatta River demonstrates the success of combining public art and interpretation into infrastructure. This method is a seamless way of presenting interpretation.
